PHOTOGRAPHS

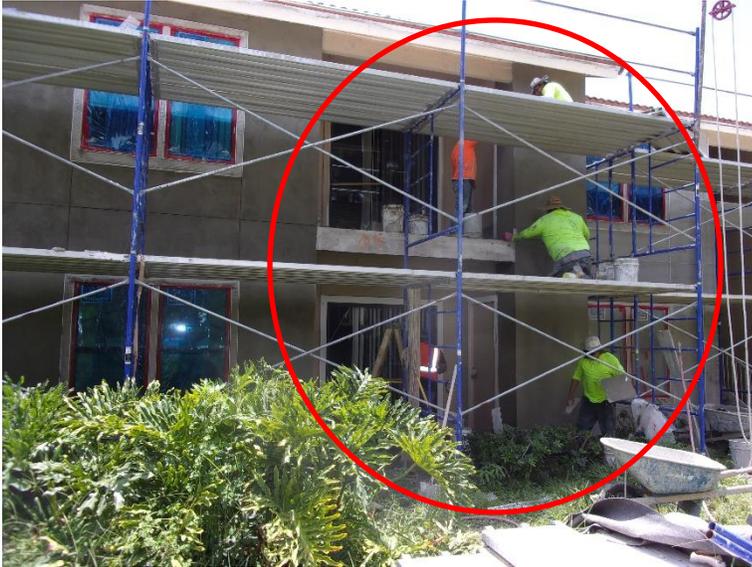
PHOTOGRAPH #1

BUILDING 21 SECTION F

Stucco sub-contractors applying finish coat of stucco.

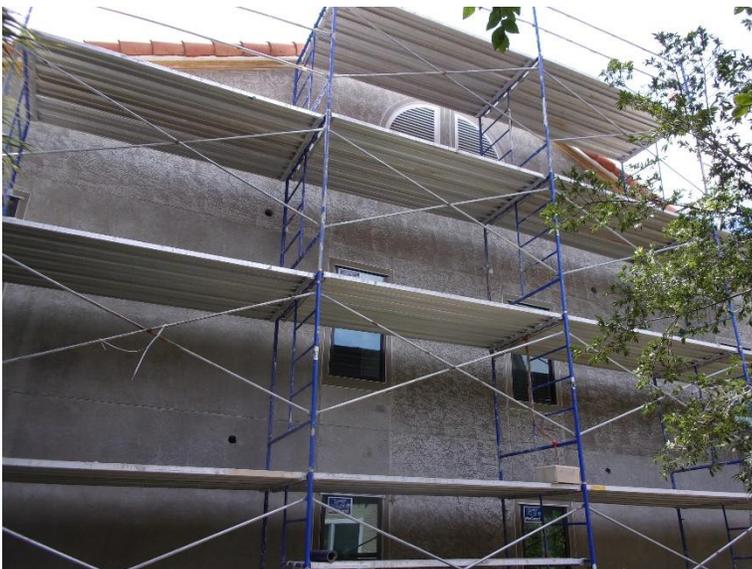
PHOTOGRAPH #2

BUILDING 21 SECTION D

Stucco sub-contractors have completed three coat stucco system using Broco premixed stucco by Cemex.

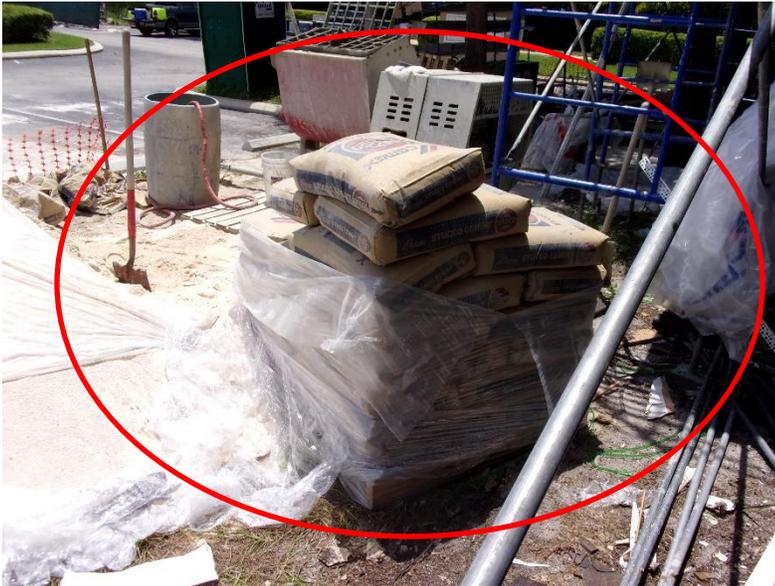
PHOTOGRAPH #3

**BUILDING 21
SECTION D**

Stucco sub-contractors have completed three coat stucco system using Broco premixed stucco by Cemex.

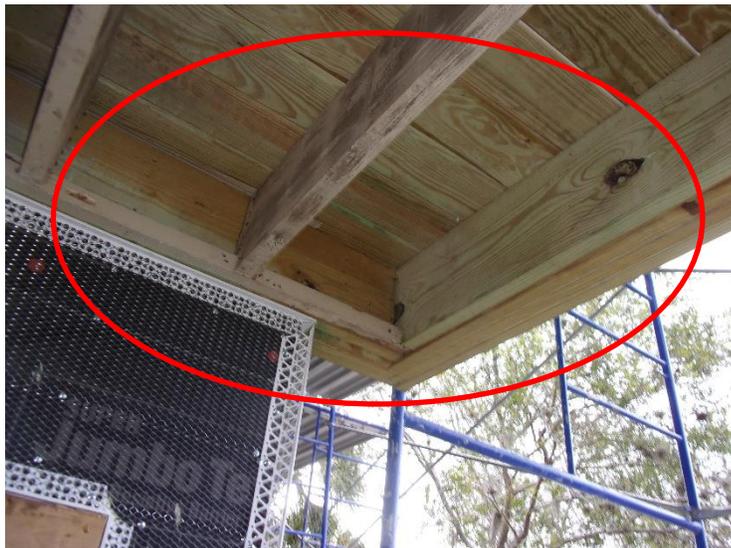
PHOTOGRAPH #4

**BUILDING 21
SECTION C**

Balconies repairs and decking replacement completed. Simpson Strong -Tie hardware has not yet been installed.

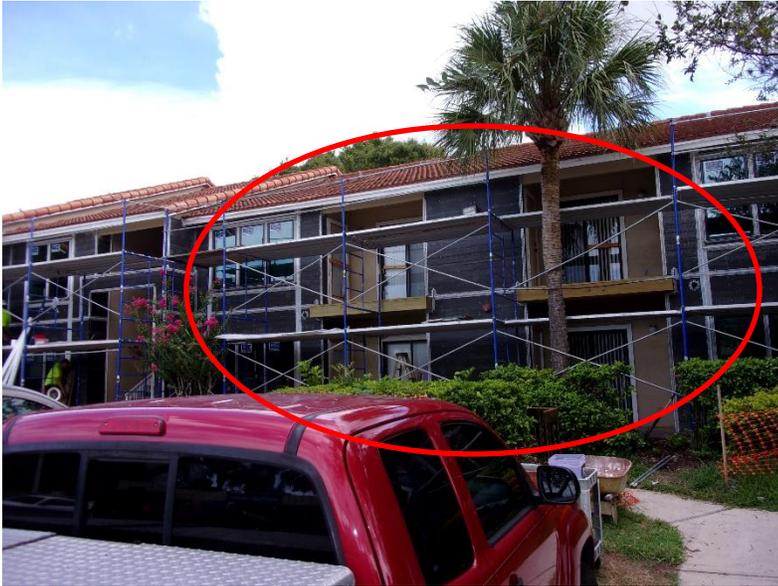
PHOTOGRAPH #5

**BUILDING 21
SECTION B**

Stucco subcontractor has applied stucco accessories and metal lathing.

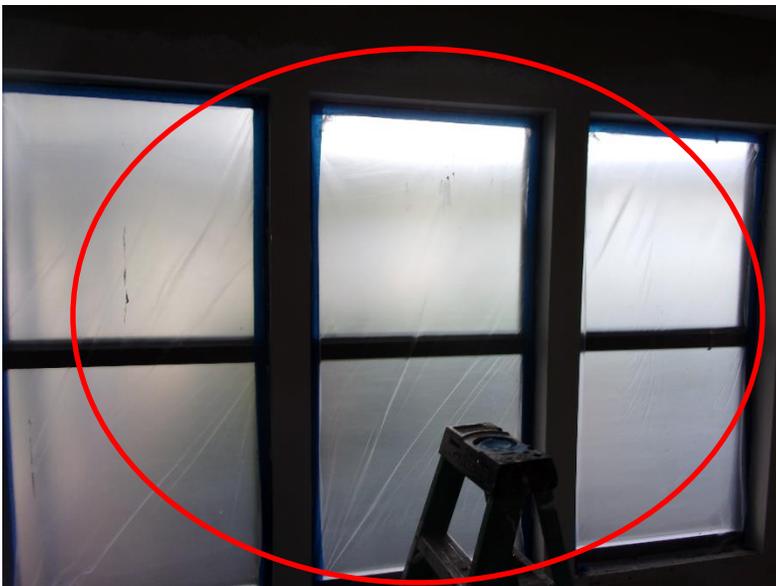
PHOTOGRAPH #6

**BUILDING 21
SECTION B- UNIT 2115**

Contractor finishing window interior sealant details, drywall replacement and drywall texture.

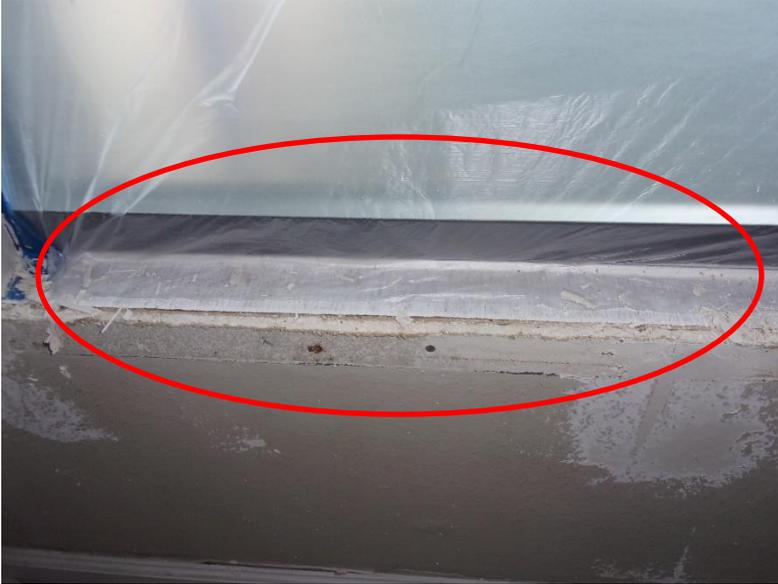
PHOTOGRAPH #7

**BUILDING 21
SECTION B- UNIT #2115**

Contractor finishing window interior sealant details, drywall replacement and drywall texture.

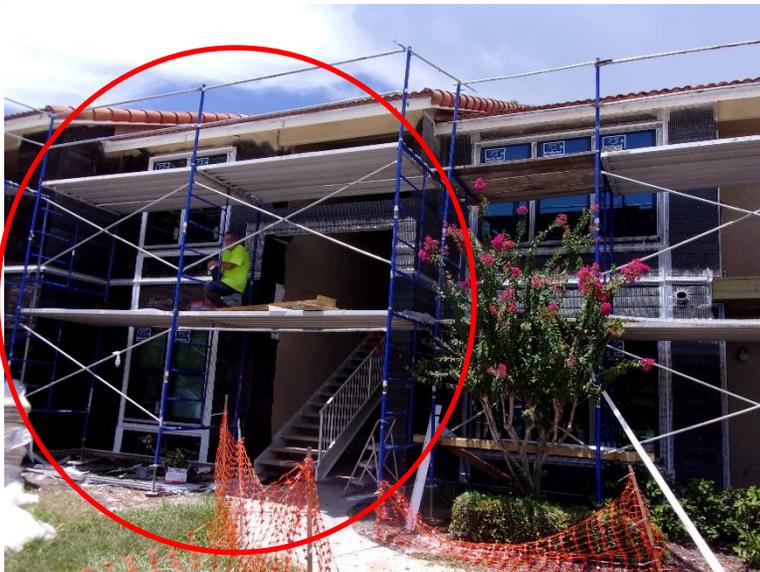
PHOTOGRAPH #8

**BUILDING 21
SECTION A**

Subcontractor has completed installation of JumboTex WRB and in process of applying stucco accessories and metal lathing.

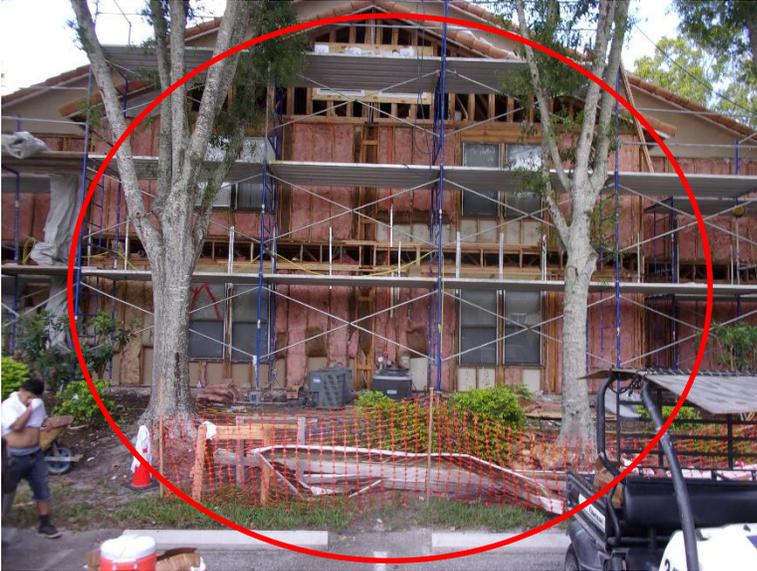
PHOTOGRAPH #9

**BUILDING 20
SECTION H**

Contractor has performed framing repairs and gable end reinforcement repairs.

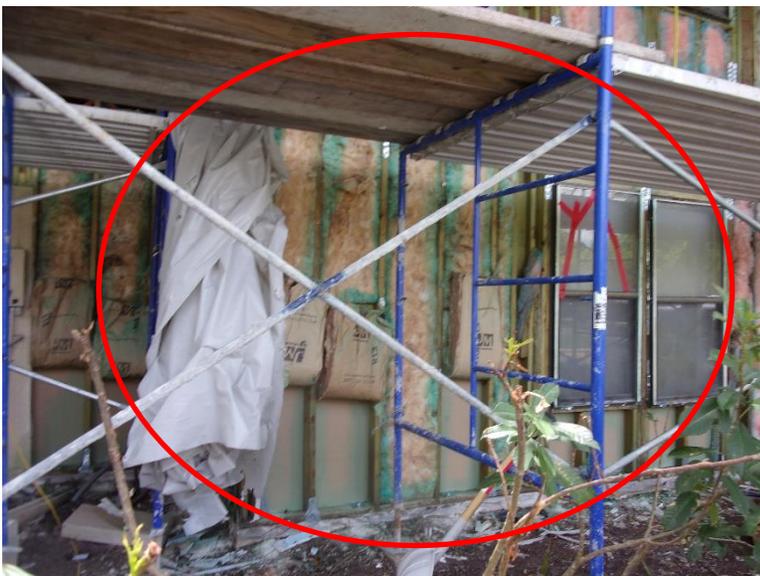
PHOTOGRAPH #10

**BUILDING 20
SECTION H**

BoraCare termite treatment applied at wall framing members by pest sub-contractor.

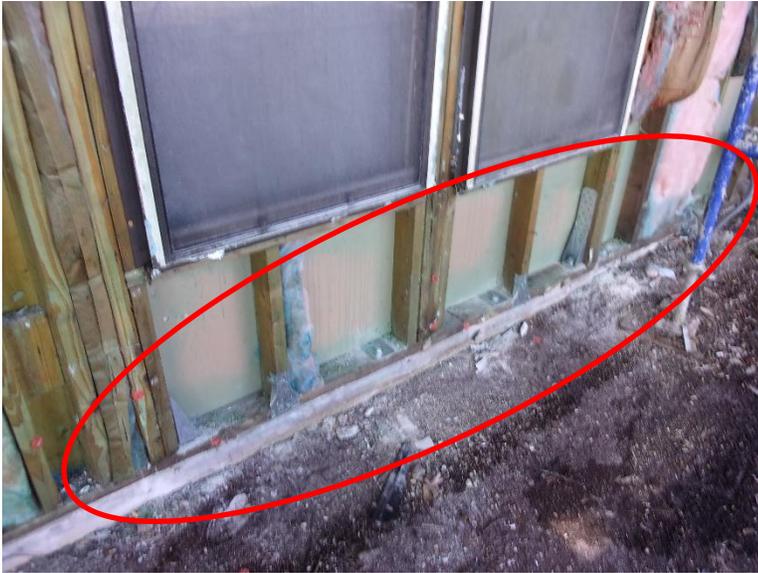
PHOTOGRAPH #11

**BUILDING 20
SECTION H**

Titan HD fasteners and Simpson Strong Tie connectors installed at base plate.

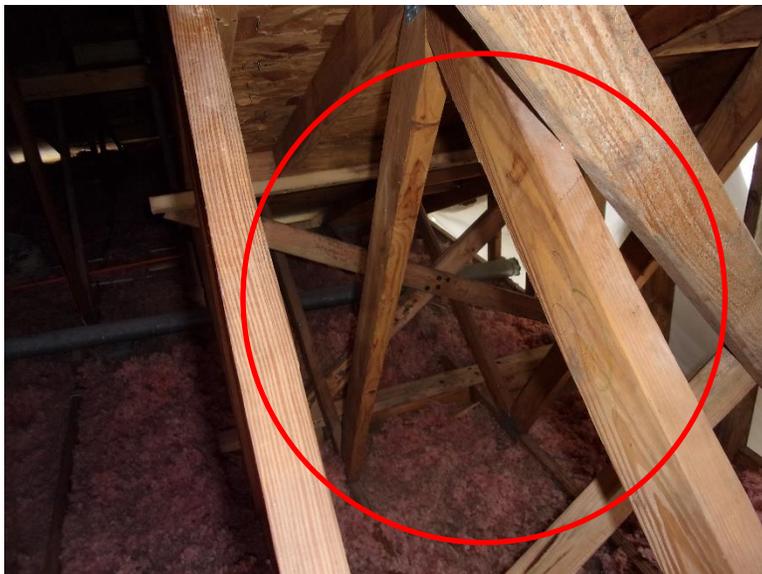
PHOTOGRAPH #12

**BUILDING 20
SECTION H**

Cross bracing gable reinforcement repairs in place.

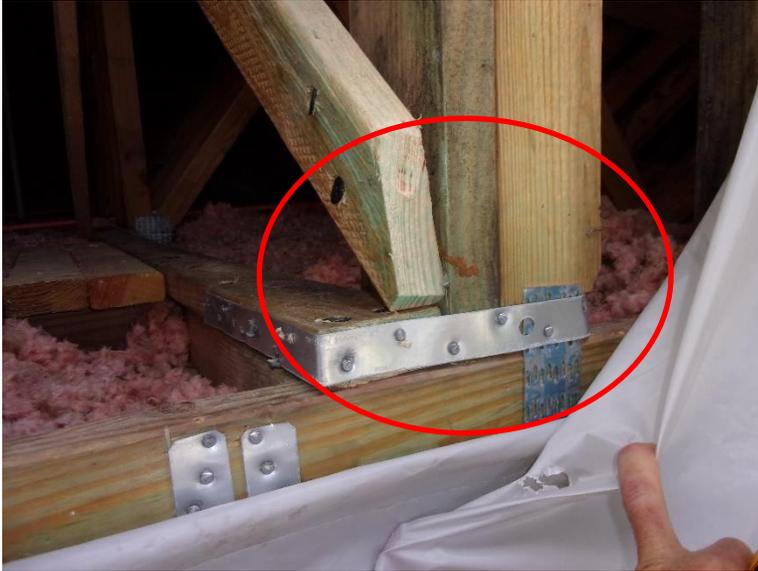
PHOTOGRAPH #13

**BUILDING 20
SECTION H**

Simpson Strong-Tie strapping installed at cross bracing reinforcement.

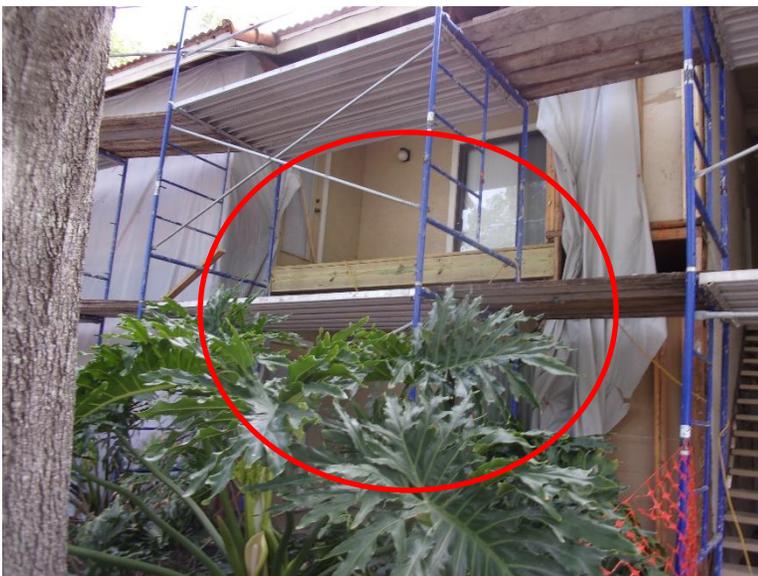
PHOTOGRAPH #14

**BUILDING 20
SECTION A**

Contractor has performed balcony edge rail beam repair.

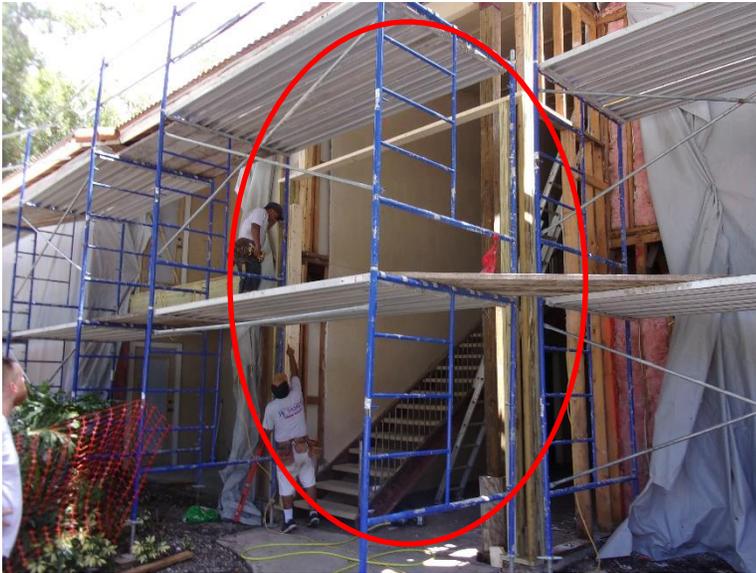
PHOTOGRAPH #15

**BUILDING 20
SECTION A**

Contractor replacing damaged breezeway framing.

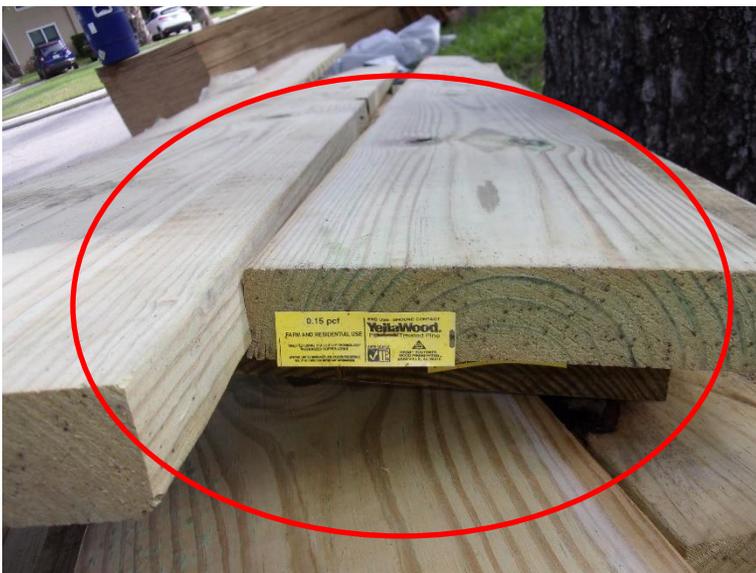
PHOTOGRAPH #16

**BUILDING 20
SECTION A**

Pressure treated lumber delivered for built up beam repairs at balconies and breezeways.
