PHOTOGRAPHS

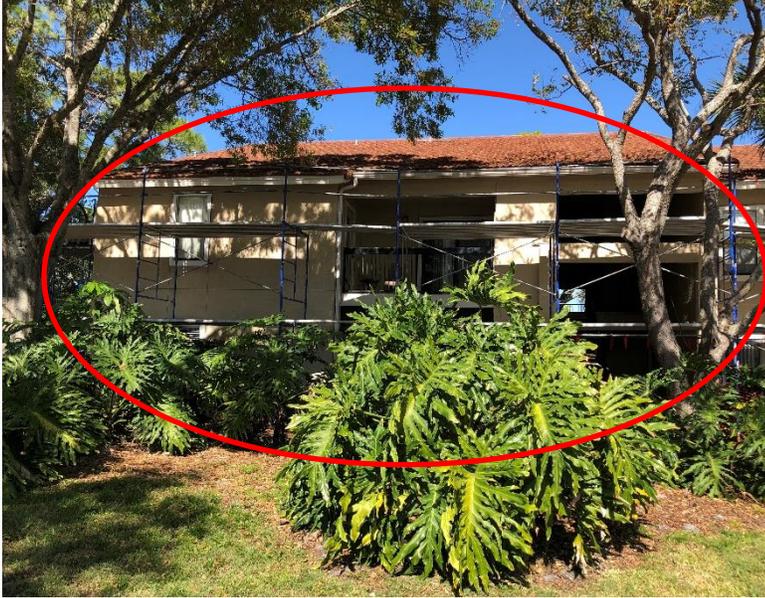
PHOTOGRAPH #1

BUILDING 7 SECTION A

Contractor installed scaffolding in preparation of sheathing removal.

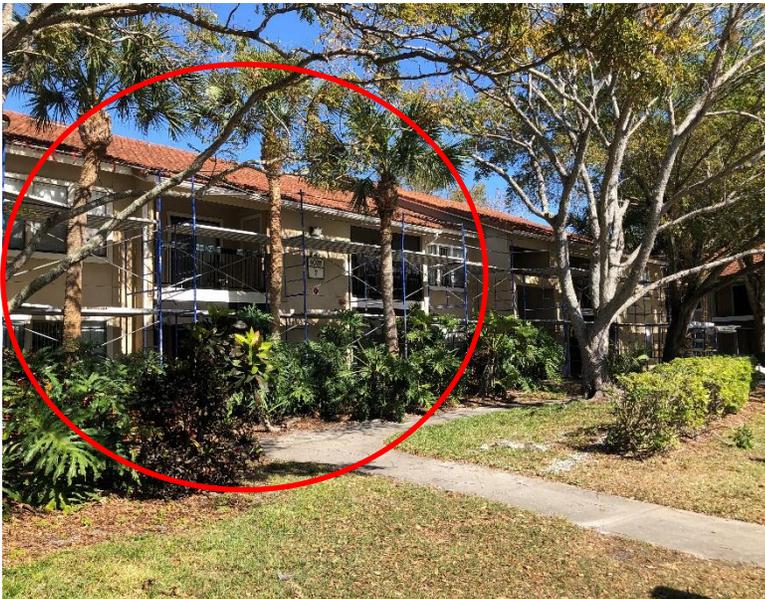
PHOTOGRAPH #2

BUILDING 7 SECTION B

Contractor installed scaffolding in preparation of sheathing removal.

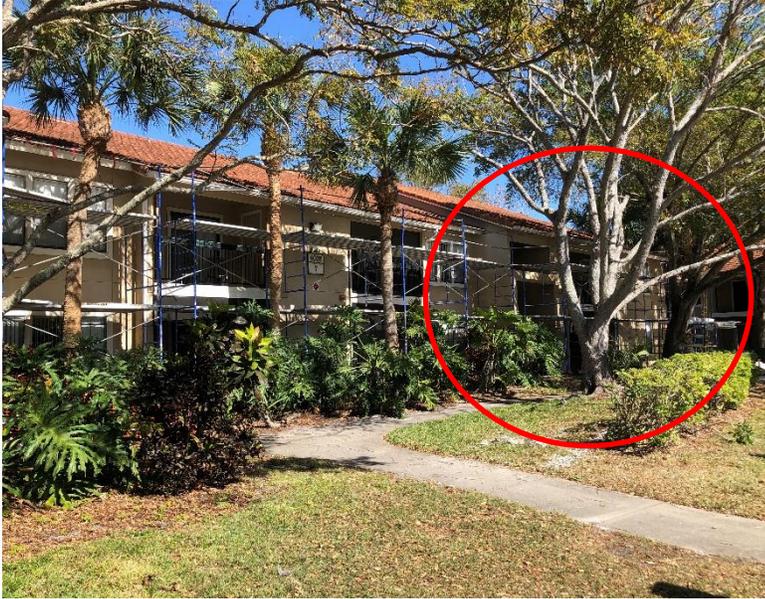
PHOTOGRAPH #3

**BUILDING 7
SECTION C**

Contractor installed scaffolding in preparation of sheathing removal.

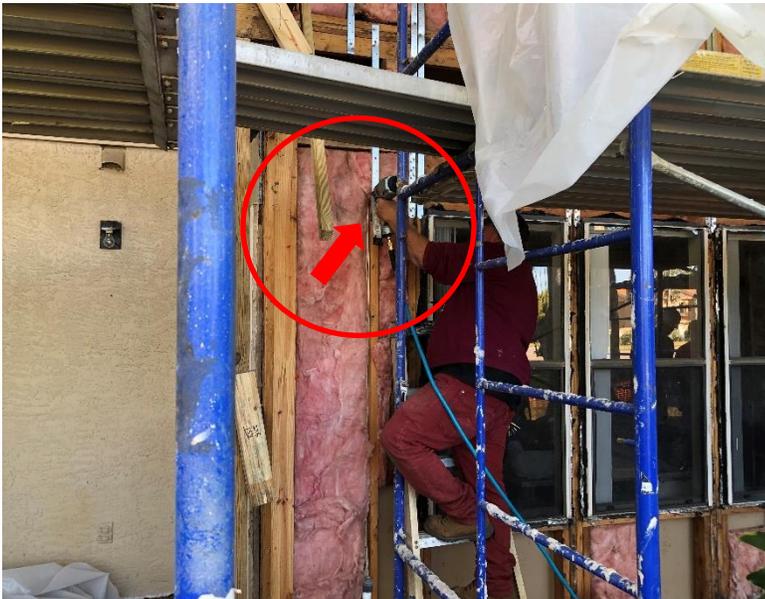
PHOTOGRAPH #4

**BUILDING 7
SECTION F**

Contractor installing 10d nails at MSTA 36 Simpson Strong-tie connectors, as per drawings and specifications.

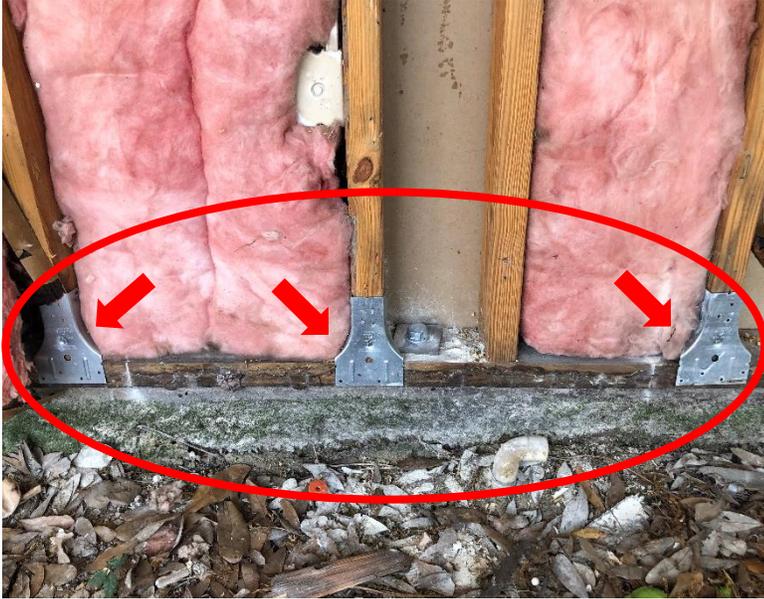
PHOTOGRAPH #5

**BUILDING 7
SECTION G**

Contractor installed Simpson Connectors (Stud Plate Tie (SP1)) for the base of all studs within the maximum allowable spacing of 16 inches, on-center for all truss bearing walls, as per drawings and specifications.

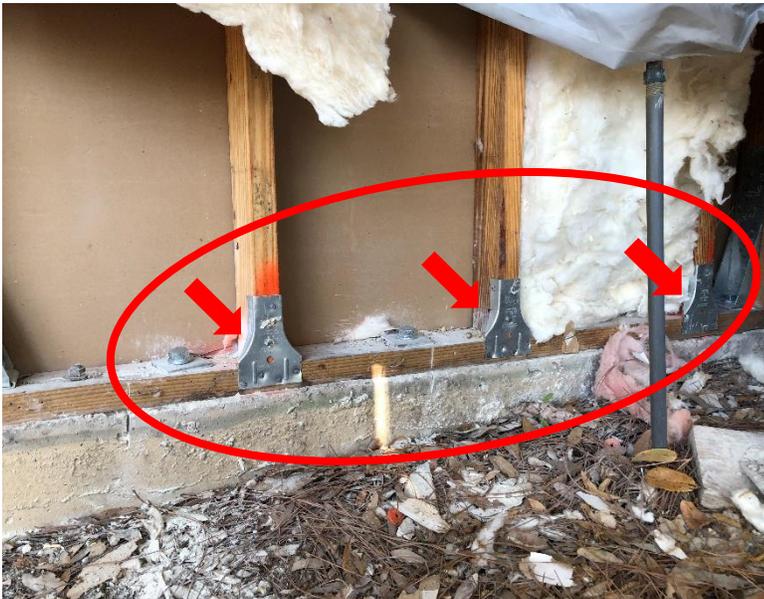
PHOTOGRAPH #6

**BUILDING 7
SECTION G**

Contractor installed Simpson Connectors (Stud Plate Tie (SP1)) for the base of all studs within the maximum allowable spacing of 16 inches, on-center for all truss bearing walls, as per drawings and specifications.

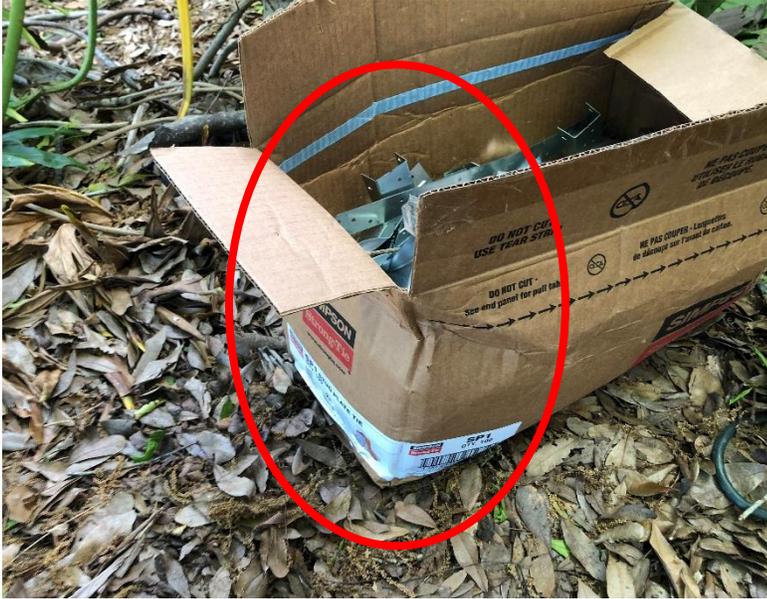
PHOTOGRAPH #7

**BUILDING 7
SECTION G**

Simpson Stud Plate Tie (SP1) to be installed at the base of all studs for Truss Bearing Walls, as per drawings and specifications.

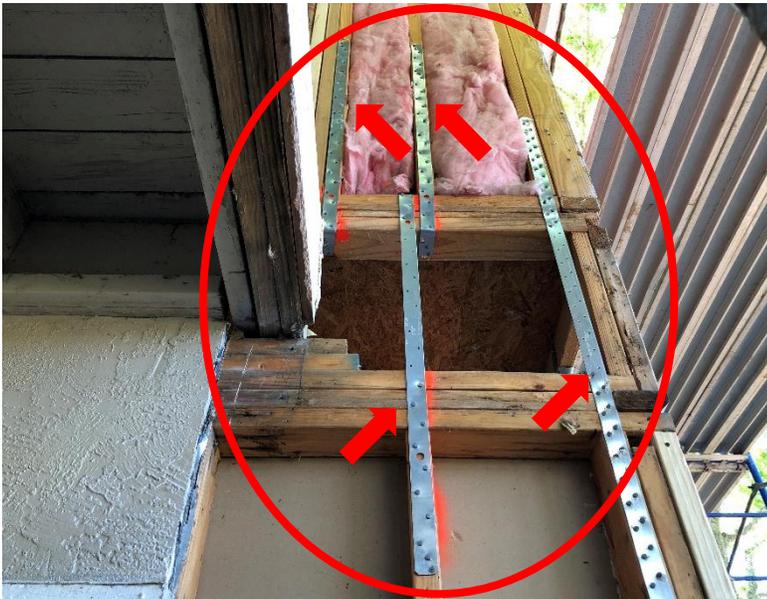
PHOTOGRAPH #8

**BUILDING 7
SECTION G**

Simpson Connector Straps (MSTA-36) installed near 2nd Floor Balcony wall return, as per drawings and specifications.

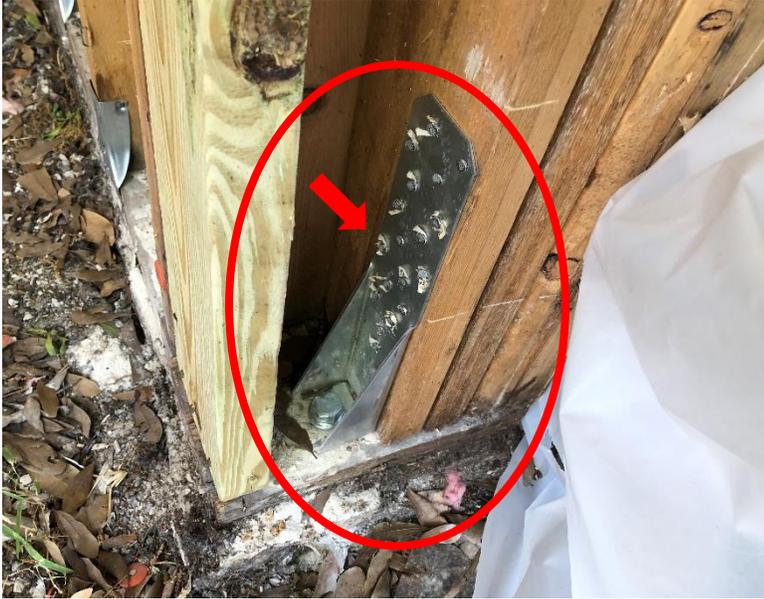
PHOTOGRAPH #9

**BUILDING 7
SECTION G**

Simpson Connector (HTT4) installed near base of Breezeway Box Beam with Simpson Connector (Simpson Strong-Tie 5/8"x 8" Titen HD Anchors), as per drawings and specifications.

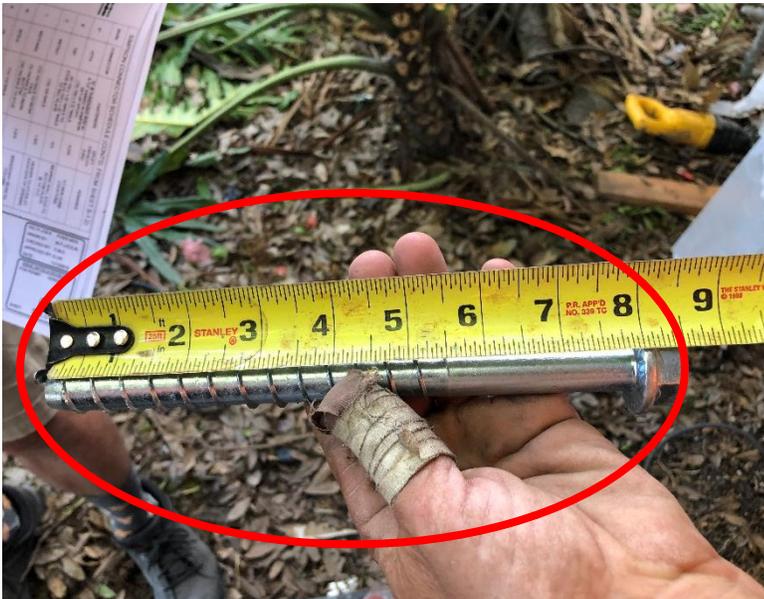
PHOTOGRAPH #10

**BUILDING 7
SECTION G**

Simpson Connector (HTT4) installed near base of Breezeway Box Beam with Simpson Connector (Simpson Strong-Tie 5/8"x 8" Titen HD Anchors), as per drawings and specifications.

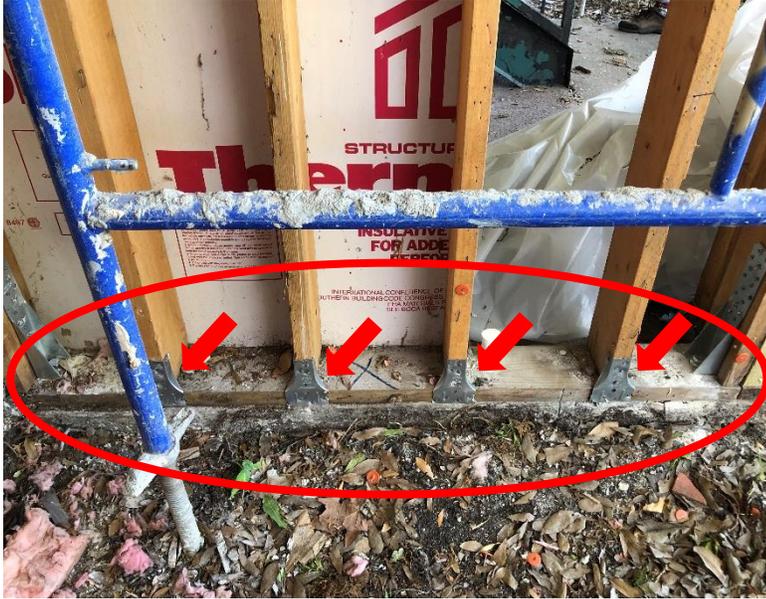
PHOTOGRAPH #11

**BUILDING 7
SECTION H**

Simpson Stud Plate Tie (SP1) to be installed at the base of all studs for Truss Bearing Walls, as per drawings and specifications.

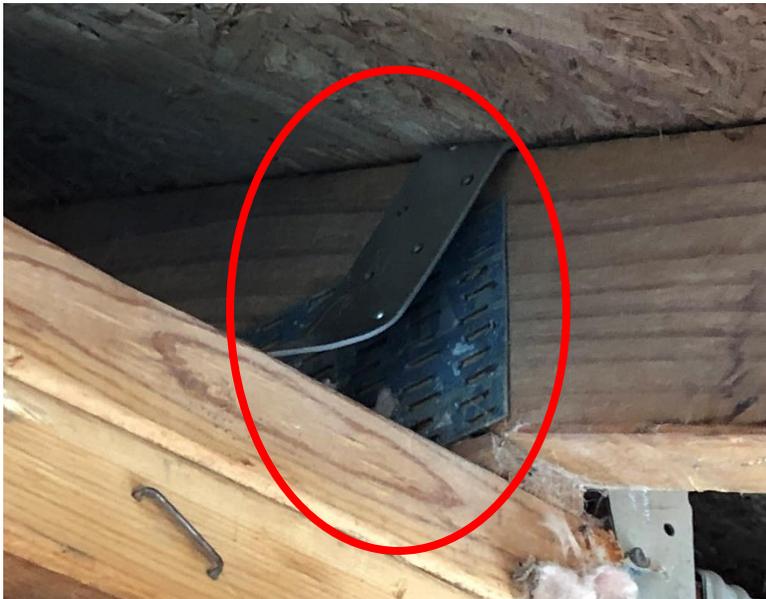
PHOTOGRAPH #12

**BUILDING 7
SECTION G**

Contractor to install missing Fasteners for the Simpson Connector MTS 18 into Roof Truss Member, as per drawings and specifications.

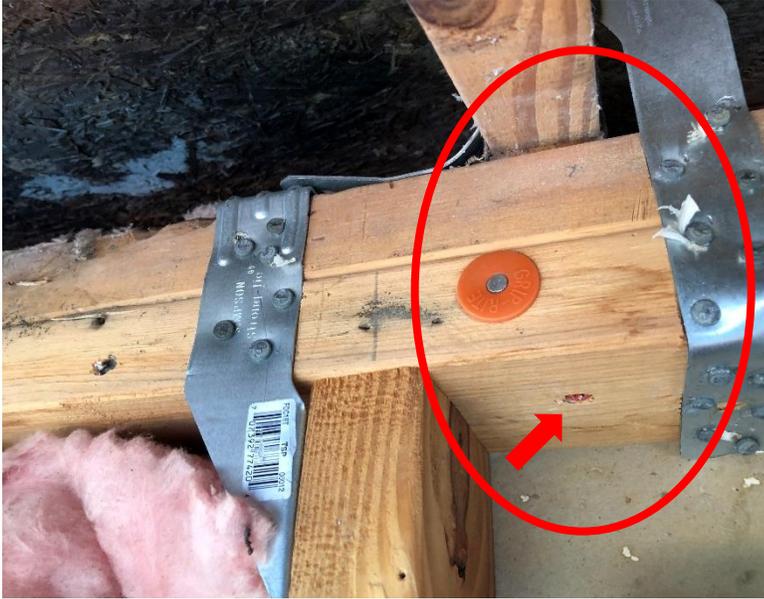
PHOTOGRAPH #13

**BUILDING 7
SECTION G**

Simpson SDWC Truss Screw (SDWC15600), installed through double-top-plate into the roof truss where Simpson Strap MTS 18 connects double-top-plate to the roof truss, as per drawings and specifications.

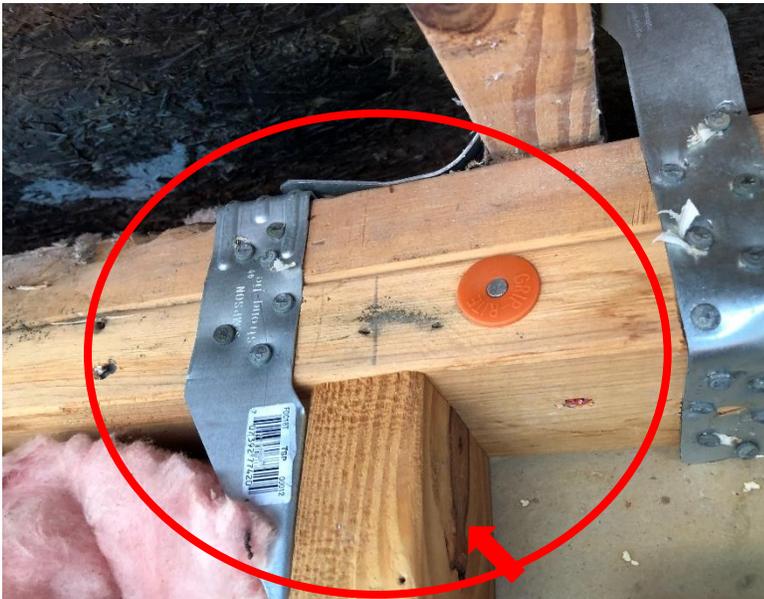
PHOTOGRAPH #14

**BUILDING 7
SECTION G**

Simpson SDWC Truss Screw (SDWC15600), to be installed through stud into double-top-plate where Simpson Connector (TSP) connects double-top-plate to the roof truss, as per drawings and specifications.

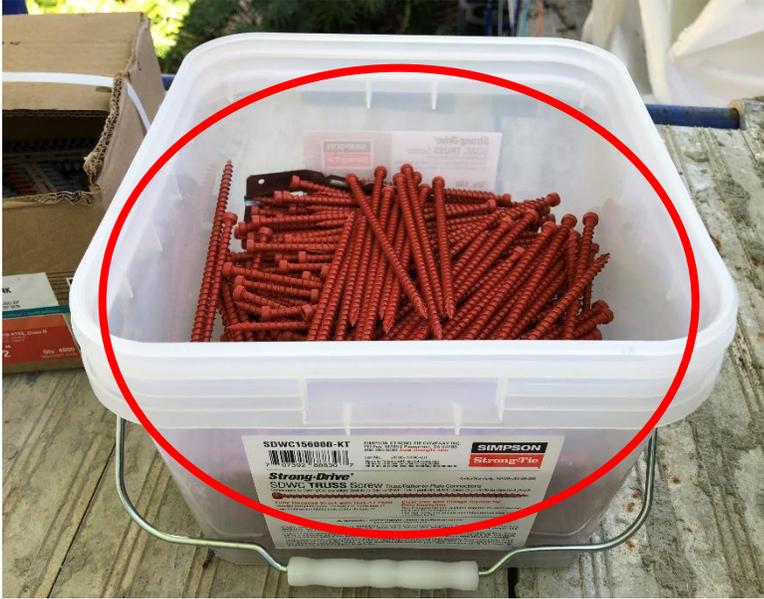
PHOTOGRAPH #15

**BUILDING 7
SECTION G**

Simpson SDWC Truss Screw (SDWC15600), installed through double-top-plate into the roof truss where Simpson Strap connects double-top-plate to the roof truss, as per drawings and specifications.

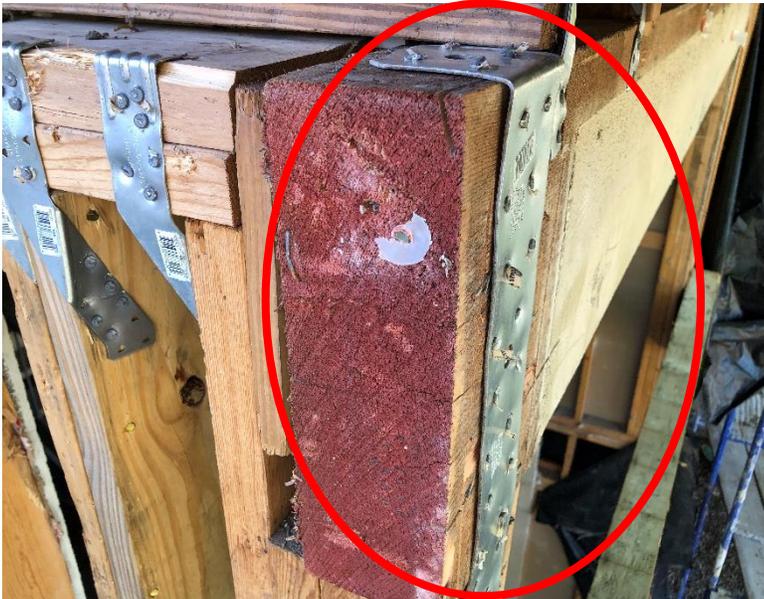
PHOTOGRAPH #16

**BUILDING 7
SECTION G**

Simpson Connector (MSTC48B3) installed to connect Breezeway Box Beam to stud, as per drawings and specifications.

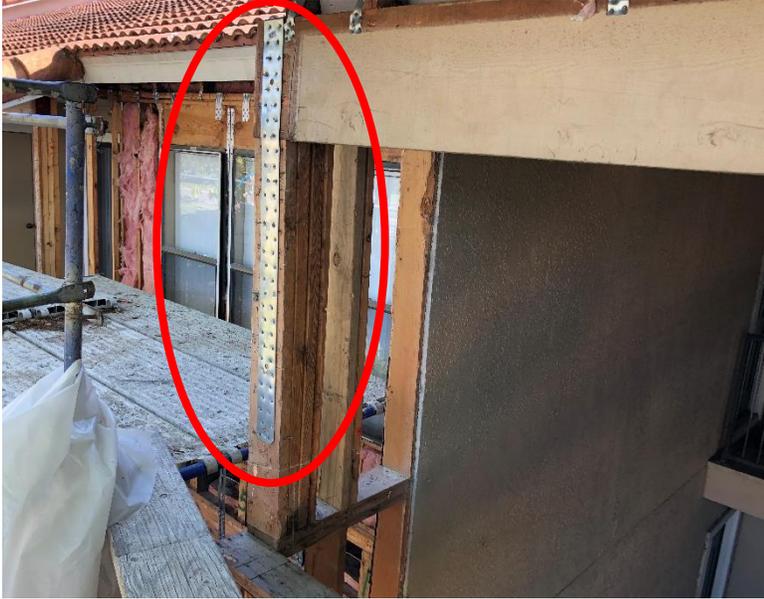
PHOTOGRAPH #17

**BUILDING 7
SECTION G**

Simpson Connector (MSTC48B3) installed to connect Breezeway Box Beam to stud, as per drawings and specifications.

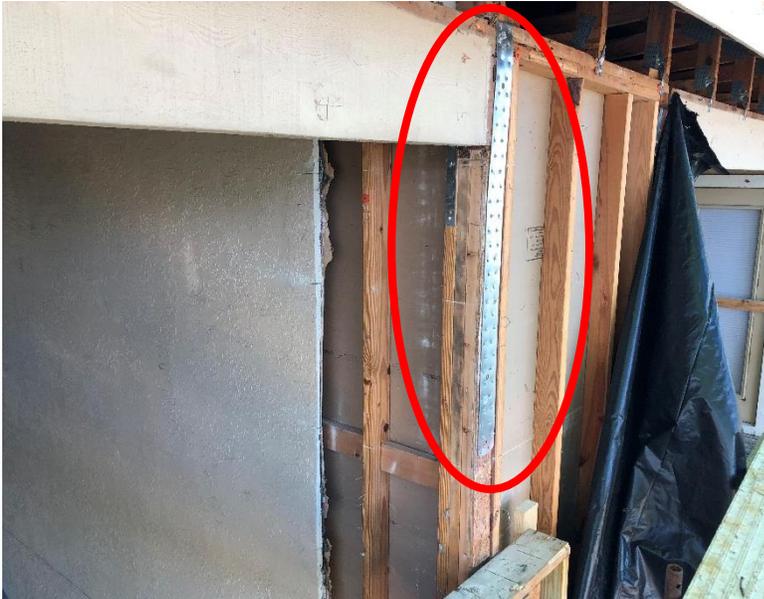
PHOTOGRAPH #18

**BUILDING 7
SECTION G**

Simpson Connector (MSTC48B3) installed to connect Breezeway Box Beam to stud, as per drawings and specifications.

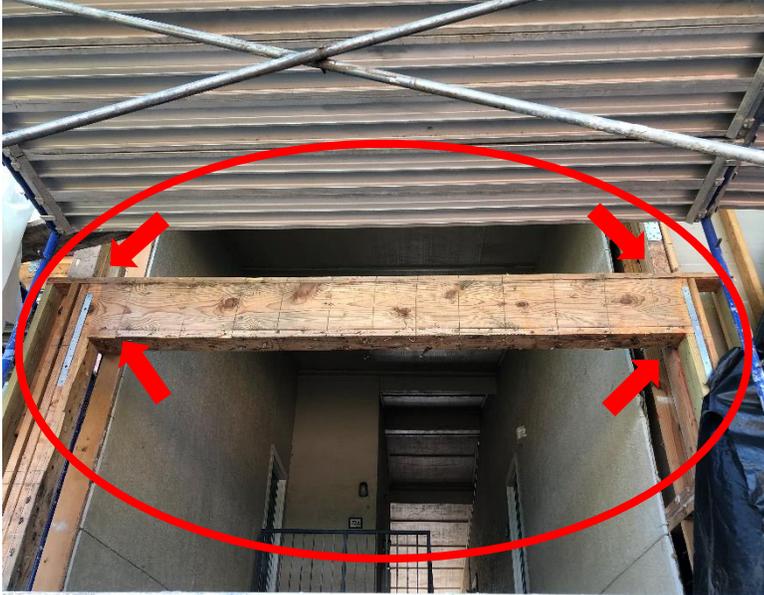
PHOTOGRAPH #19

**BUILDING 7
SECTION G**

Contractor to install Simpson Connector (H3) to connect Breezeway Box Beam to adjacent stud, above and below the Box Beam, as per drawings and specifications.

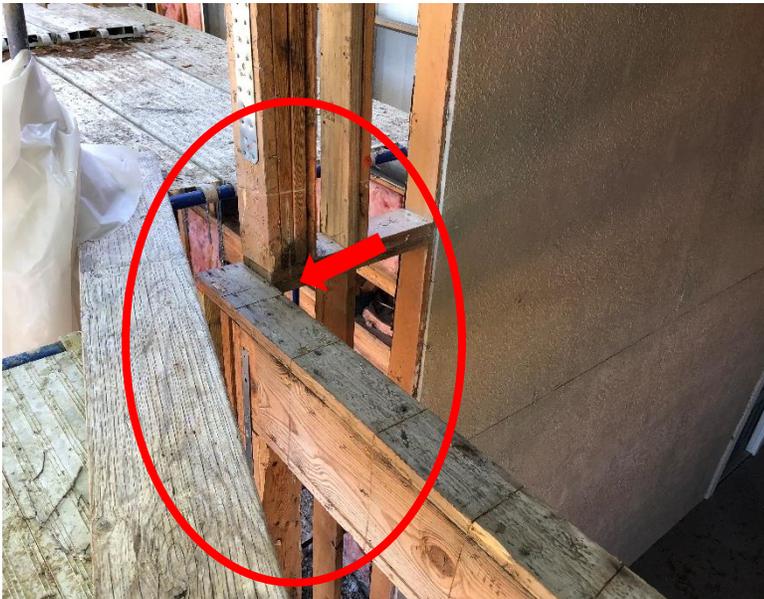
PHOTOGRAPH #20

**BUILDING 7
SECTION G**

Contractor to install Simpson Connector (H3) to connect Breezeway Box Beam to adjacent stud, above and below the Box Beam, as per drawings and specifications.

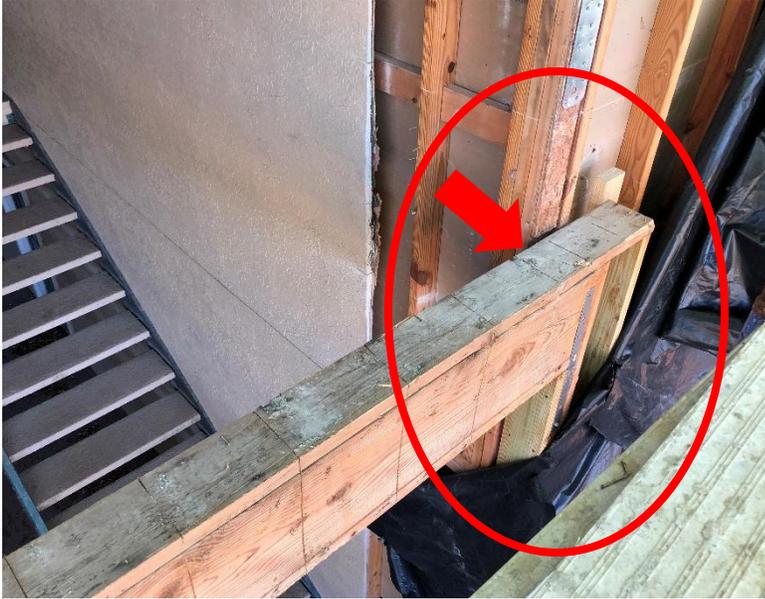
PHOTOGRAPH #21

**BUILDING 7
SECTION G**

Contractor to install Simpson Connector (H3) to connect Breezeway Box Beam to adjacent stud, above and below the Box Beam, as per drawings and specifications.

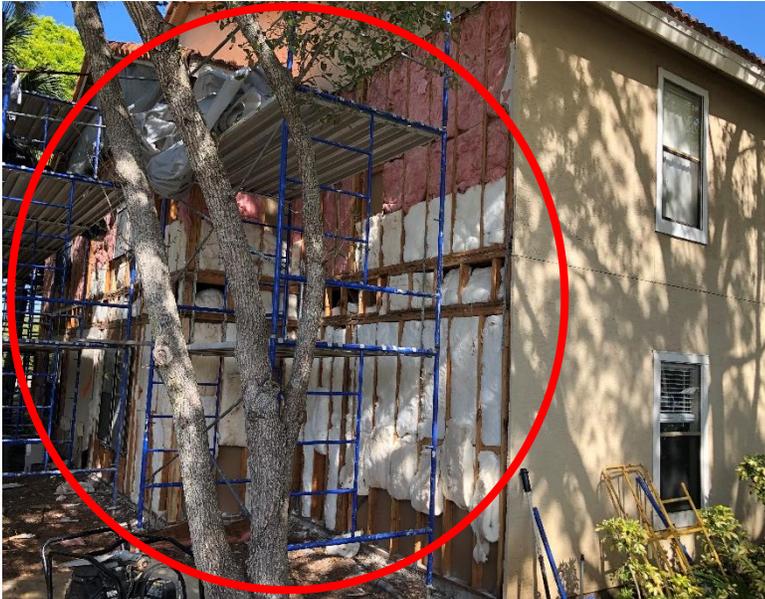
PHOTOGRAPH #22

**BUILDING 7
SECTION H**

Contractor performing framing repairs.

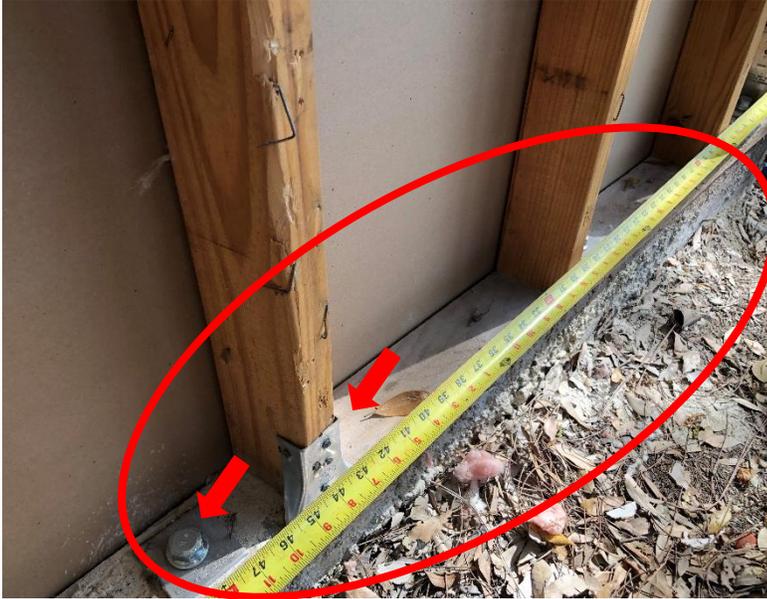
PHOTOGRAPH #23

**BUILDING 7
SECTION H**

Simpson Strong-Tie connectors installed with proper locations and spacing, as per drawings and specifications.

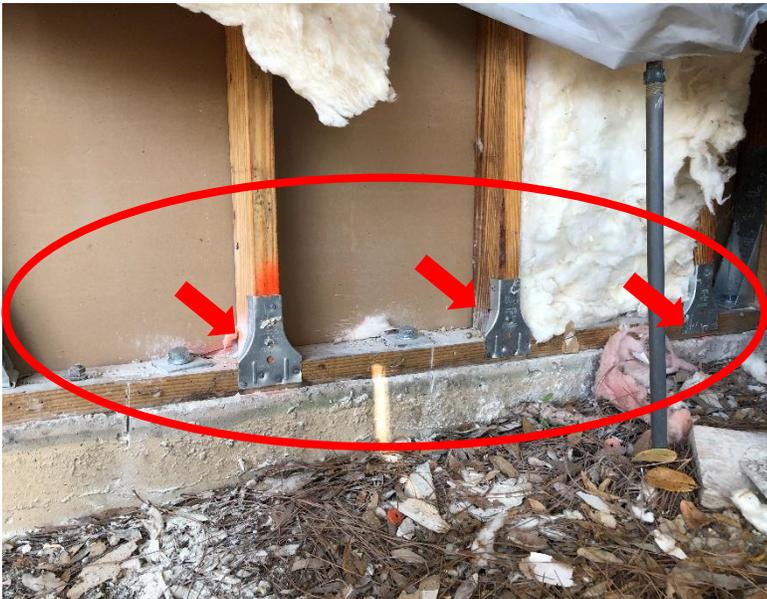
PHOTOGRAPH #24

**BUILDING 7
SECTION H**

Simpson Stud Plate Tie (SP1) to be installed at the base of all studs for Truss Bearing Walls, as per drawings and specifications.

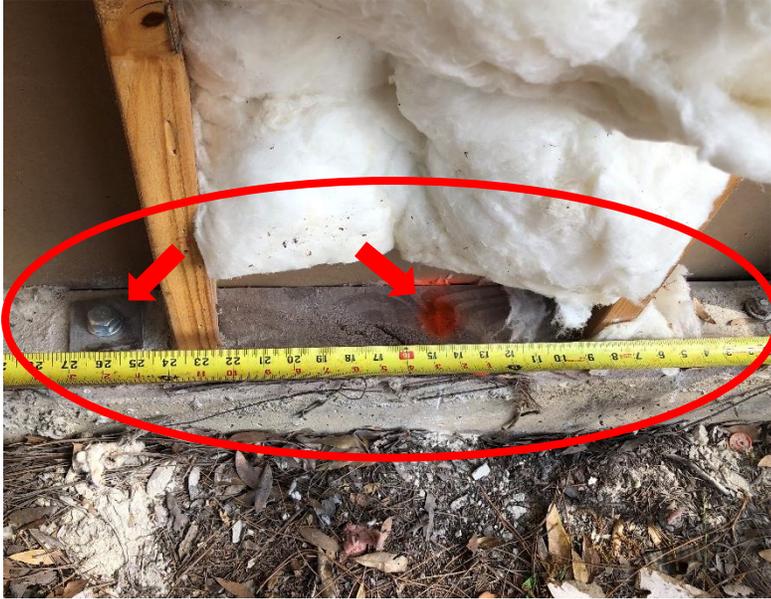
PHOTOGRAPH #25

**BUILDING 7
SECTION H**

Simpson Connector (Strong-Tie 5/8" x 8" Titen HD Anchors) to be installed 24" on-center max., and to be installed where indicated in photo.
