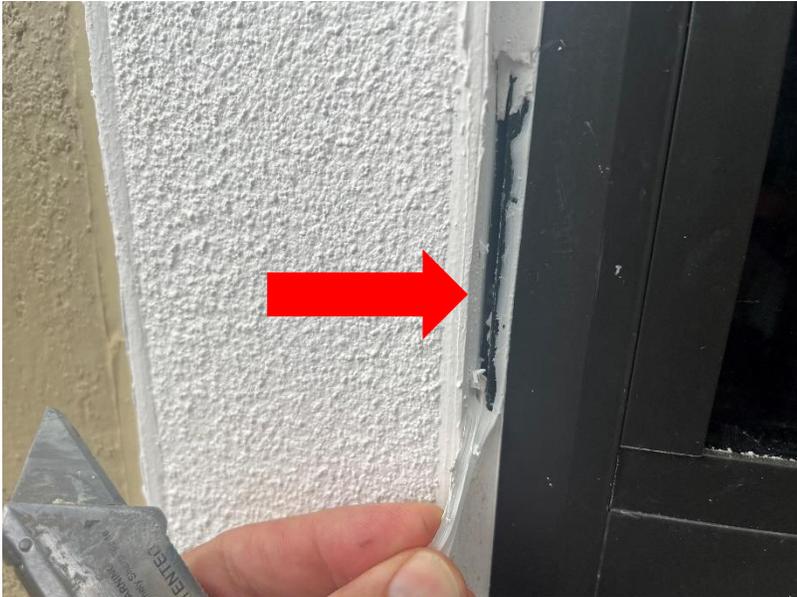
PHOTOGRAPH #1

**BUILDING 9
SECTION H**

Delta performed successful sealant adhesion test at new PGT window perimeter.

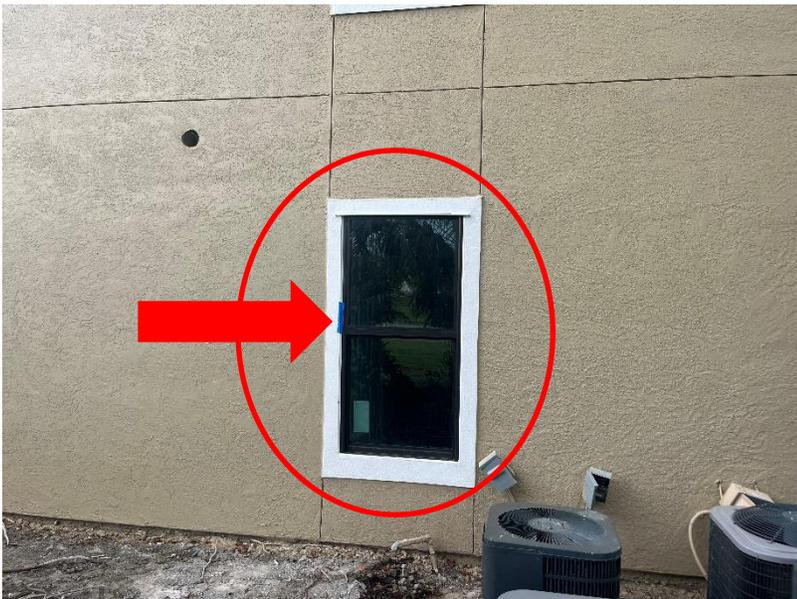
PHOTOGRAPH #2

**BUILDING 9
SECTION H**

Delta performed successful sealant adhesion test at new PGT window perimeter.

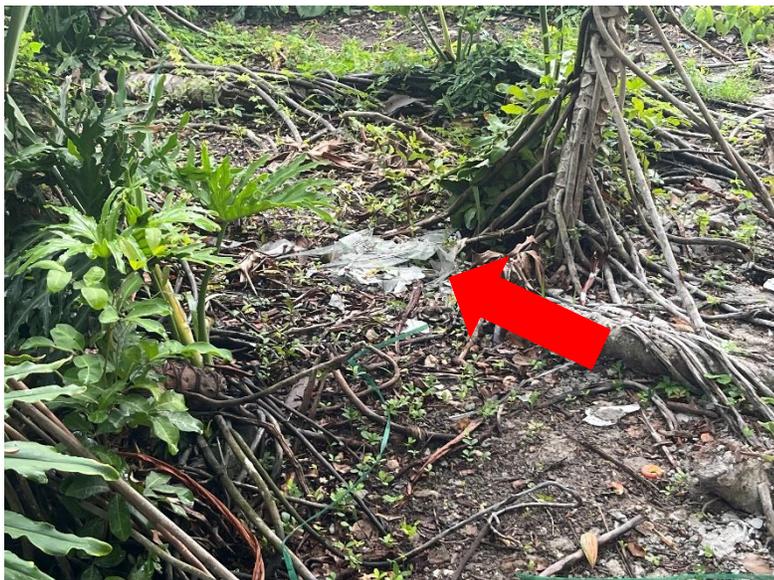
PHOTOGRAPH #3

**BUILDING 9
SECTION H**

Broken glass pointed out for removal as storm preparation. RLJ removed.

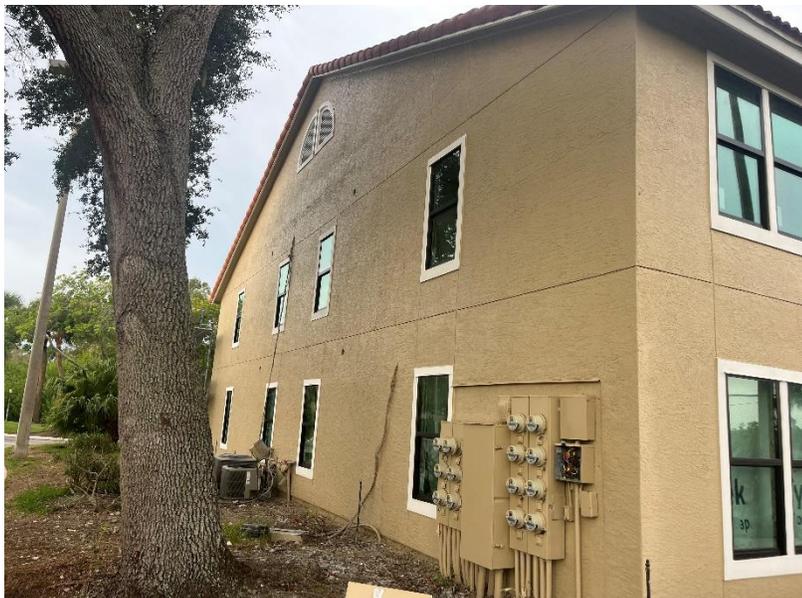
PHOTOGRAPH #4

**BUILDING 9
SECTION D**

Painting completed at gable end wall. Grounds cleaned in preparation for high winds.

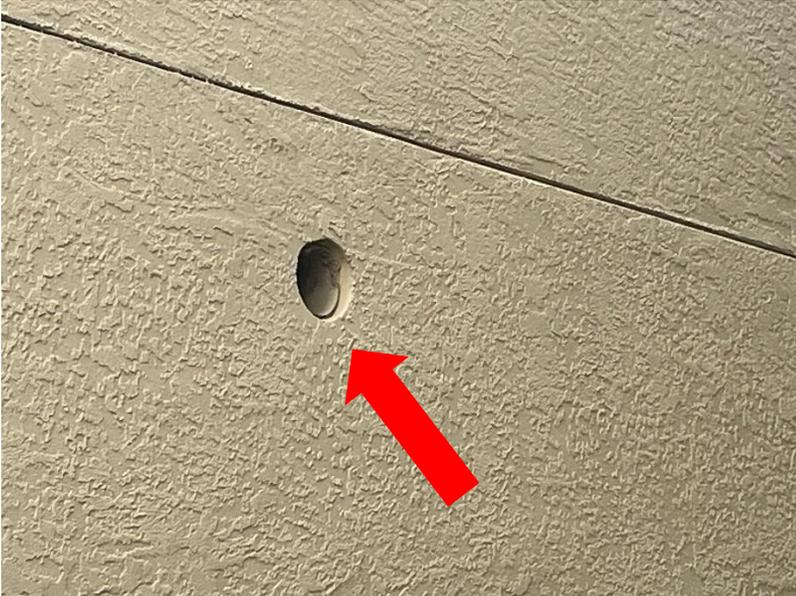
PHOTOGRAPH #5

**BUILDING 9
SECTION D**

Dryer vents have not yet been installed at gable end walls.

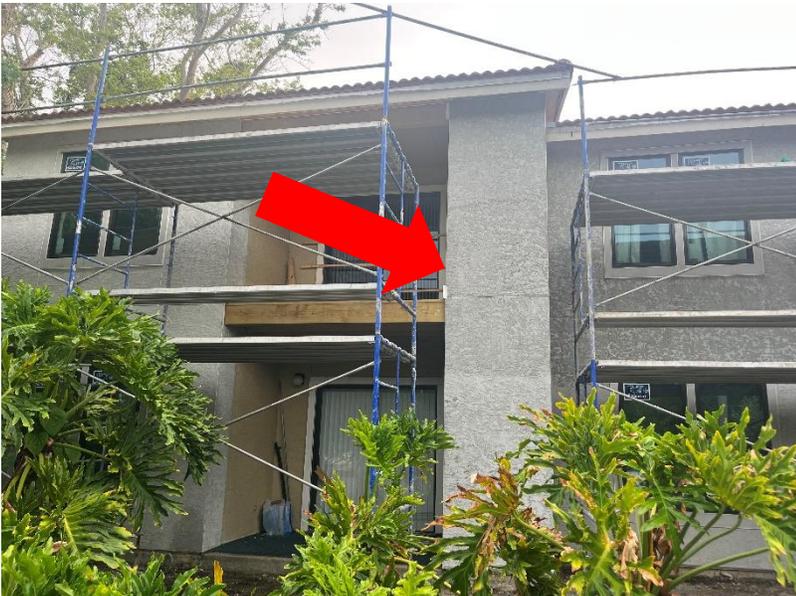
PHOTOGRAPH #6

**BUILDING 9
SECTION A**

Stucco sub-contractor has completed finish coat of stucco at all walls.

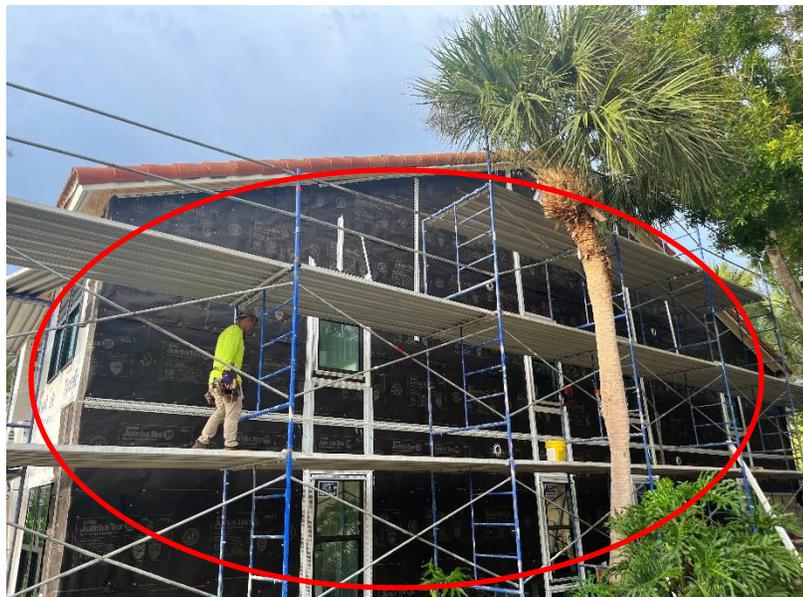
PHOTOGRAPH #7

**BUILDING 15
SECTION H**

Stucco Subcontractor applying new vinyl stucco accessories and securing site for high winds and rain.

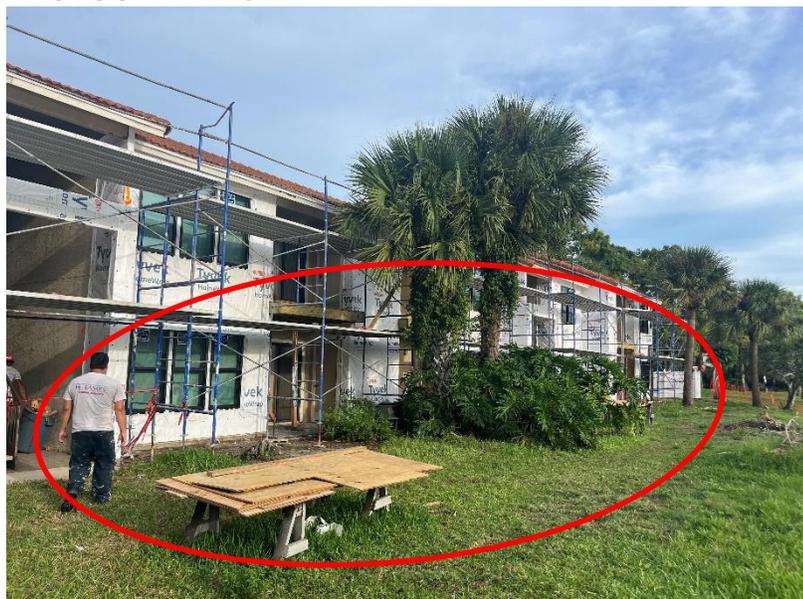
PHOTOGRAPH #8

**BUILDING 15
SECTION F**

Contractor preparing for high winds and rain from hurricane Idalia.

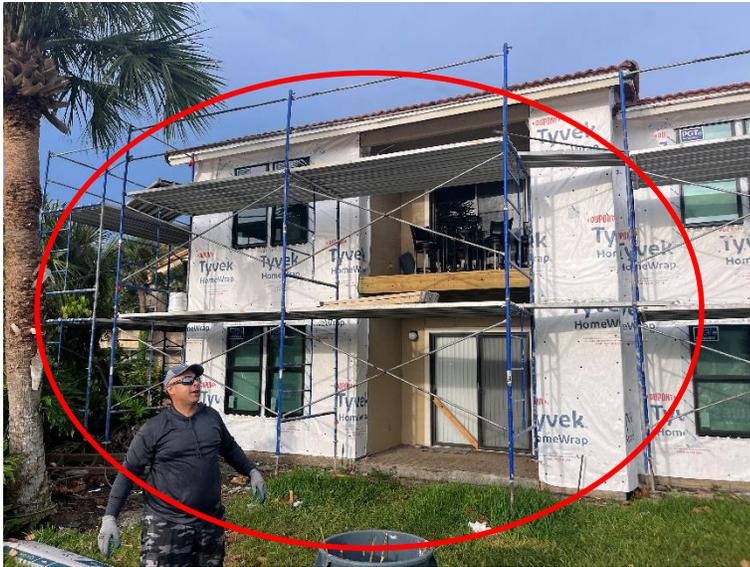
PHOTOGRAPH #9

**BUILDING 15
SECTION E**

Contractor preparing for high winds and rain from hurricane Idalia.

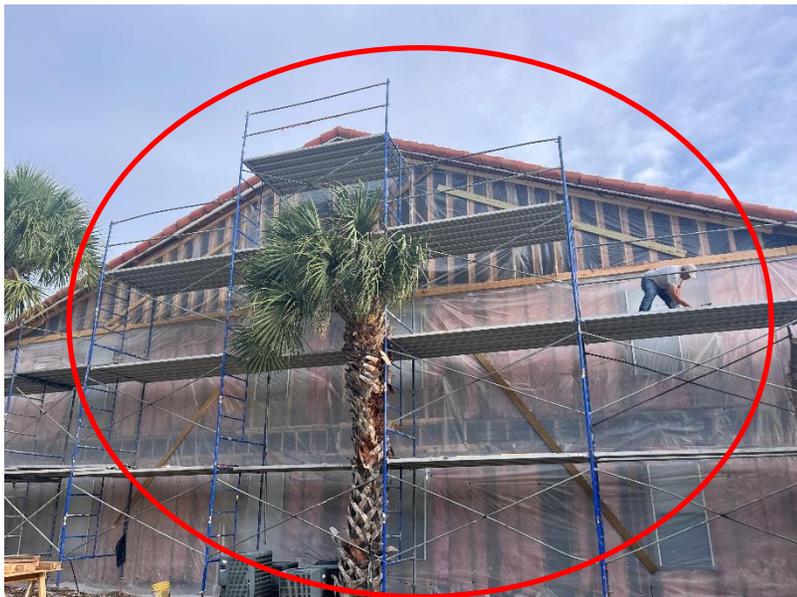
PHOTOGRAPH #10

**BUILDING 15
SECTION D**

Contractor fastening additional boarding over weather protection in preparing for high winds and rain from hurricane Idalia.

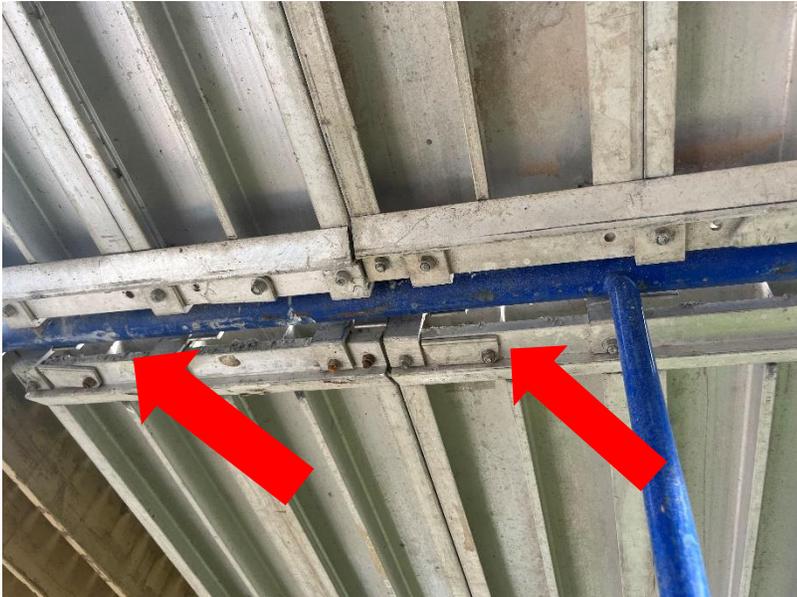
PHOTOGRAPH #11

**BUILDING 15
SECTION D**

Scaffolding boards required to be secured with mechanical tabs to pipe scaffolding in preparing for high winds and rain from hurricane Idalia. Contractor secured all tabs.

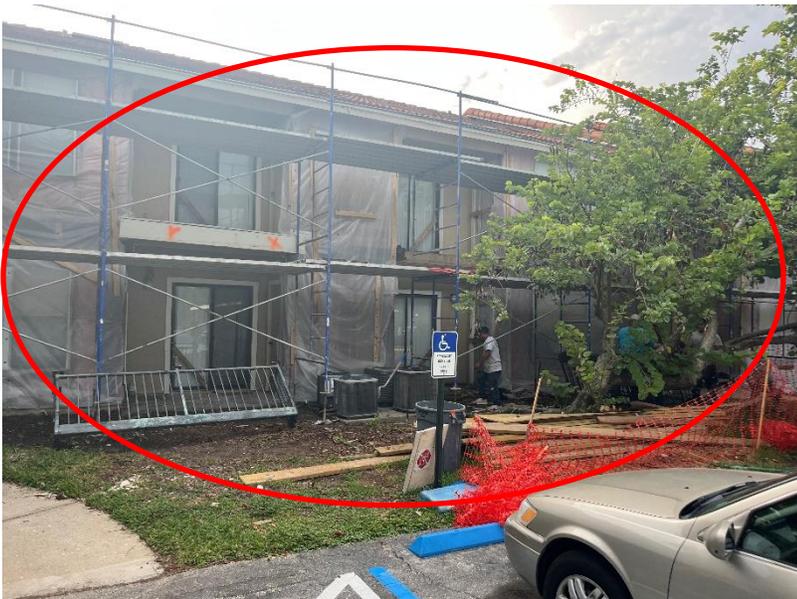
PHOTOGRAPH #12

**BUILDING 15
SECTION B**

Contractor fastening additional boarding over weather protection in preparing for high winds and rain from hurricane Idalia.

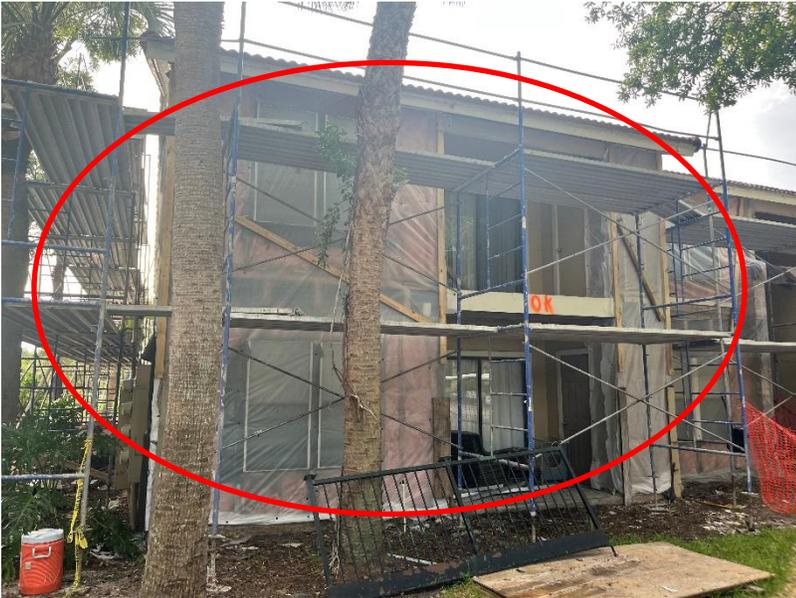
PHOTOGRAPH #13

**BUILDING 15
SECTION A**

Contractor fastening additional boarding over weather protection in preparing for high winds and rain from hurricane Idalia.

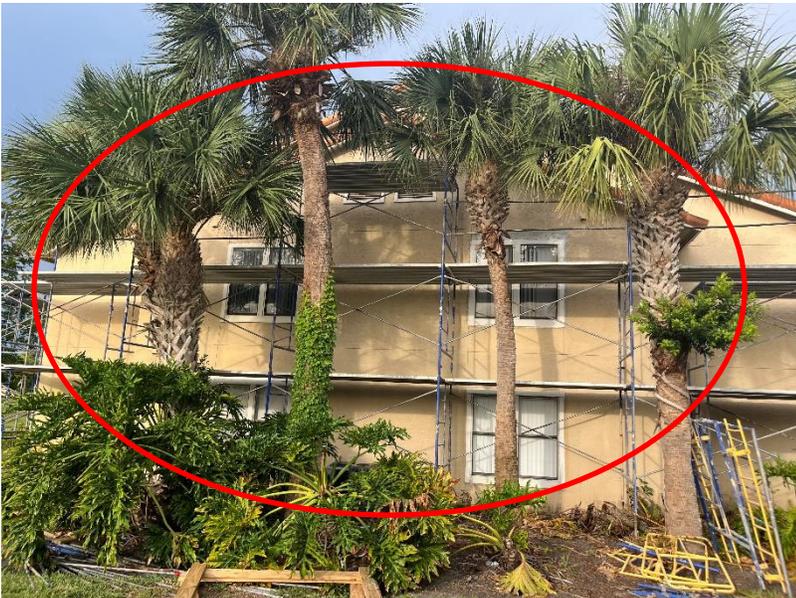
PHOTOGRAPH #14

**BUILDING 16
SECTION H**

Contractor has built access scaffolding and prepared for wind and rain from hurricane Idalia.

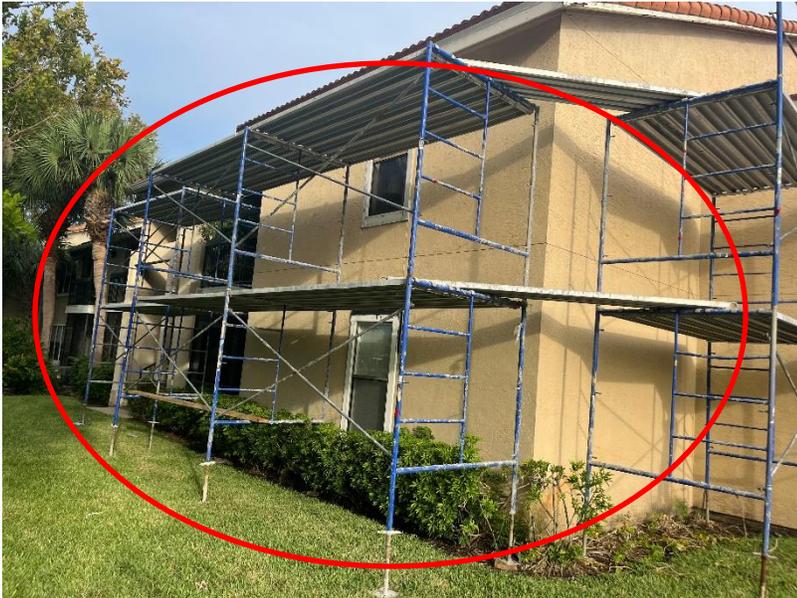
PHOTOGRAPH #15

**BUILDING 16
SECTION G**

Contractor has built access scaffolding and prepared for wind and rain from hurricane Idalia.
