SUPPLEMENTAL DESTRUCTIVE INVESTIGATION

**Vintage Grand Condominium
4012 Crockers Lake Blvd.
Sarasota, FL 34238**

Project No. R1606-231

October 28, 2016

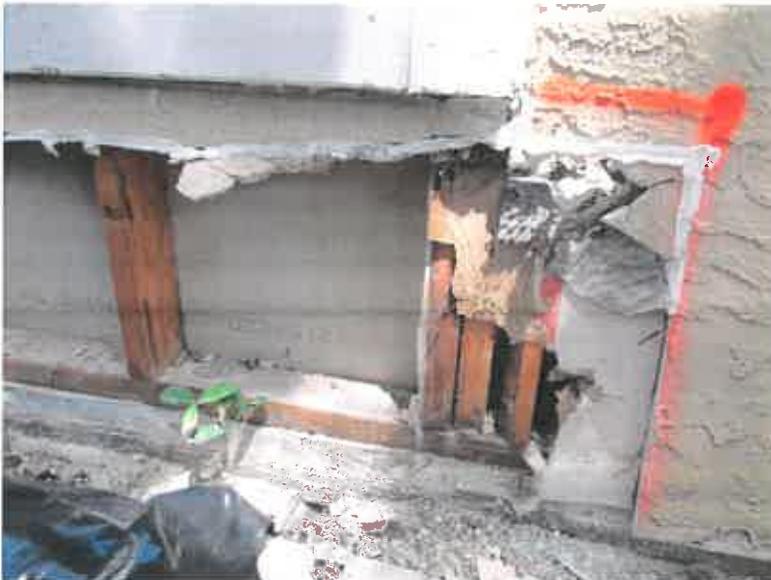
PHOTOGRAPH #2

**DESTRUCTIVE INVESTIGATION
OPENINGS – MARK 2
1st Floor Below Window**

No damage

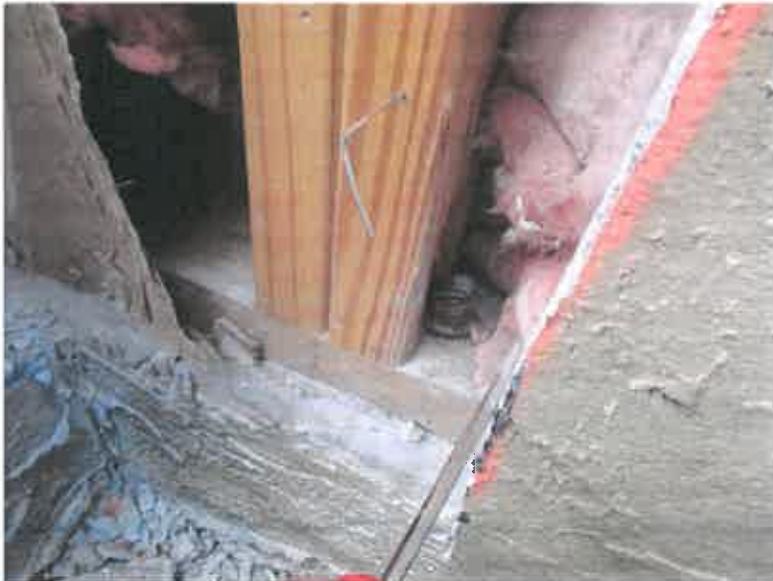
PHOTOGRAPH #8

**DESTRUCTIVE INVESTIGATION
OPENINGS – MARK 8
1st Floor Near Stairs at Base**

No damage

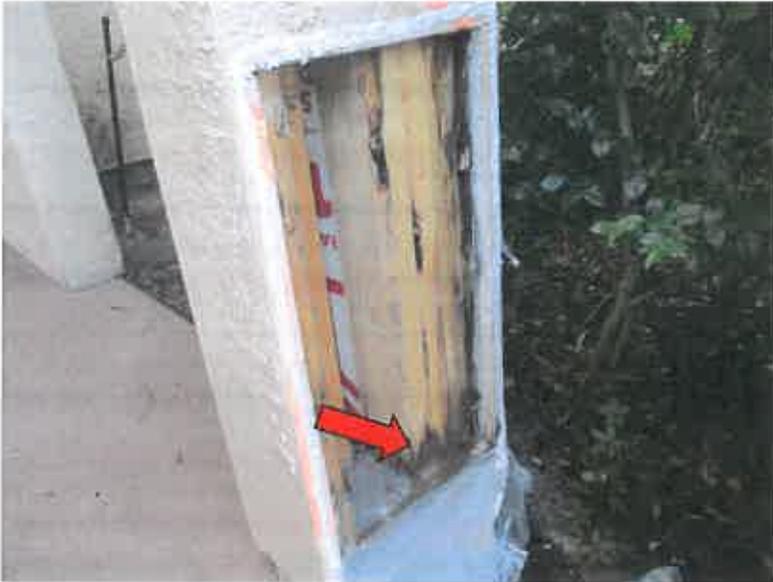
PHOTOGRAPH #9

**DESTRUCTIVE INVESTIGATION
OPENINGS – MARK 9
1st Floor Near Stair at Base**

Wet framing, water stains on studs

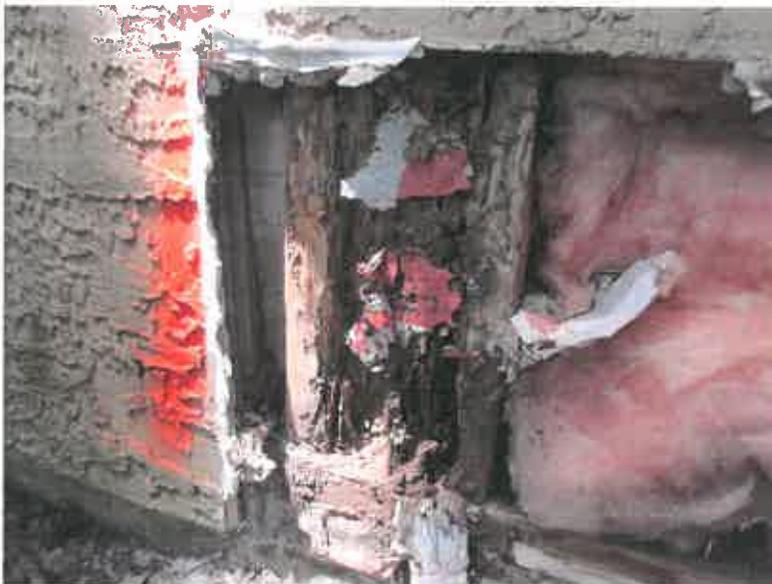
PHOTOGRAPH #10

**DESTRUCTIVE INVESTIGATION
OPENINGS – MARK 10
1st Floor Below Window**

Wood frame damage

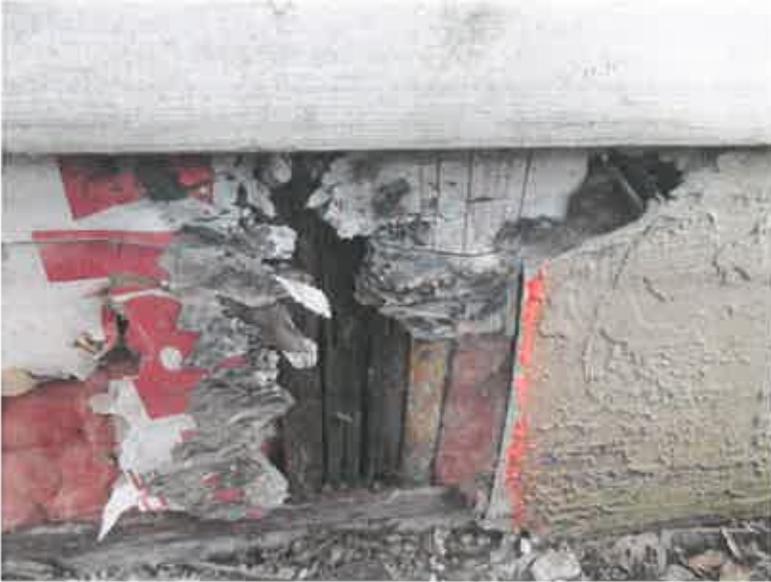
PHOTOGRAPH #21

**DESTRUCTIVE INVESTIGATION
OPENINGS – MARK 21
1st Floor Below Window**

Wood frame damage

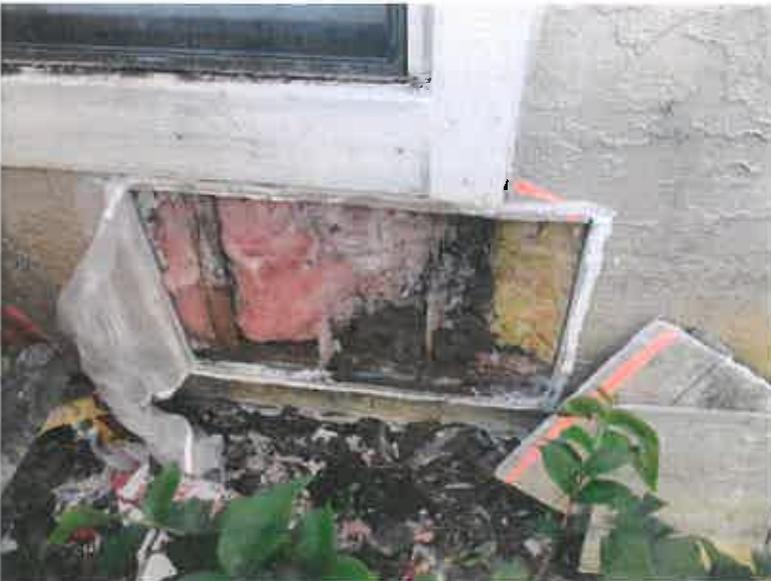
PHOTOGRAPH #22

**DESTRUCTIVE INVESTIGATION
OPENINGS – MARK 22
1st Floor Below Window**

Wood frame damage

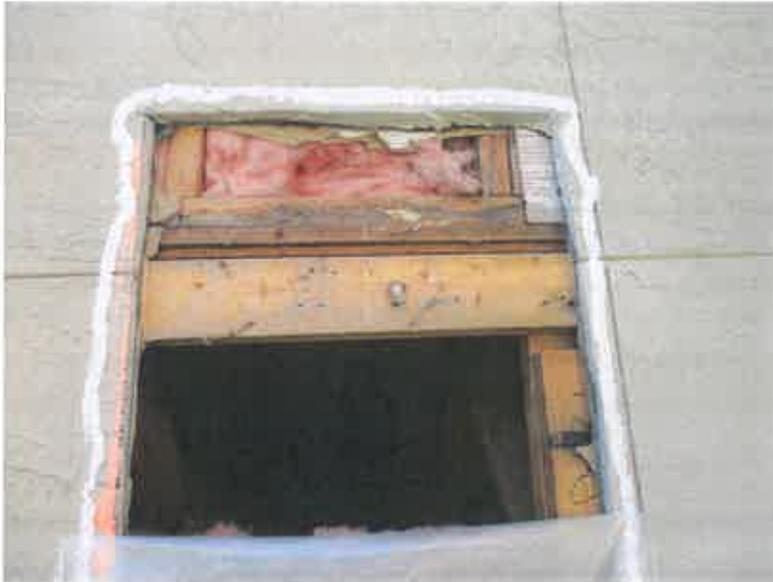
PHOTOGRAPH #25

**DESTRUCTIVE INVESTIGATION
OPENINGS – MARK 25
1st & 2nd Floor at Control Joint**

No damage

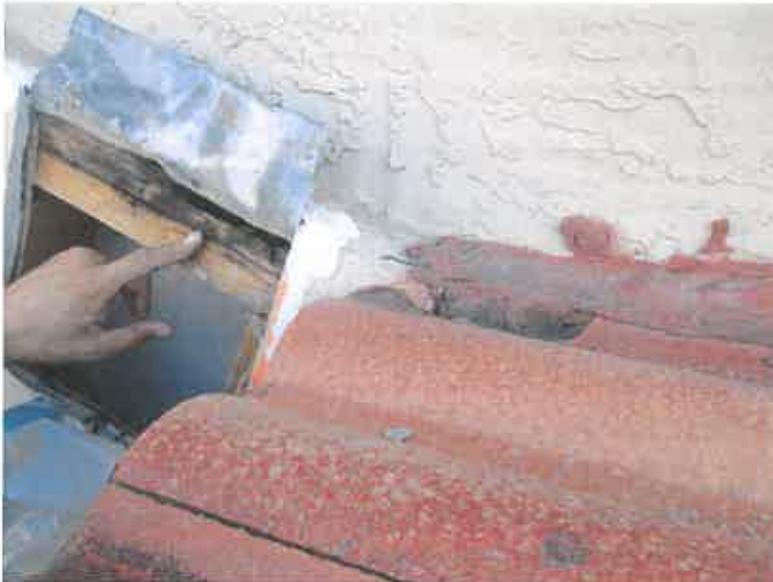
PHOTOGRAPH #33

32	2nd floor below window	No damage (Photograph #32)
33	Roof to wall intersection	Wood frame damage (Photograph #33)
34	1st floor near stairs at base	Wood frame damage (Photograph #34)

**DESTRUCTIVE INVESTIGATION
OPENINGS – MARK 33
Roof to Wall Intersection**

Wood frame damage

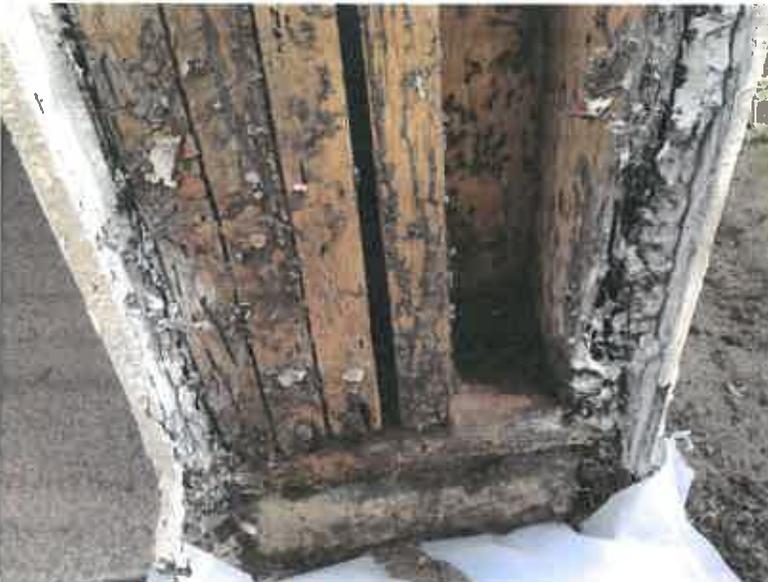
PHOTOGRAPH #40

**DESTRUCTIVE INVESTIGATION
OPENINGS – MARK 6
1st Floor Near Stairs at Base**

Wood frame damage

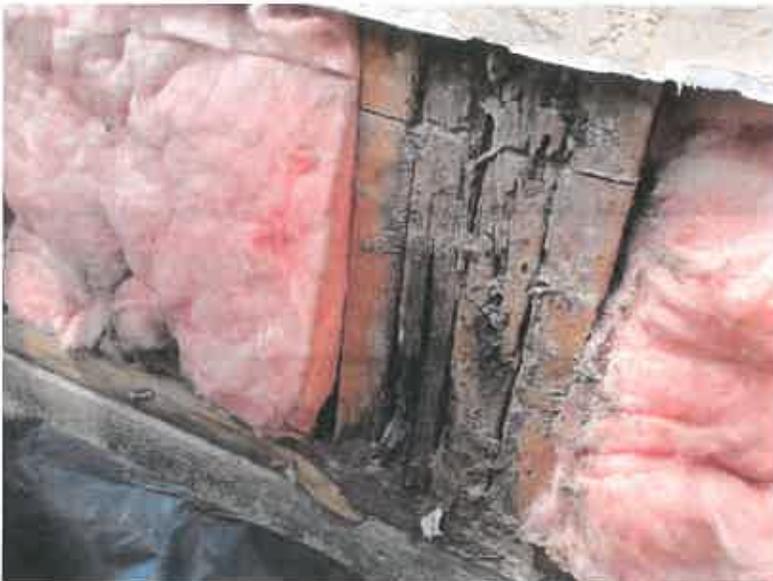
PHOTOGRAPH #58

**DESTRUCTIVE INVESTIGATION
OPENINGS – MARK 24
1st Floor Below Window**

Wood frame damage

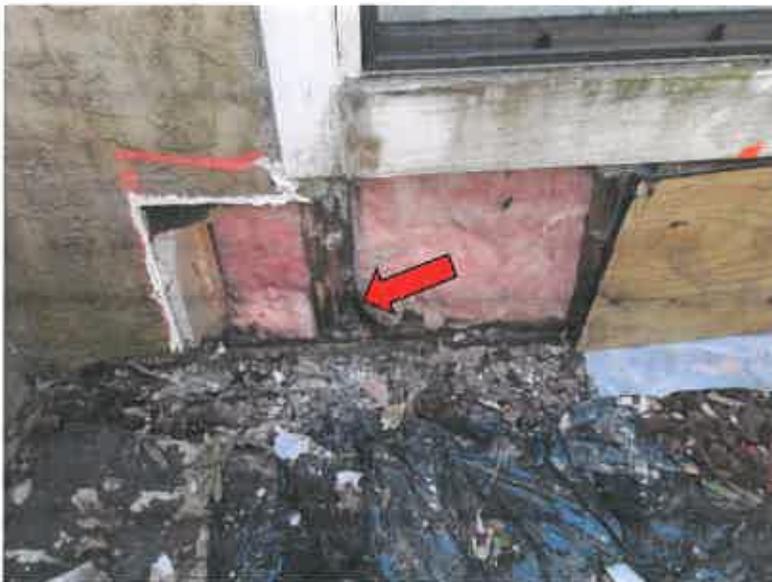
PHOTOGRAPH #70

**DESTRUCTIVE INVESTIGATION
OPENINGS – MARK 8
1st Floor Below Window**

Wood frame damage

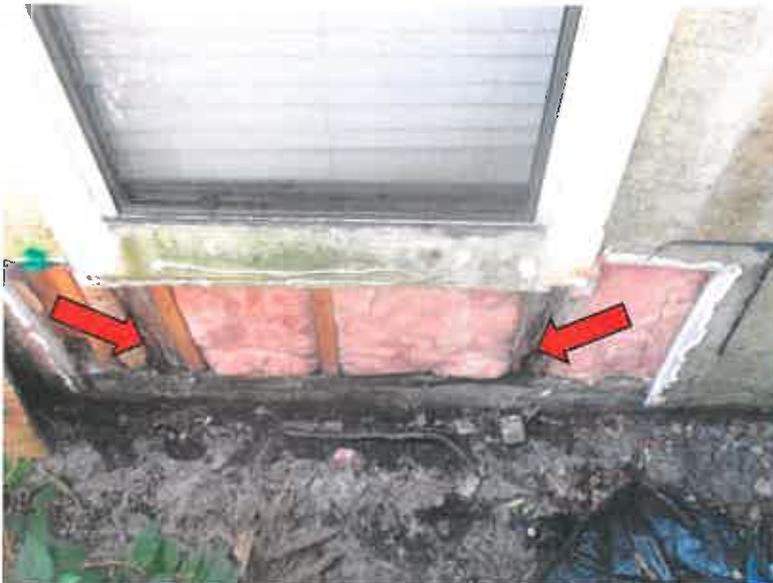
PHOTOGRAPH #74

**DESTRUCTIVE INVESTIGATION
OPENINGS – MARK 12
1st Floor Below Window**

Wood frame damage

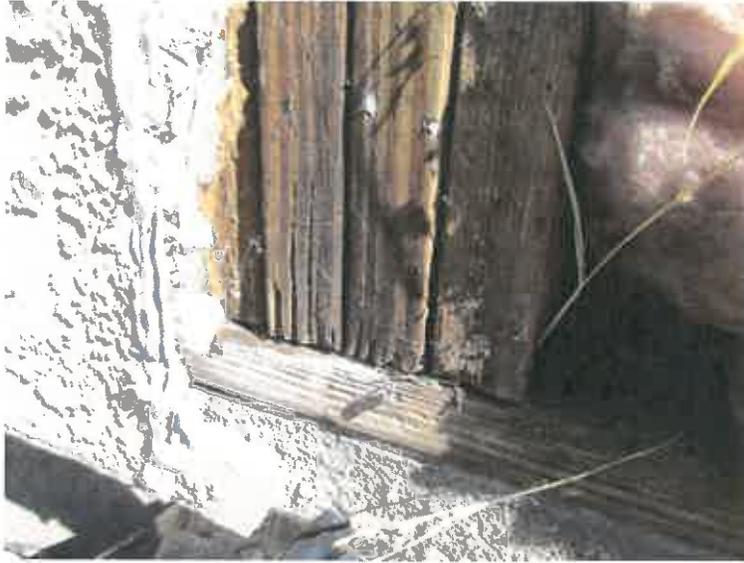
PHOTOGRAPH #80

BUILDING 9		
Mark	Location	Observation
1	1st floor below window	Wood frame damage (Photograph #80)
2	1st floor below window	No damage (Photograph #81)
3	1st & 2nd floor at control joint	No damage (Photograph #82)
4	1st floor below window	No damage (Photograph #83)
5	2nd floor adjacent to balcony	No damage (Photograph #84)
6	1st floor below window	Wood frame damage (Photograph #85)
7	1st floor near stairs at base	No damage (Photograph #86)
8	1st floor below window	Wood frame damage (Photograph #87)
9	2nd floor below window	Wood frame damage (Photograph #88)
10	2nd floor adjacent to balcony	Wood frame damage (Photograph #89)
11	1st floor below window	No damage (Photograph #90)
12	1st floor near stairs at base	No damage (Photograph #91)
13	1st floor near stairs at base	No damage (Photograph #92)
14	1st floor below window	No damage (Photograph #93)
15	1st floor below window	Wood frame damage (Photograph #94)

**DESTRUCTIVE INVESTIGATION
OPENINGS – MARK 1
1st Floor Below Window**

Wood frame damage

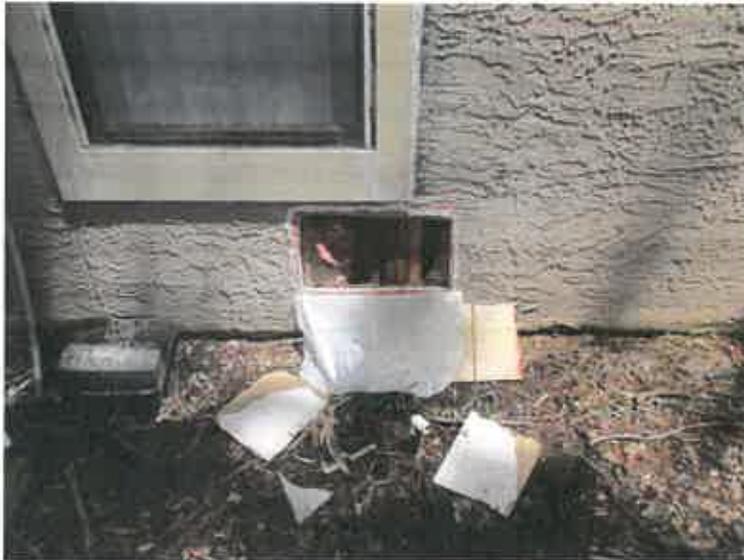
PHOTOGRAPH #81

**DESTRUCTIVE INVESTIGATION
OPENINGS – MARK 2
1st Floor Below Window**

No damage

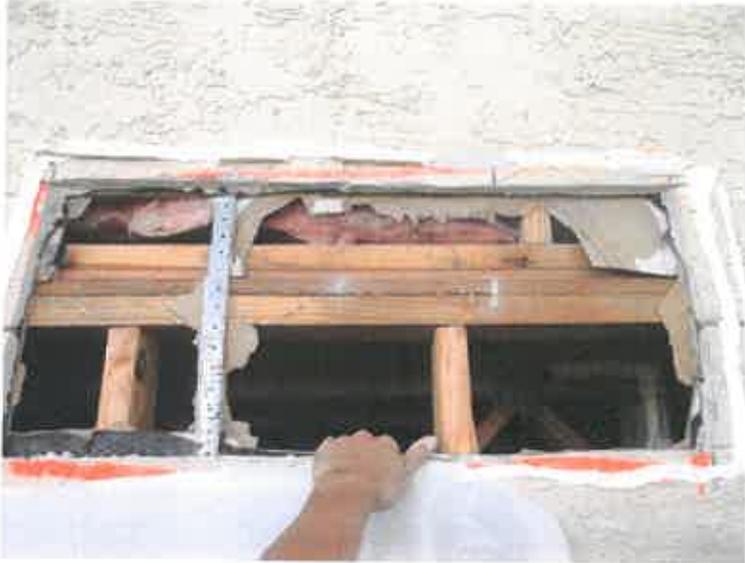
PHOTOGRAPH #82

**DESTRUCTIVE INVESTIGATION
OPENINGS – MARK 3
1st & 2nd Floor at Control Joint**

No damage

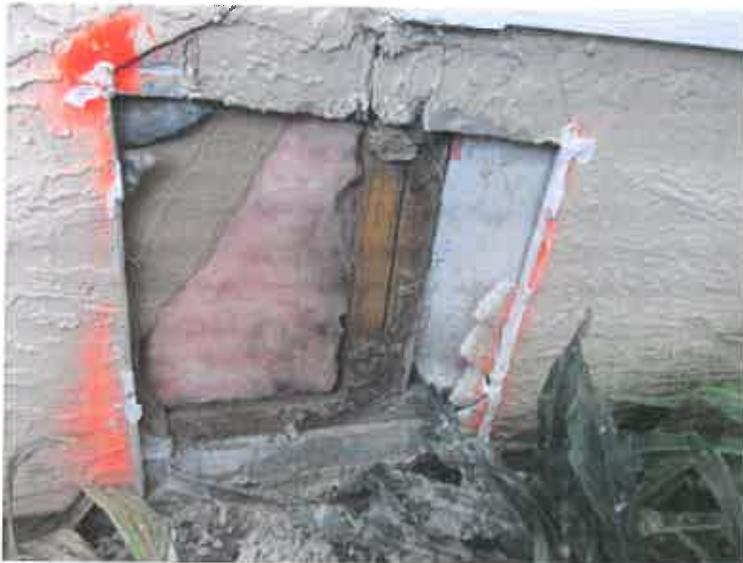
PHOTOGRAPH #83

**DESTRUCTIVE INVESTIGATION
OPENINGS – MARK 4
1st Floor Below Window**

No damage

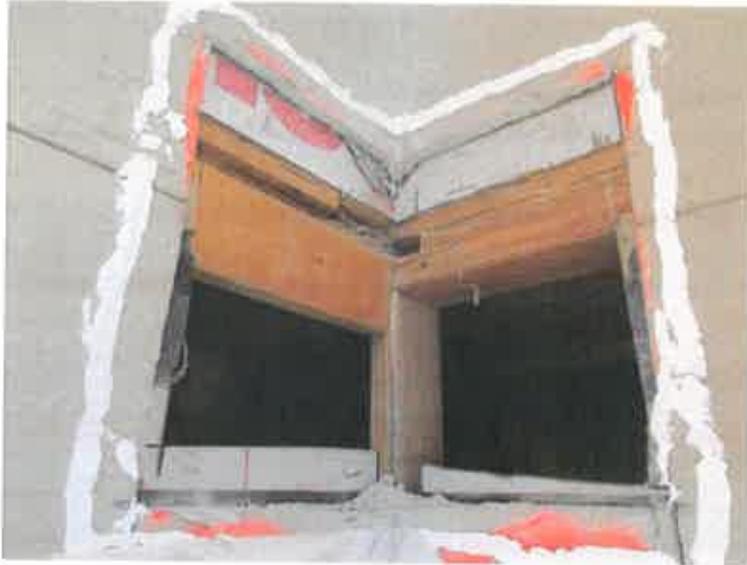
PHOTOGRAPH #84

**DESTRUCTIVE INVESTIGATION
OPENINGS – MARK 5
1st & 2nd Floor Inside Corner**

No damage

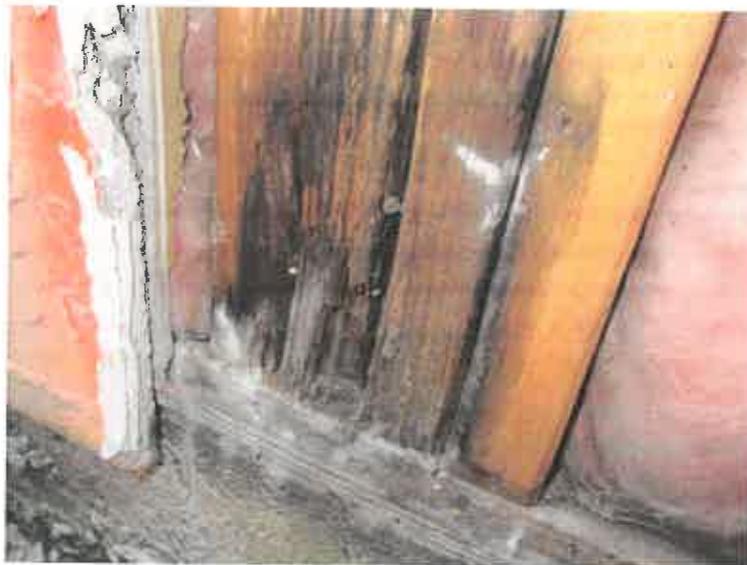
PHOTOGRAPH #85

**DESTRUCTIVE INVESTIGATION
OPENINGS – MARK 6
1st Floor Below Window**

Wood frame damage

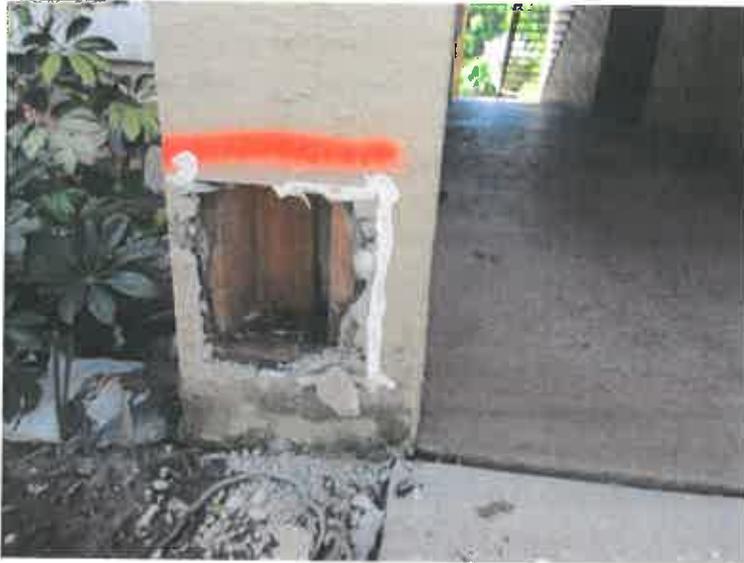
PHOTOGRAPH #86

**DESTRUCTIVE INVESTIGATION
OPENINGS – MARK 7
1st Floor Near Stair at Base**

No damage

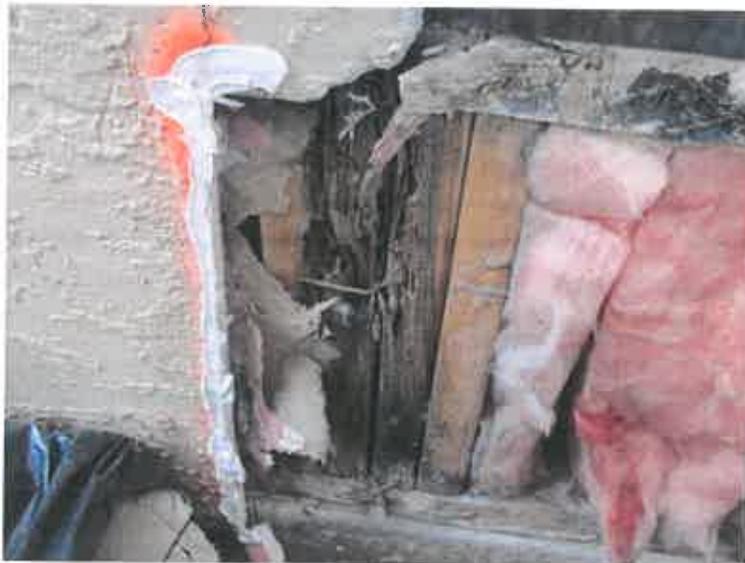
PHOTOGRAPH #87

**DESTRUCTIVE INVESTIGATION
OPENINGS – MARK 8
1st Floor Below Window**

Wood frame damage

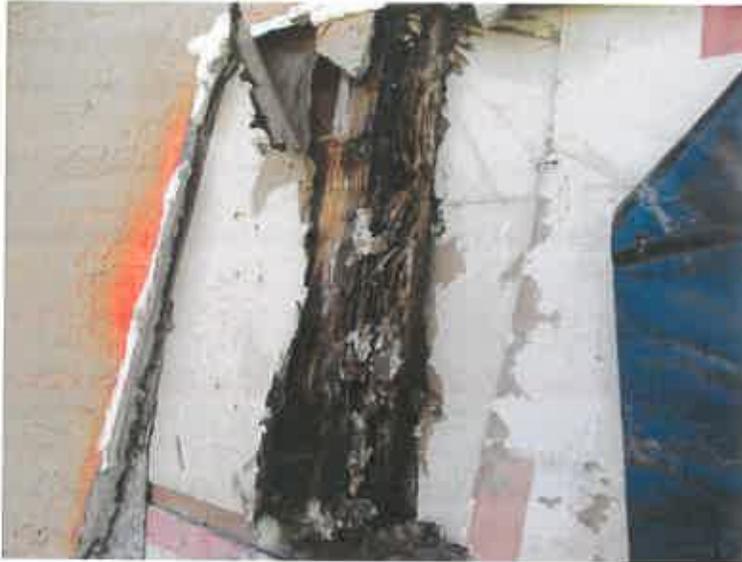
PHOTOGRAPH #88

**DESTRUCTIVE INVESTIGATION
OPENINGS – MARK 9
2nd Floor Below Window**

Wood frame damage

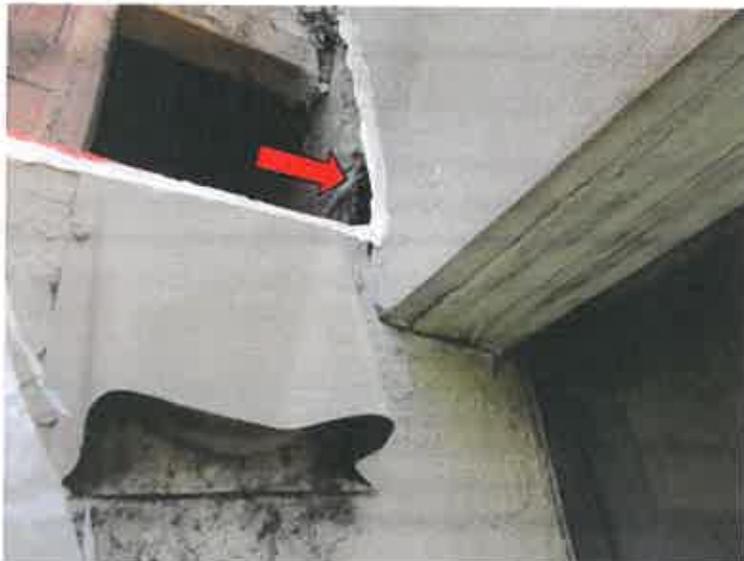
PHOTOGRAPH #89

**DESTRUCTIVE INVESTIGATION
OPENINGS – MARK 10
2nd Floor Adjacent to Balcony**

Wood frame damage

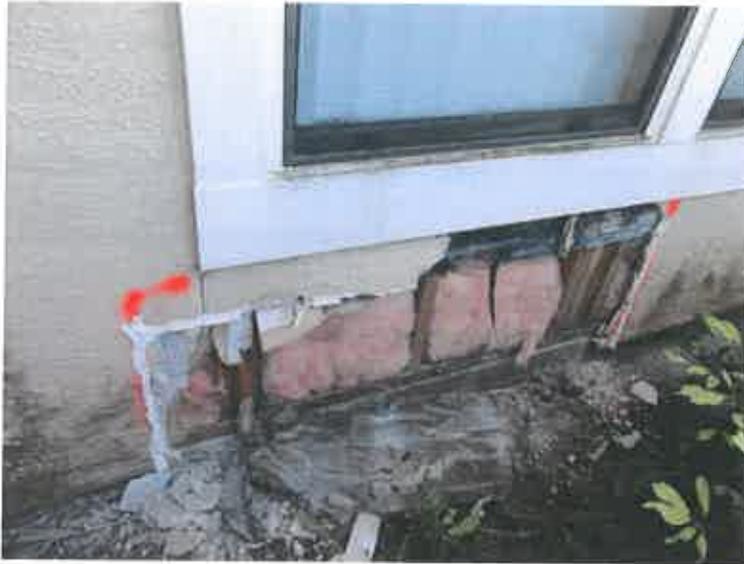
PHOTOGRAPH #90

**DESTRUCTIVE INVESTIGATION
OPENINGS – MARK 11
1st Floor Below Window**

No damage

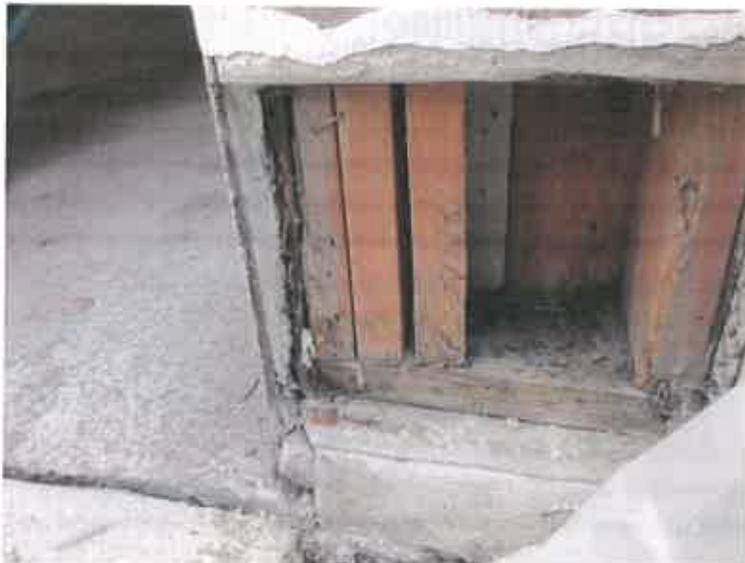
PHOTOGRAPH #91

**DESTRUCTIVE INVESTIGATION
OPENINGS – MARK 12
1st Floor Near Stair at Base**

No damage

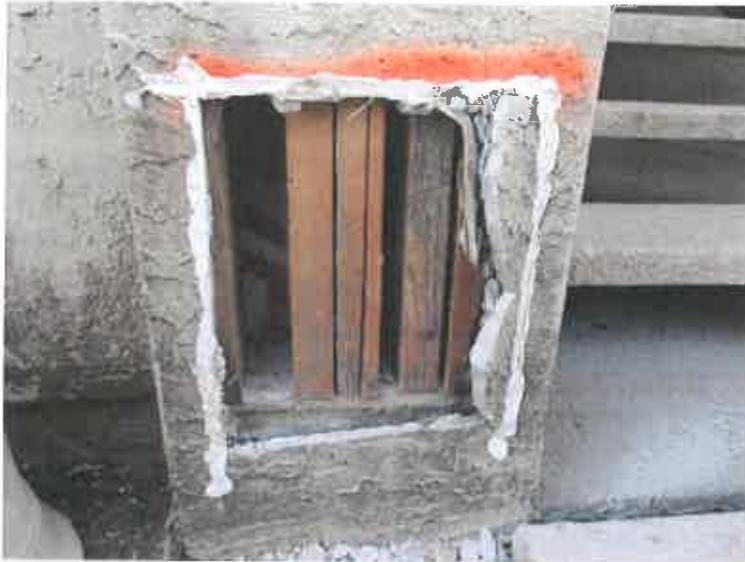
PHOTOGRAPH #92

**DESTRUCTIVE INVESTIGATION
OPENINGS – MARK 13
1st Floor Near Stair at Base**

No damage

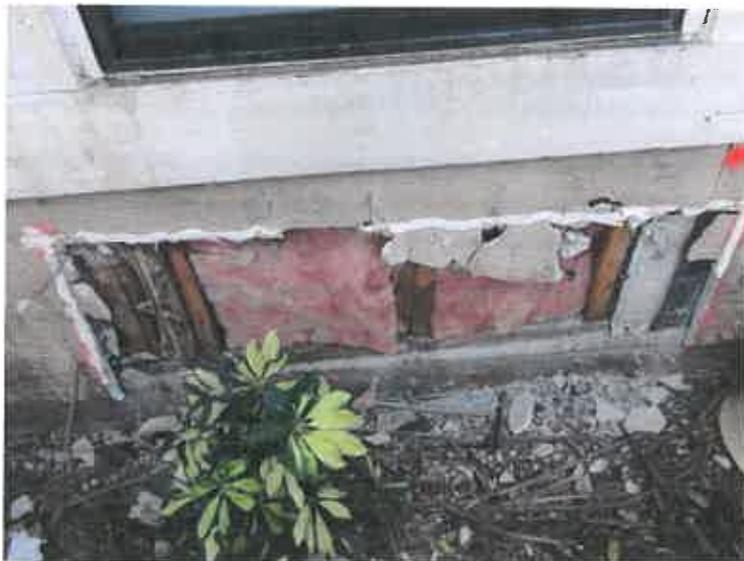
PHOTOGRAPH #93

**DESTRUCTIVE INVESTIGATION
OPENINGS – MARK 14
1st Floor Below Window**

No damage

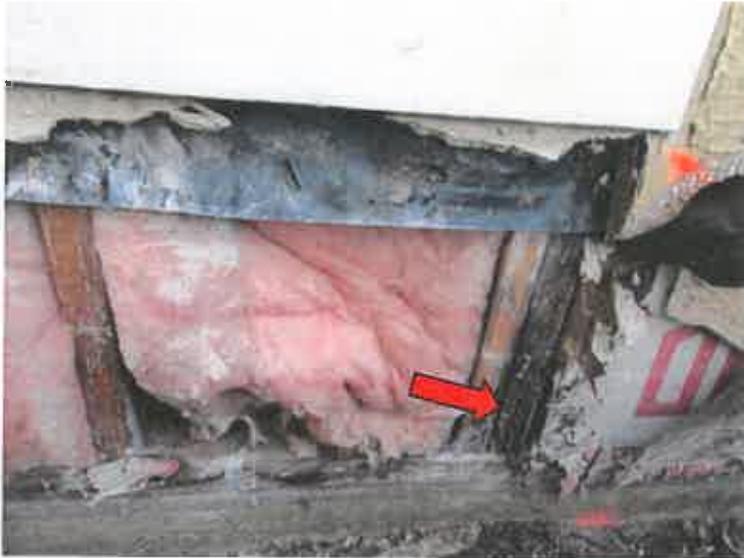
PHOTOGRAPH #94

**DESTRUCTIVE INVESTIGATION
OPENINGS – MARK 15
1st Floor Below Window**

Wood frame damage

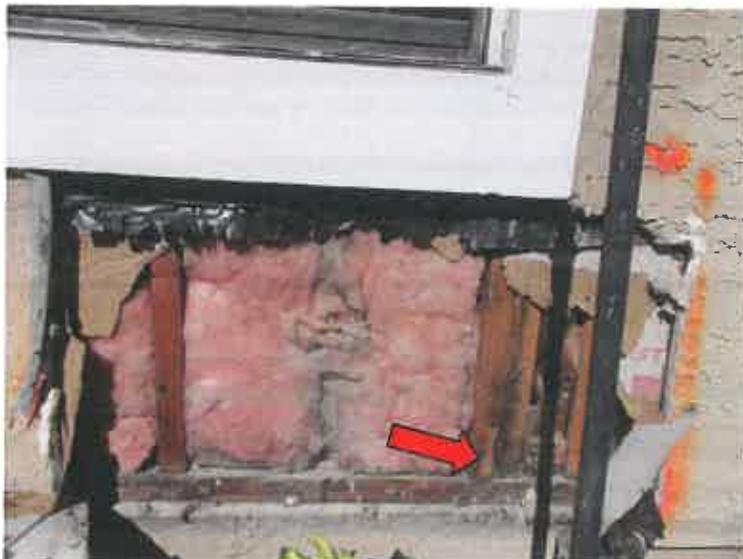
PHOTOGRAPH #95

**DESTRUCTIVE INVESTIGATION
OPENINGS – MARK 16
1st Floor Below Window**

Wood frame damage

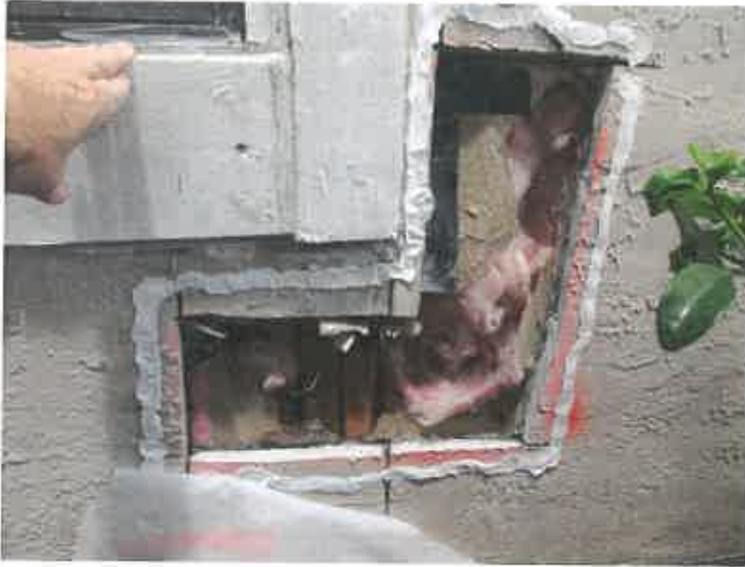
PHOTOGRAPH #96

**DESTRUCTIVE INVESTIGATION
OPENINGS – MARK 17
1st Floor Below Window**

No damage

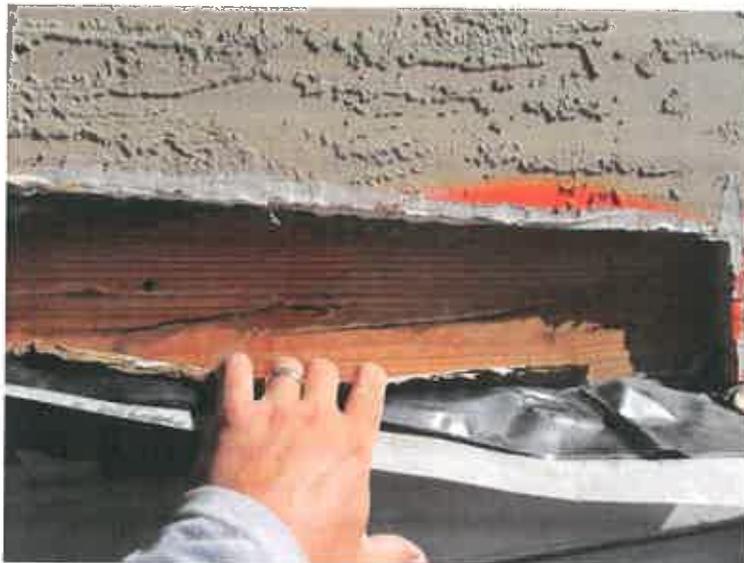
PHOTOGRAPH #97

**DESTRUCTIVE INVESTIGATION
OPENINGS – MARK 18
1st Floor Above Window**

No damage

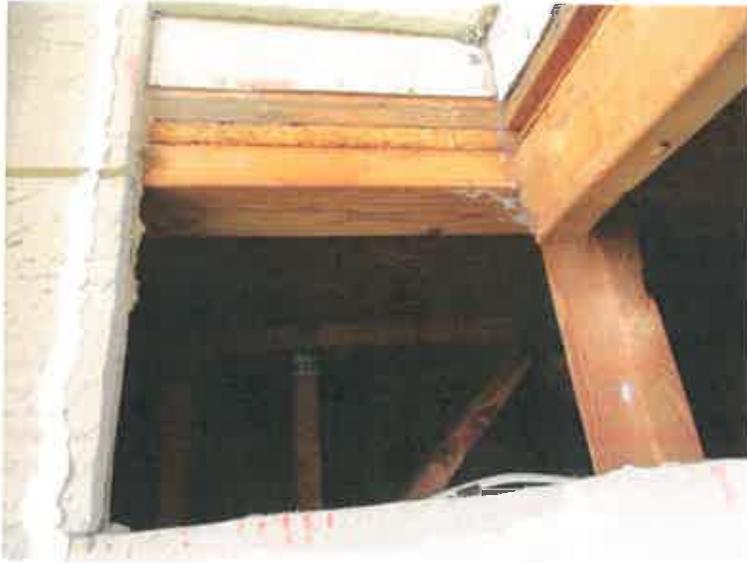
PHOTOGRAPH #98

**DESTRUCTIVE INVESTIGATION
OPENINGS – MARK 19
1st & 2nd Floor Inside Corner**

No damage

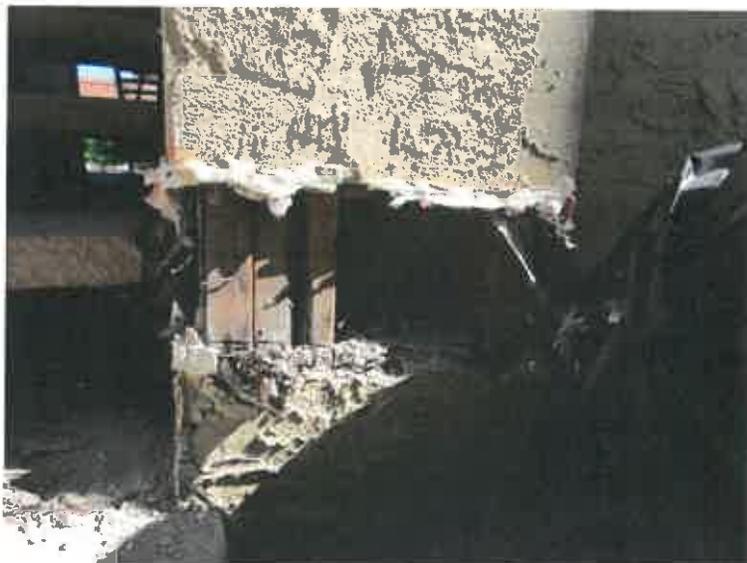
PHOTOGRAPH #99

**DESTRUCTIVE INVESTIGATION
OPENINGS – MARK 20
1st Floor Near Stair at Base**

No damage

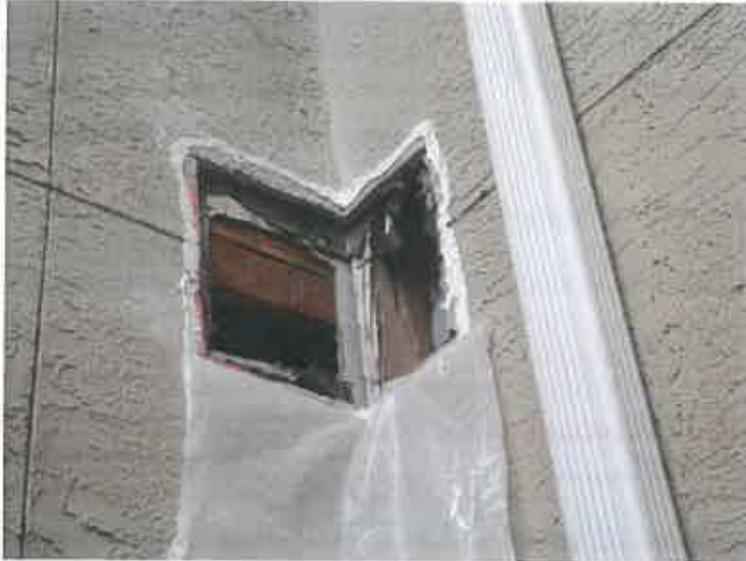
PHOTOGRAPH #100

**DESTRUCTIVE INVESTIGATION
OPENINGS – MARK 21
1st & 2nd Floor Inside Corner**

No damage

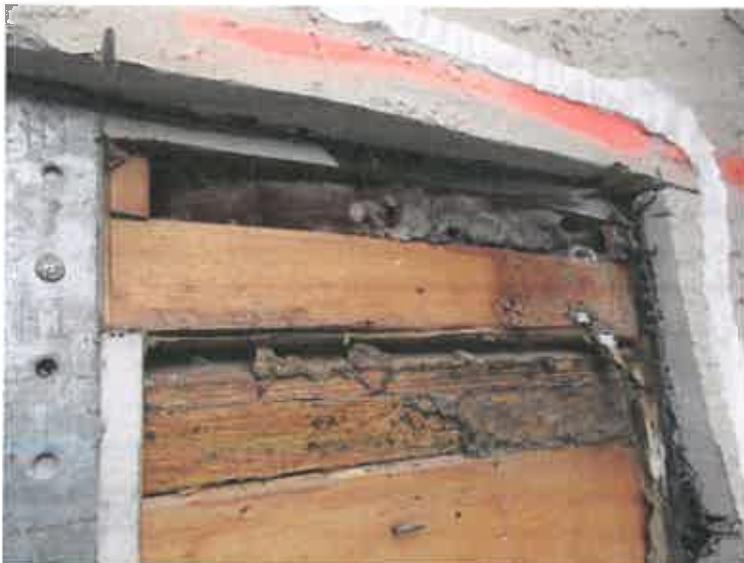
PHOTOGRAPH #101

**DESTRUCTIVE INVESTIGATION
OPENINGS – MARK 22
2nd Floor Below Window**

No damage

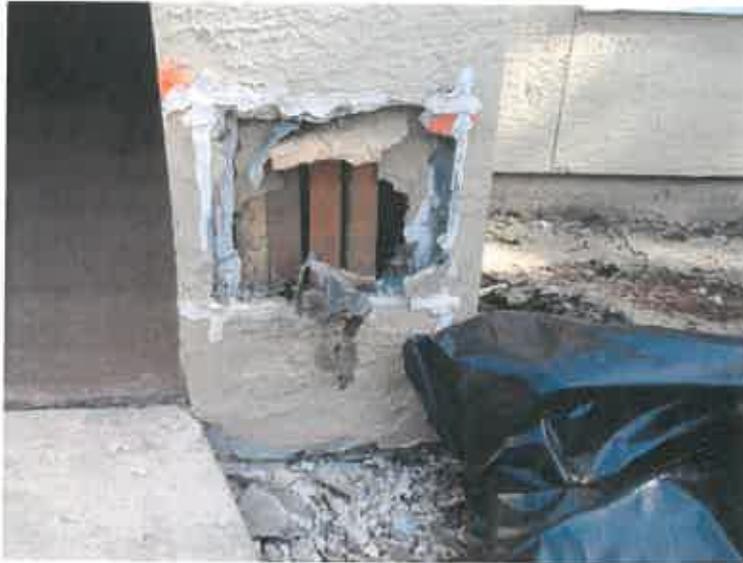
PHOTOGRAPH #102

**DESTRUCTIVE INVESTIGATION
OPENINGS – MARK 23
1st Floor Near Stair at Base**

No damage

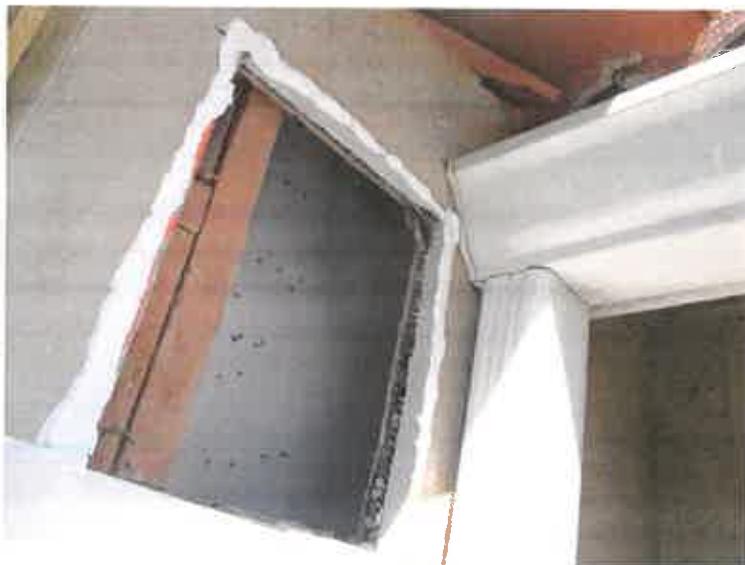
PHOTOGRAPH #103

**DESTRUCTIVE INVESTIGATION
OPENINGS – MARK 24
Roof to Wall Intersection**

No damage

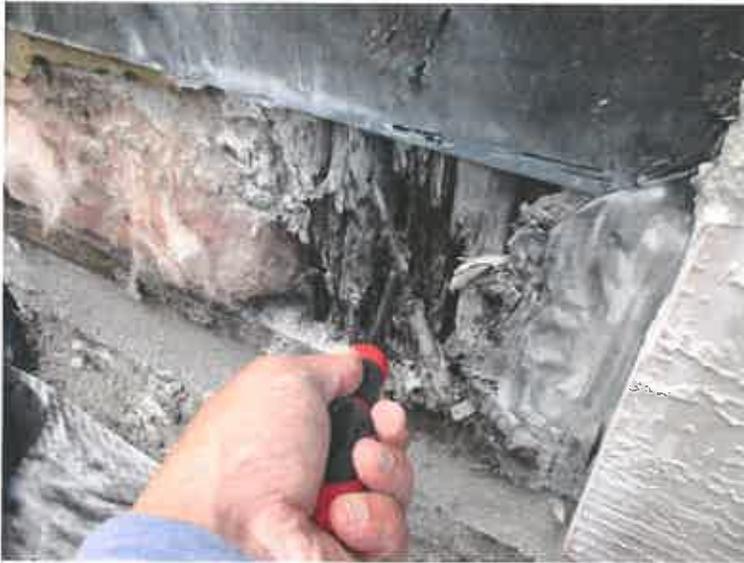
PHOTOGRAPH #104

**DESTRUCTIVE INVESTIGATION
OPENINGS – MARK 1
1st Floor Below Window**

Wood frame damage

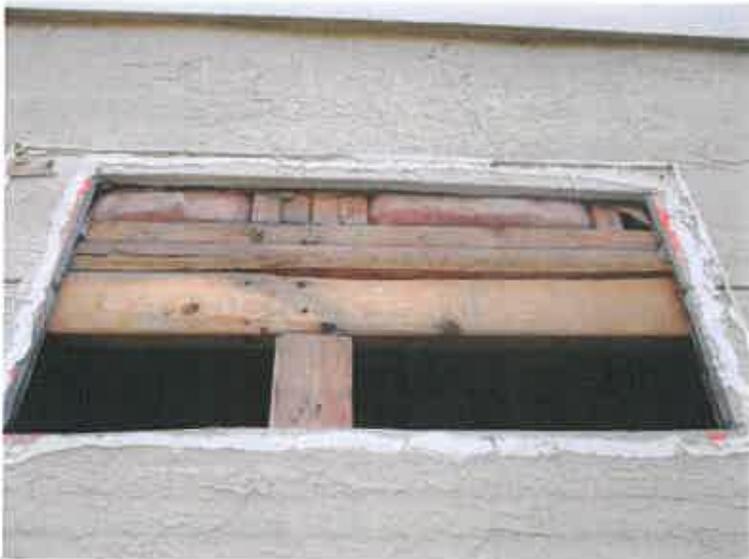
PHOTOGRAPH #105

**DESTRUCTIVE INVESTIGATION
OPENINGS – MARK 2
1st & 2nd Floor at Control Joint**

No damage

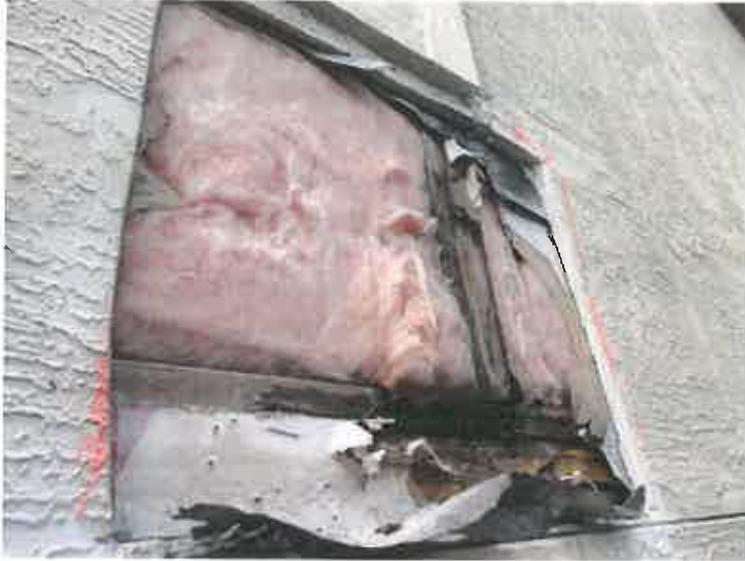
PHOTOGRAPH #106

**DESTRUCTIVE INVESTIGATION
OPENINGS – MARK 3
2nd Floor Below Window**

Wood frame damage

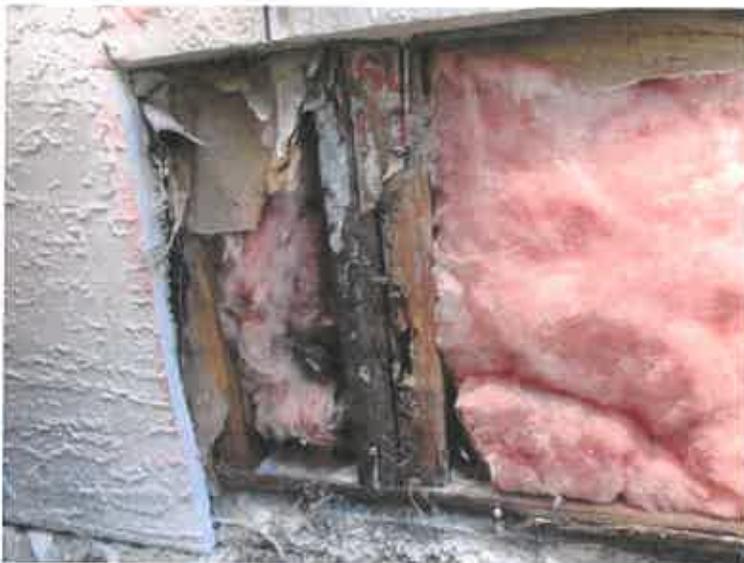
PHOTOGRAPH #107

**DESTRUCTIVE INVESTIGATION
OPENINGS – MARK 4
1st Floor Below Window**

Wood frame damage

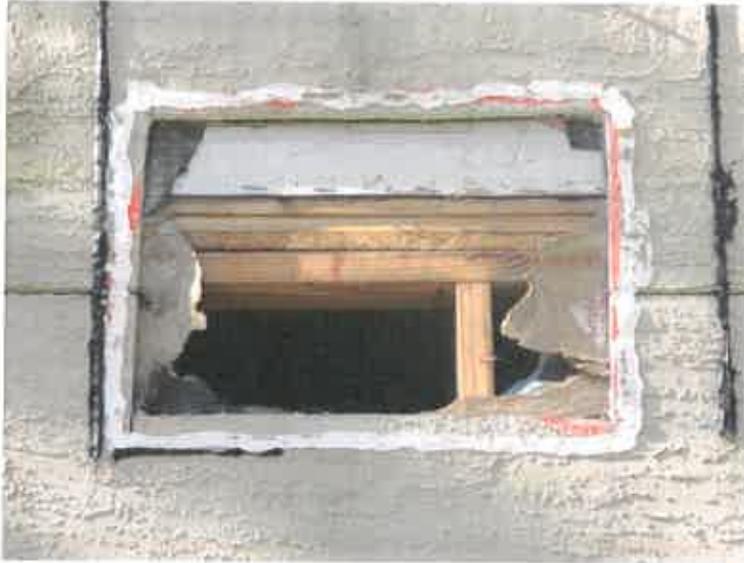
PHOTOGRAPH #108

**DESTRUCTIVE INVESTIGATION
OPENINGS – MARK 5
1st & 2nd Floor at Control Joint**

No damage

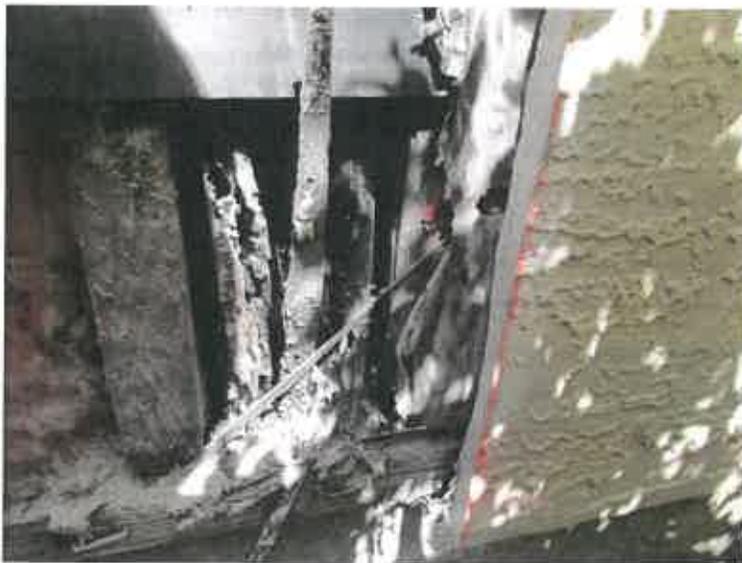
PHOTOGRAPH #109

**DESTRUCTIVE INVESTIGATION
OPENINGS – MARK 6
1st Floor Below Window**

Wood frame damage

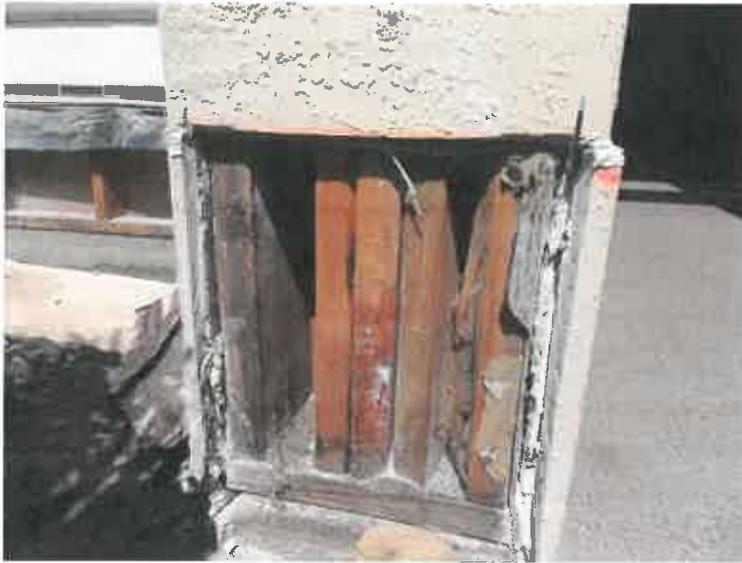
PHOTOGRAPH #110

**DESTRUCTIVE INVESTIGATION
OPENINGS – MARK 7
1st Floor Near Stair at Base**

No damage

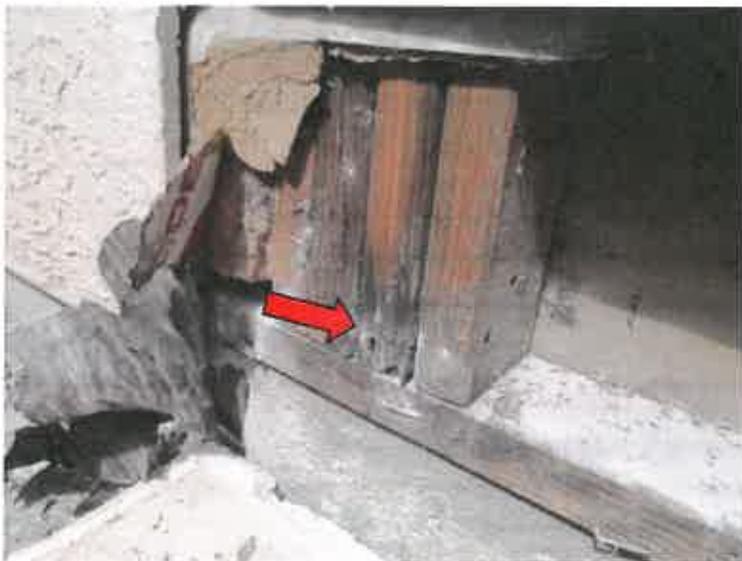
PHOTOGRAPH #111

**DESTRUCTIVE INVESTIGATION
OPENINGS – MARK 8
1st Floor Below Window**

Wood frame damage

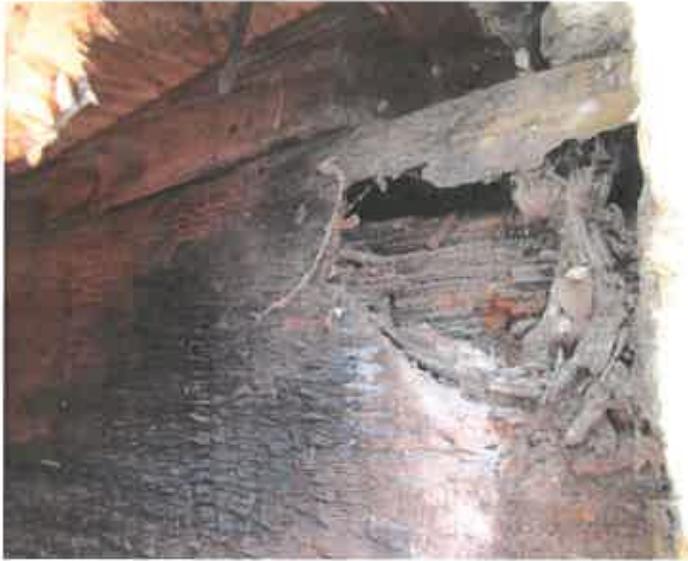
PHOTOGRAPH #112

**DESTRUCTIVE INVESTIGATION
OPENINGS – MARK 9
2nd Floor Adjacent to Balcony**

Wood frame damage

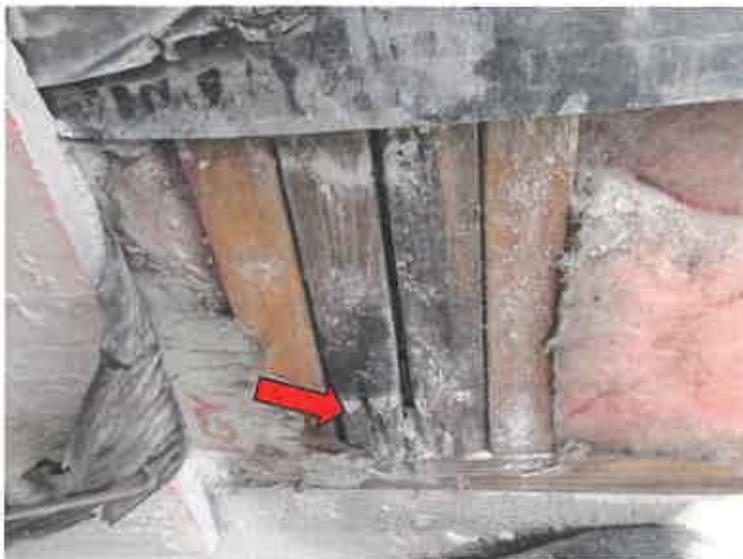
PHOTOGRAPH #113

**DESTRUCTIVE INVESTIGATION
OPENINGS – MARK 10
1st Floor Below Window**

Wood frame damage

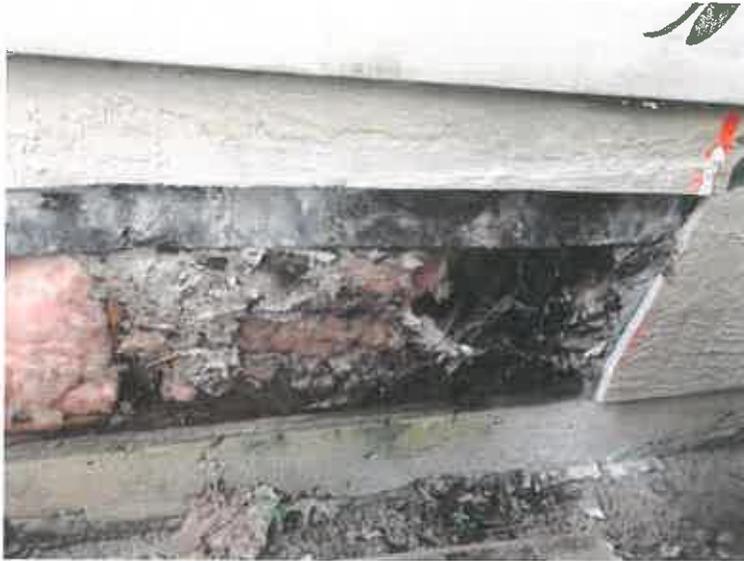
PHOTOGRAPH #114

**DESTRUCTIVE INVESTIGATION
OPENINGS – MARK 11
1st Floor Below Window**

Wood frame damage

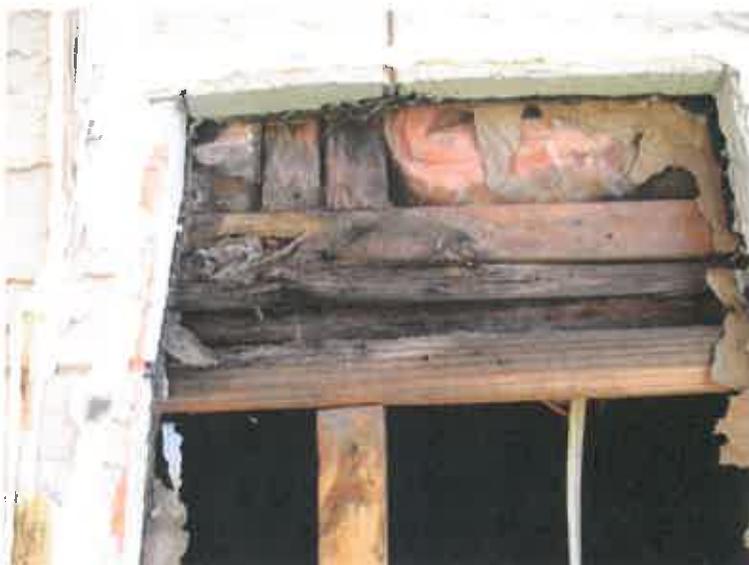
PHOTOGRAPH #115

**DESTRUCTIVE INVESTIGATION
OPENINGS – MARK 12
1st & 2nd Floor at Control Joint**

Wood frame damage

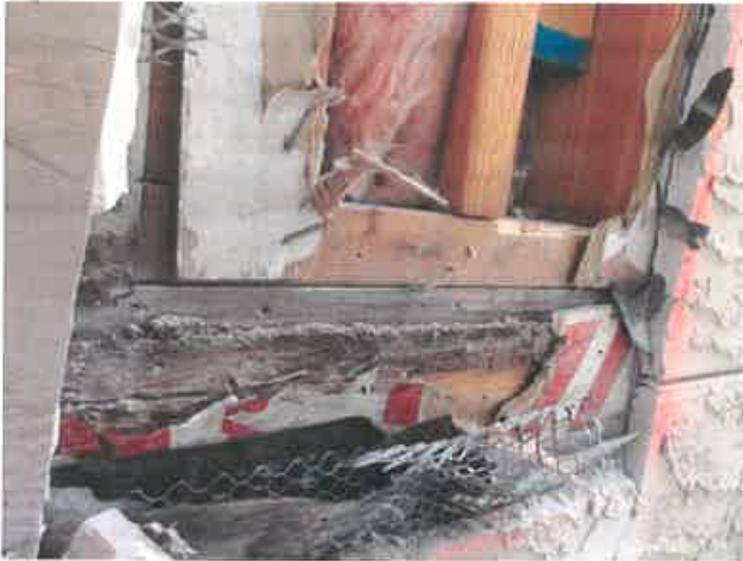
PHOTOGRAPH #116

**DESTRUCTIVE INVESTIGATION
OPENINGS – MARK 13
2nd Floor Below Window**

Wood frame damage

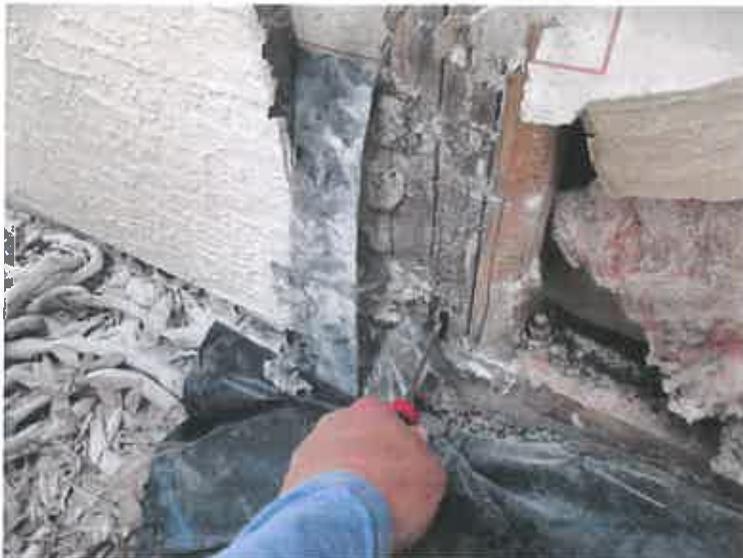
PHOTOGRAPH #117

**DESTRUCTIVE INVESTIGATION
OPENINGS – MARK 14
1st Floor Below Window**

Wood frame damage
