SUPPLEMENTAL DESTRUCTIVE INVESTIGATION

**Vintage Grand Condominium
4012 Crockers Lake Blvd.
Sarasota, FL 34238**

Project No. R1606-231

October 28, 2016

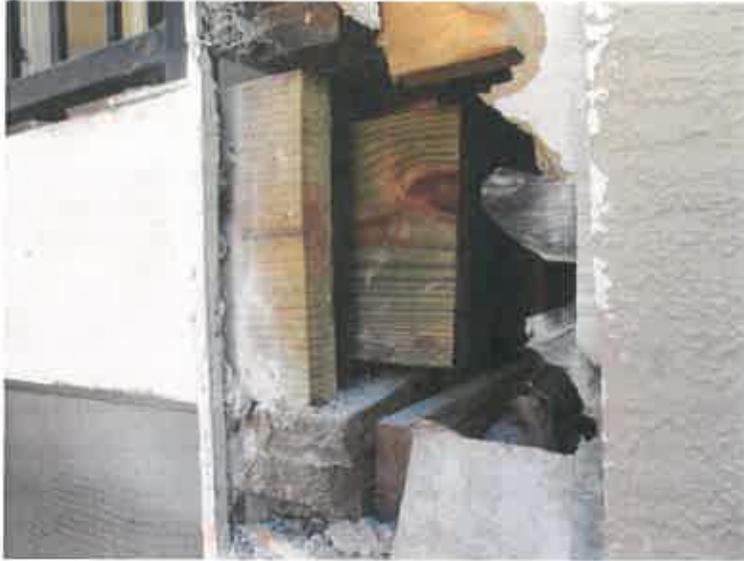
PHOTOGRAPH #118

**DESTRUCTIVE INVESTIGATION
OPENINGS – MARK 15
2nd Floor Adjacent to Balcony**

No damage

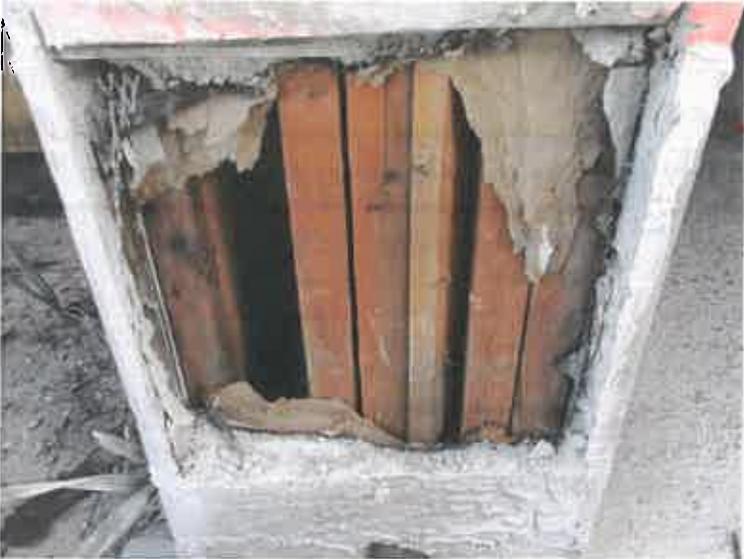
PHOTOGRAPH #120

**DESTRUCTIVE INVESTIGATION
OPENINGS – MARK 17
1st Floor Near Stair at Base**

No damage

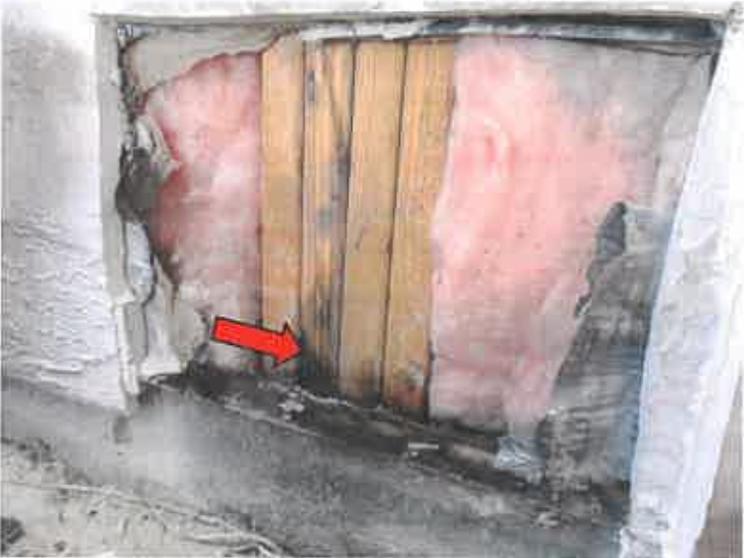
PHOTOGRAPH #121

**DESTRUCTIVE INVESTIGATION
OPENINGS – MARK 18
1st Floor Below Window**

Wet framing, water stains on studs

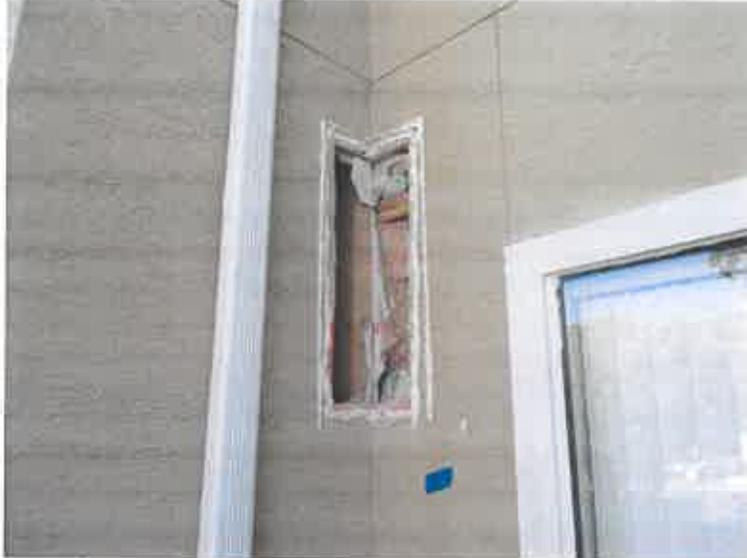
PHOTOGRAPH #122

**DESTRUCTIVE INVESTIGATION
OPENINGS – MARK 19
1st & 2nd Floor Inside Corner**

No damage

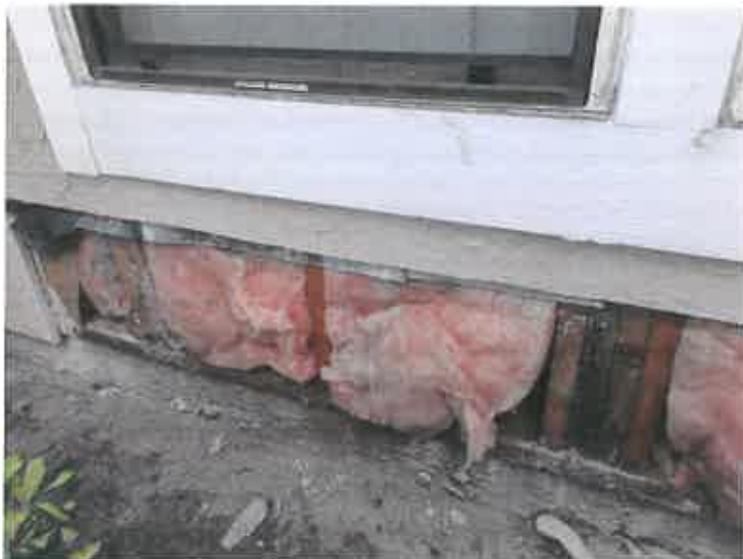
PHOTOGRAPH #123

**DESTRUCTIVE INVESTIGATION
OPENINGS – MARK 20
1st Floor Below Window**

No damage

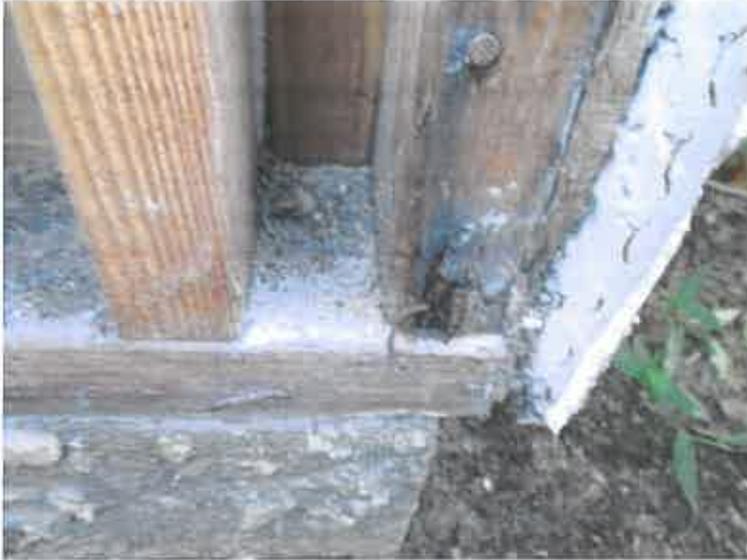
PHOTOGRAPH #124

**DESTRUCTIVE INVESTIGATION
OPENINGS – MARK 21
1st Floor Outside Corner**

Wood frame damage

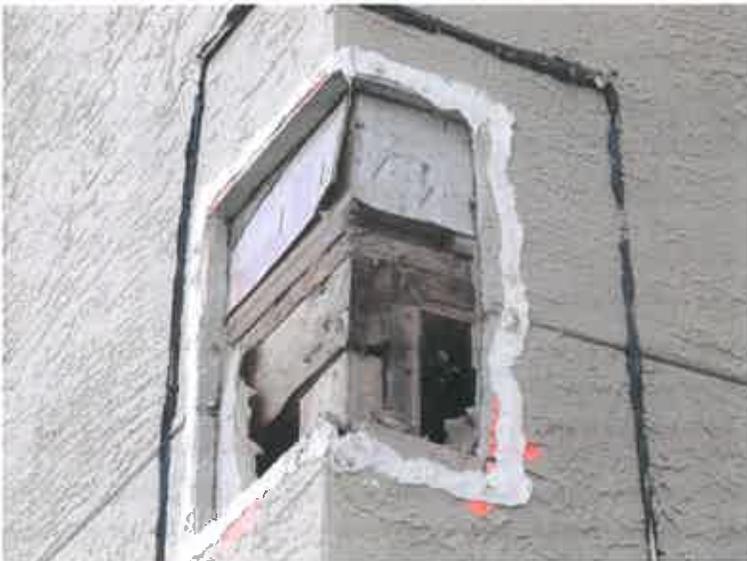
PHOTOGRAPH #125

**DESTRUCTIVE INVESTIGATION
OPENINGS – MARK 22
1st & 2nd Floor Outside Corner**

No damage

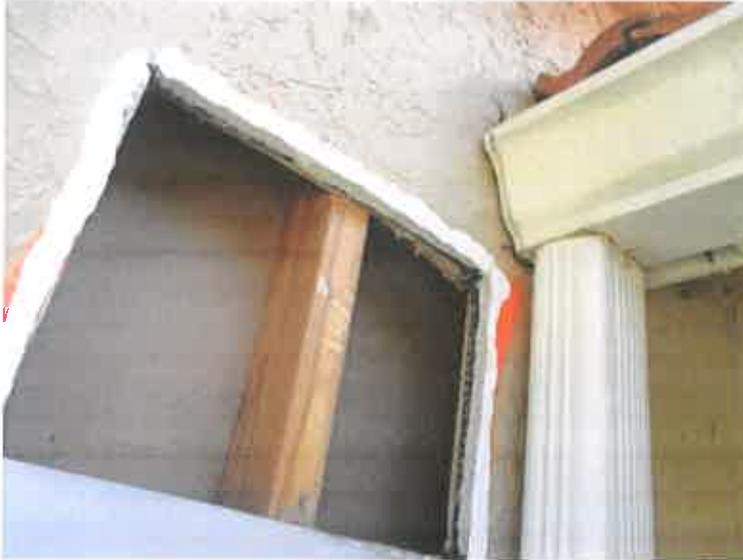
PHOTOGRAPH #126

**DESTRUCTIVE INVESTIGATION
OPENINGS – MARK 23
Roof to Wall Intersection**

No damage

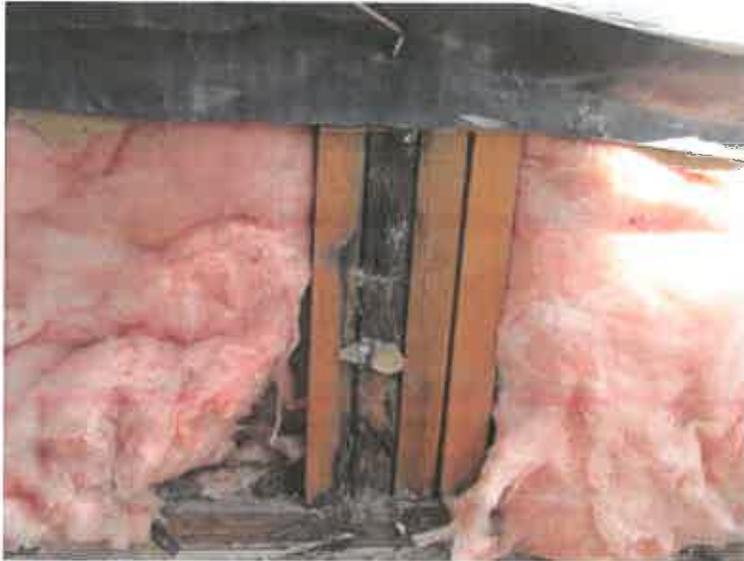
PHOTOGRAPH #127

**DESTRUCTIVE INVESTIGATION
OPENINGS – MARK 1
1st Floor Below Window**

Wood frame damage

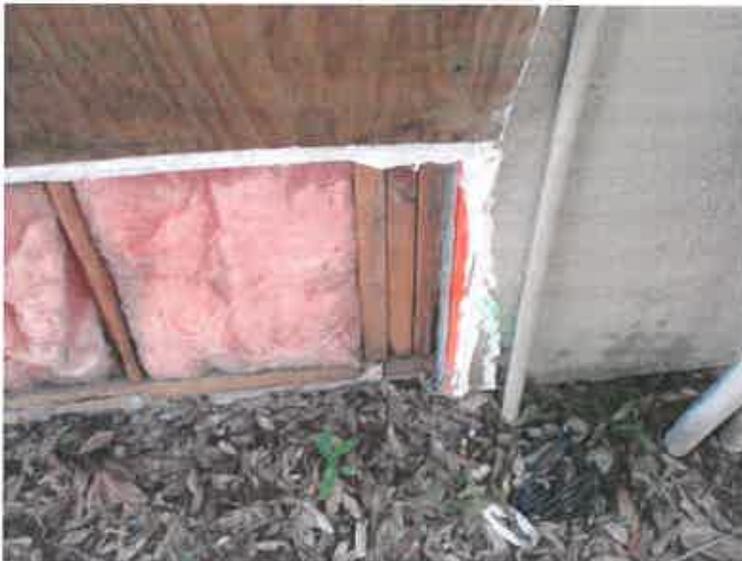
PHOTOGRAPH #128

**DESTRUCTIVE INVESTIGATION
OPENINGS – MARK 2
1st Floor Below Window**

No damage

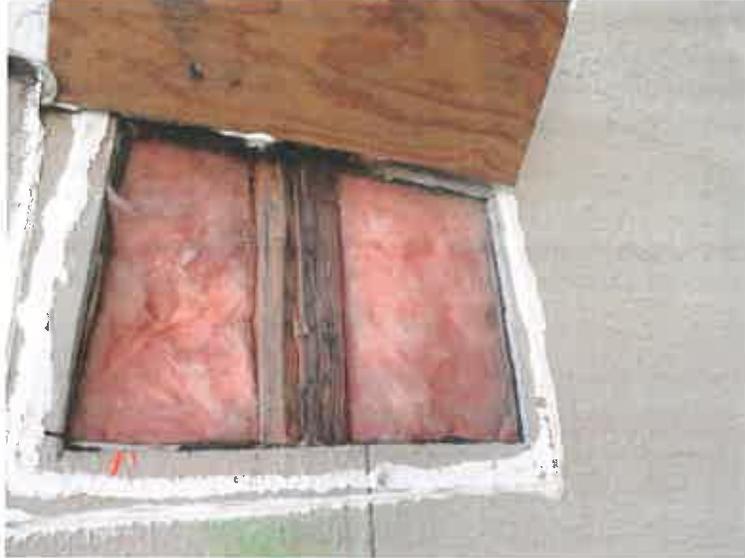
PHOTOGRAPH #129

**DESTRUCTIVE INVESTIGATION
OPENINGS – MARK 3
2nd Floor Below Window**

No damage

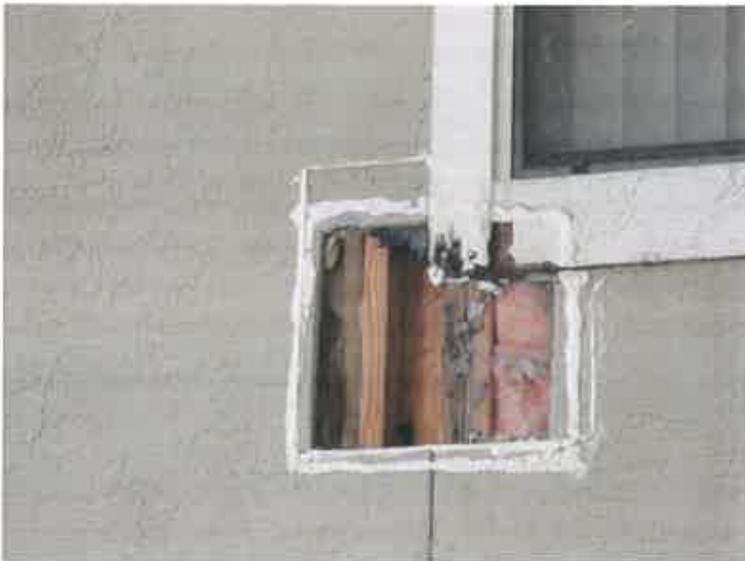
PHOTOGRAPH #130

**DESTRUCTIVE INVESTIGATION
OPENINGS – MARK 4
2nd Floor Below Window**

No damage

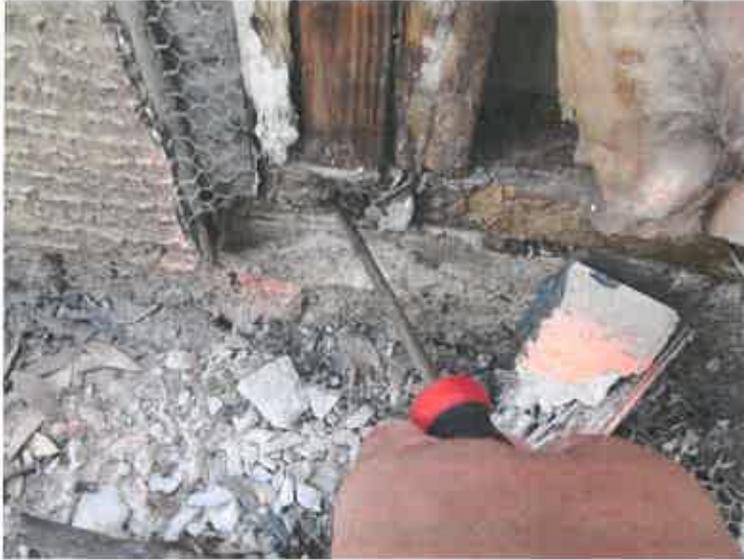
PHOTOGRAPH #131

**DESTRUCTIVE INVESTIGATION
OPENINGS – MARK 5
1st Floor Below Window**

Wood frame damage

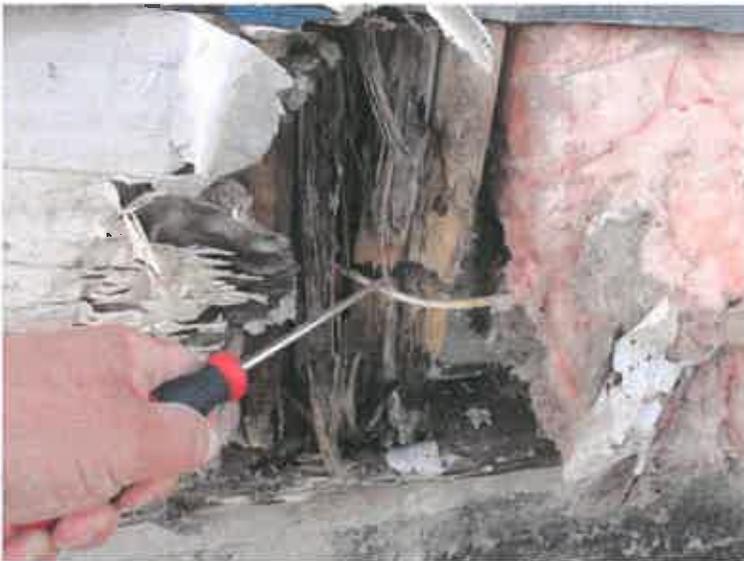
PHOTOGRAPH #132

**DESTRUCTIVE INVESTIGATION
OPENINGS – MARK 6
1st Floor Below Window**

Wood frame damage

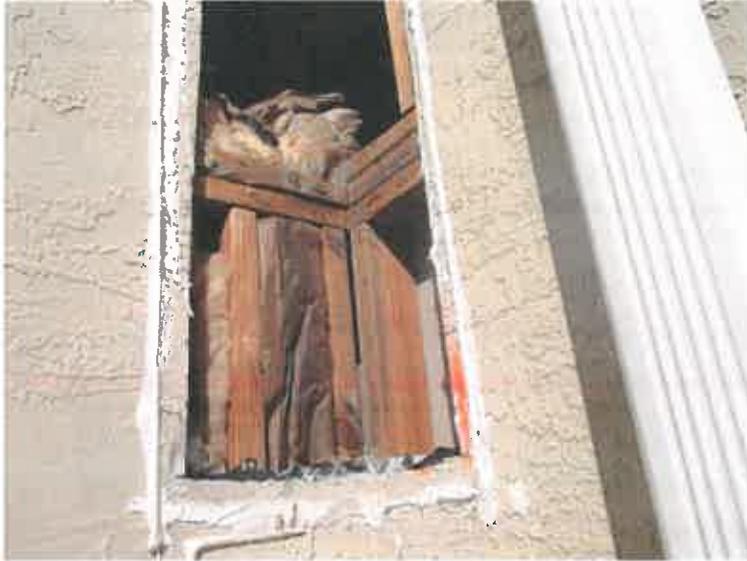
PHOTOGRAPH #133

**DESTRUCTIVE INVESTIGATION
OPENINGS – MARK 7
1st & 2nd Floor Inside Corner**

No damage

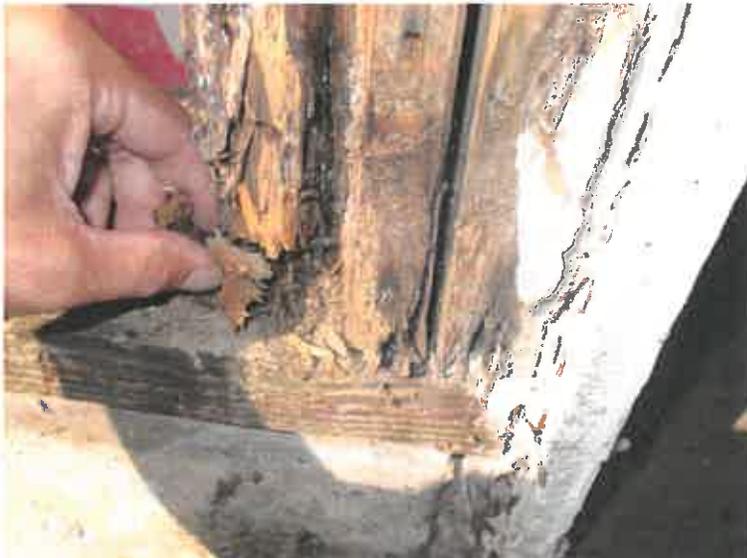
PHOTOGRAPH #134

**DESTRUCTIVE INVESTIGATION
OPENINGS – MARK 8
1st Floor Near Stairs at Base**

Wood frame damage

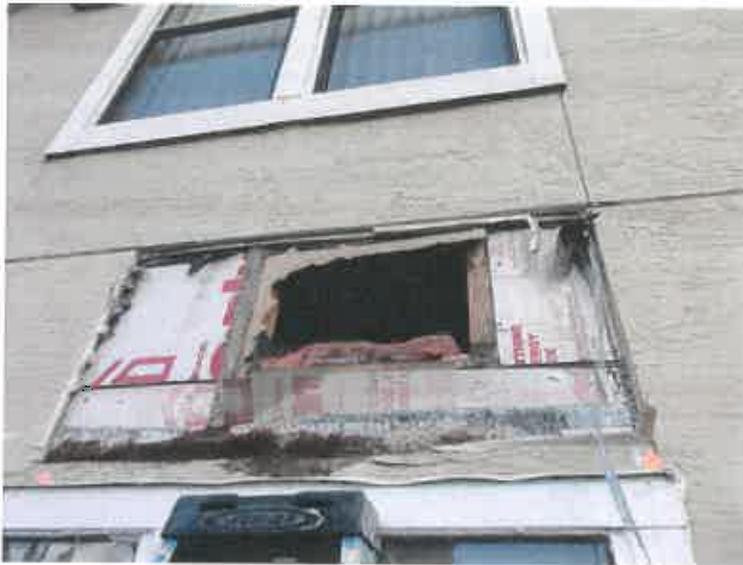
PHOTOGRAPH #135

**DESTRUCTIVE INVESTIGATION
OPENINGS – MARK 9
1st Floor Above Window**

No damage

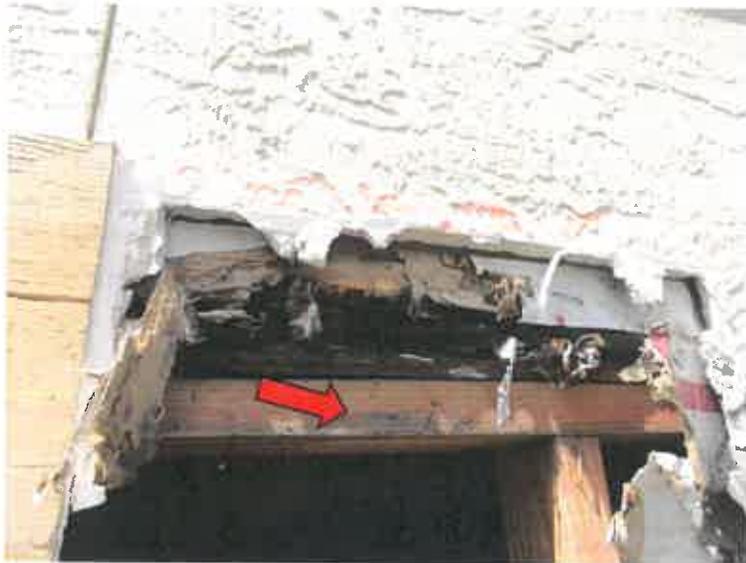
PHOTOGRAPH #136

**DESTRUCTIVE INVESTIGATION
OPENINGS – MARK 10
1st & 2nd Floor at Control Joint**

Wood frame damage

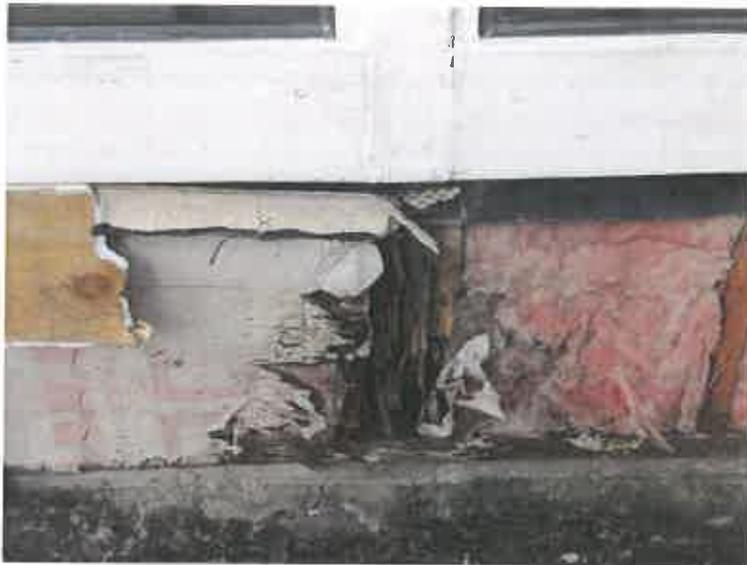
PHOTOGRAPH #137

**DESTRUCTIVE INVESTIGATION
OPENINGS – MARK 11
1st Floor Below Window**

Wood frame damage

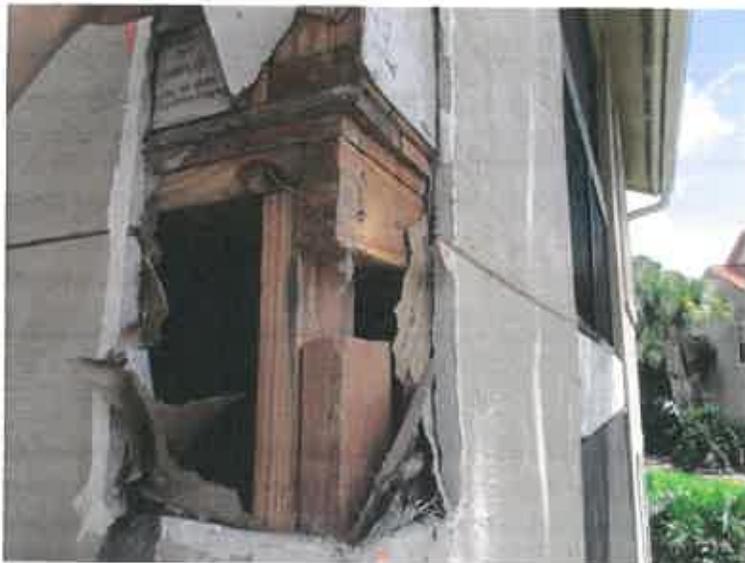
PHOTOGRAPH #138

**DESTRUCTIVE INVESTIGATION
OPENINGS – MARK 12
1st & 2nd Floor Outside Corner**

No damage

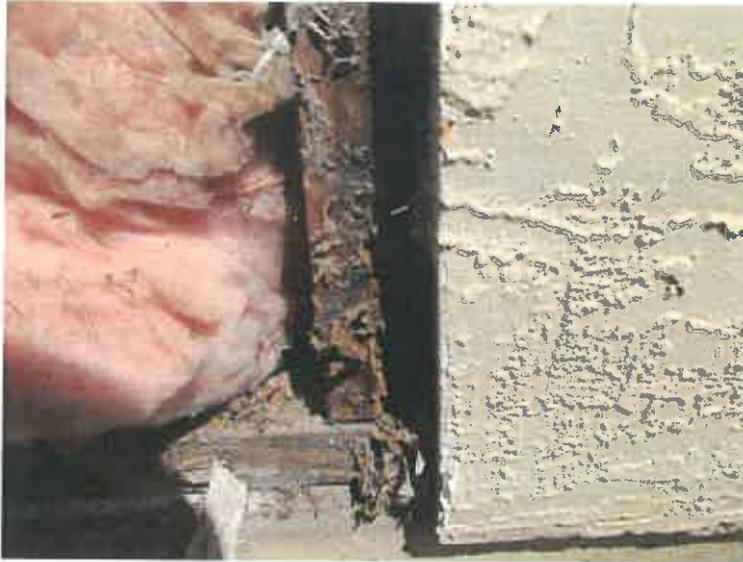
PHOTOGRAPH #139

**DESTRUCTIVE INVESTIGATION
OPENINGS – MARK 13
1st Floor Below Window**

Wood frame damage

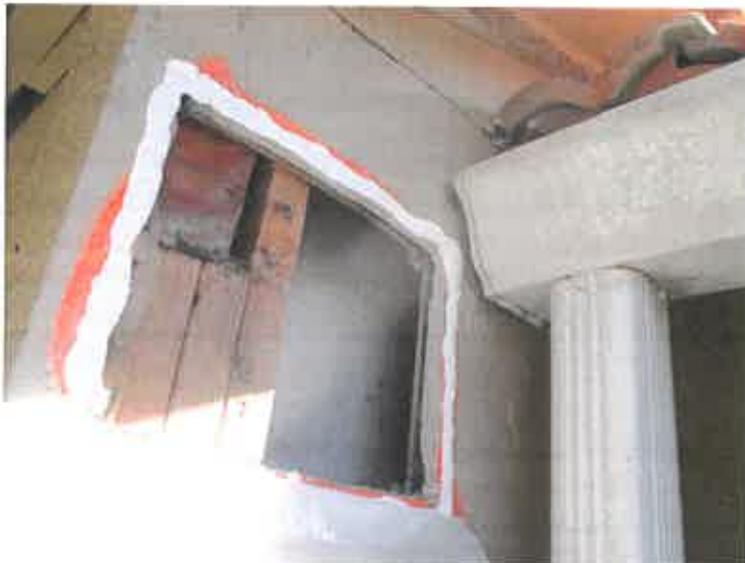
PHOTOGRAPH #140

**DESTRUCTIVE INVESTIGATION
OPENINGS – MARK 14
Roof to Wall Intersection**

No damage

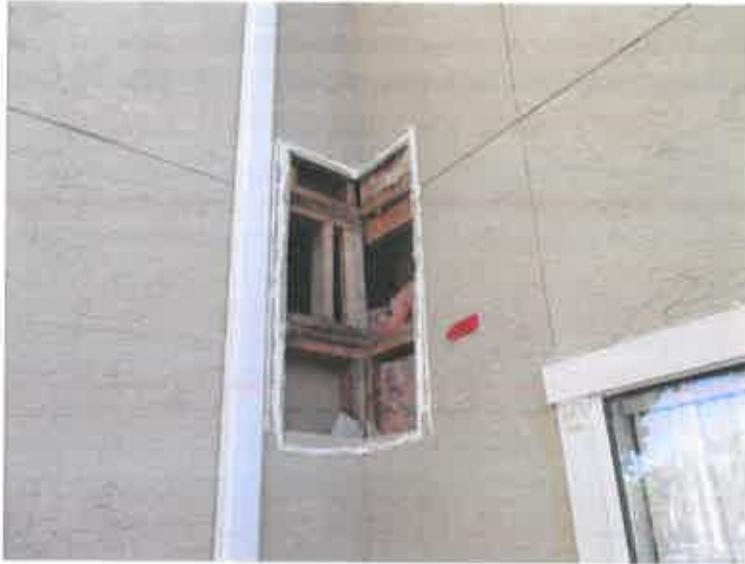
PHOTOGRAPH #141

**DESTRUCTIVE INVESTIGATION
OPENINGS – MARK 15
1st & 2nd Floor Inside Corner**

No damage

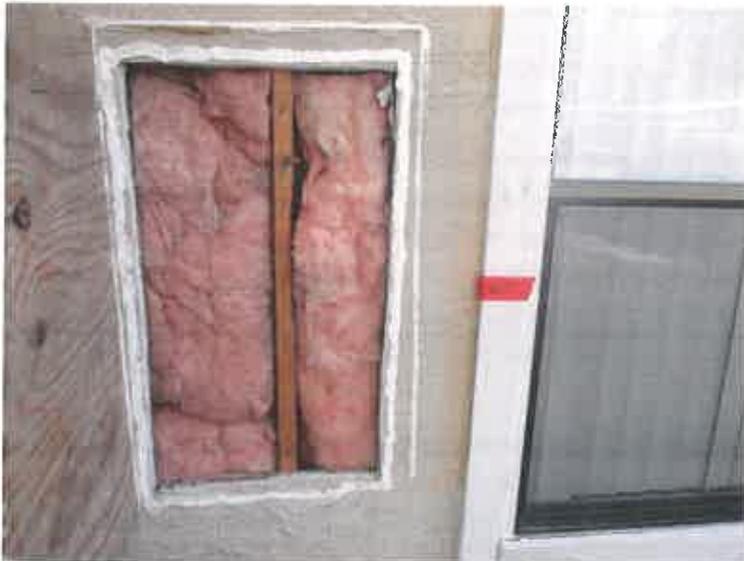
PHOTOGRAPH #142

**DESTRUCTIVE INVESTIGATION
OPENINGS – MARK 16
1st Floor Adjacent to Window**

No damage

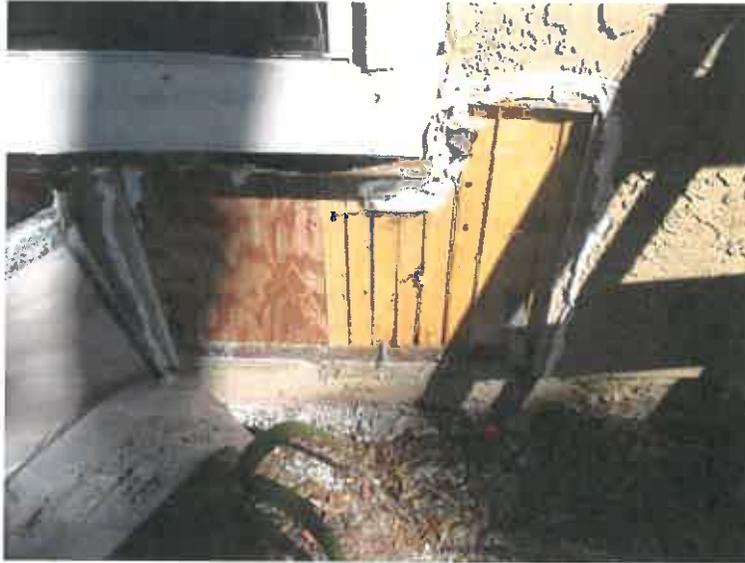
PHOTOGRAPH #163

**DESTRUCTIVE INVESTIGATION
OPENINGS – MARK 1
1st Floor Below Window**

No damage, previous repair by others

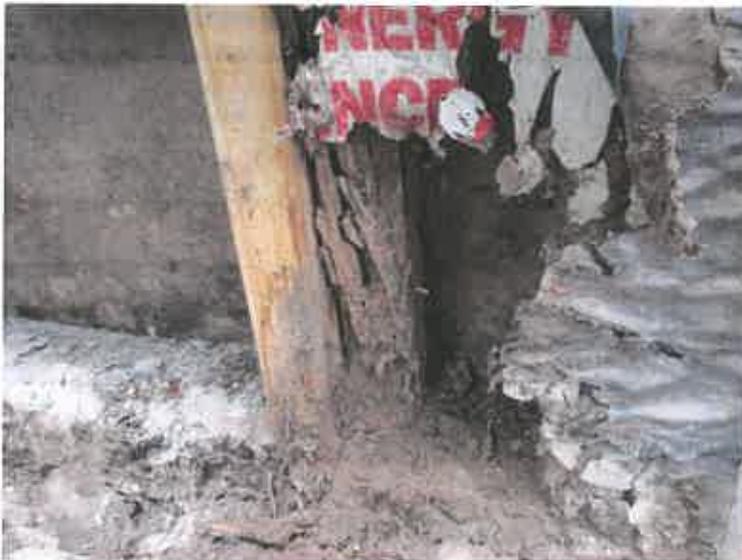
PHOTOGRAPH #164

**DESTRUCTIVE INVESTIGATION
OPENINGS – MARK 2
1st Floor Below Window**

Wood frame damage

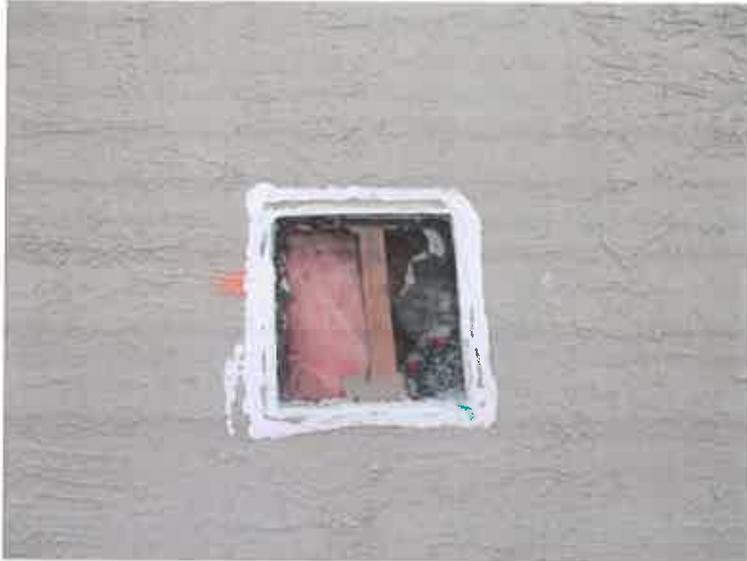
PHOTOGRAPH #165

**DESTRUCTIVE INVESTIGATION
OPENINGS – MARK 3
1st & 2nd Floor at Control Joint**

No damage

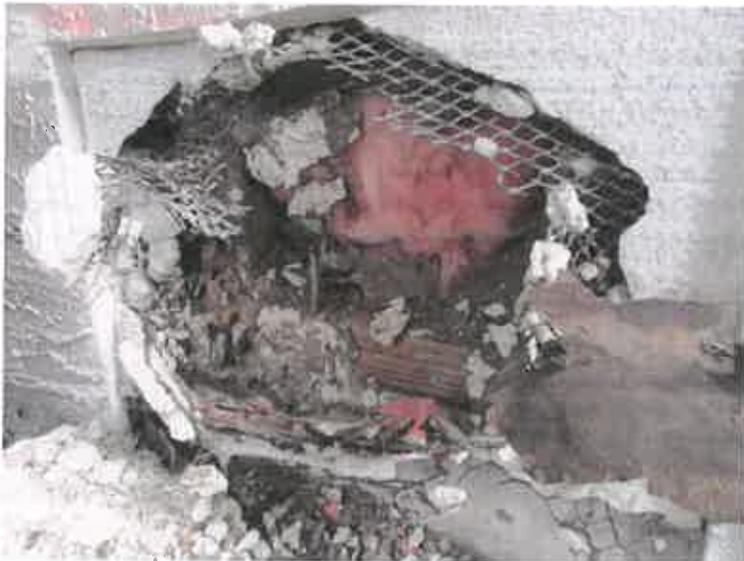
PHOTOGRAPH #166

**DESTRUCTIVE INVESTIGATION
OPENINGS – MARK 4
1st Floor Outside Corner**

Wood frame damage

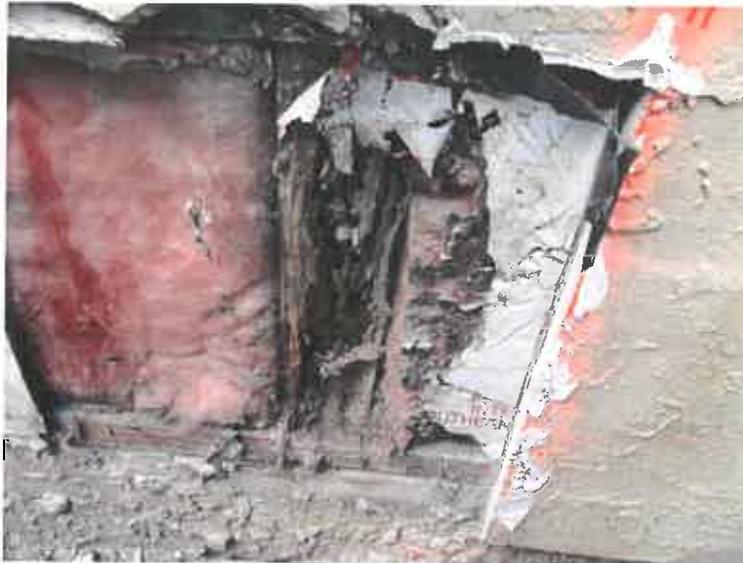
PHOTOGRAPH #167

**DESTRUCTIVE INVESTIGATION
OPENINGS – MARK 5
1st Floor Below Window**

Wood frame damage

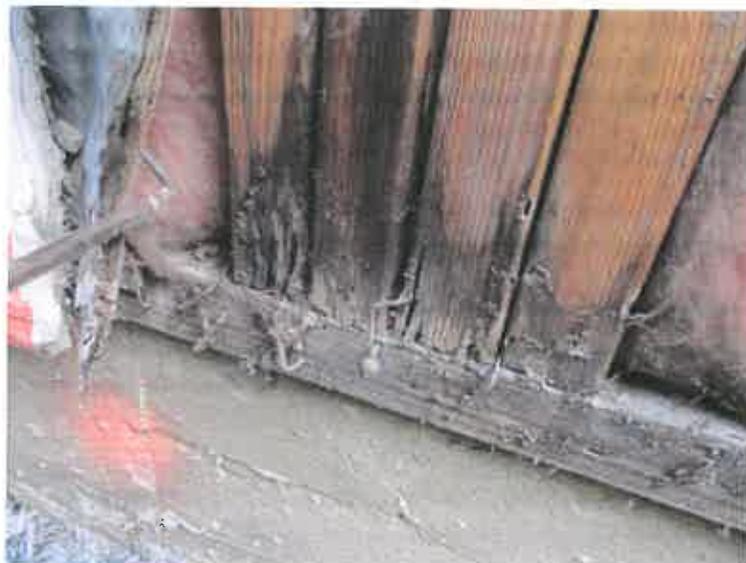
PHOTOGRAPH #168

**DESTRUCTIVE INVESTIGATION
OPENINGS – MARK 6
1st Floor Below Window**

Wood frame damage

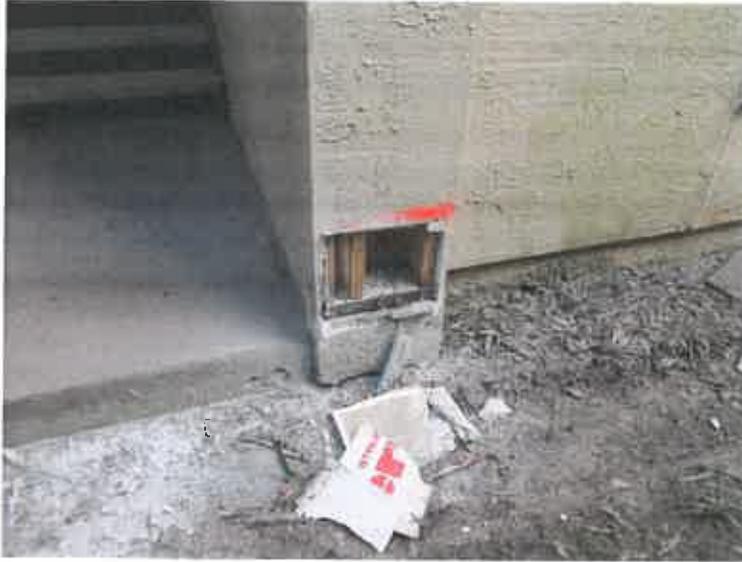
PHOTOGRAPH #169

**DESTRUCTIVE INVESTIGATION
OPENINGS – MARK 7
1st Floor Near Stair at Base**

No damage

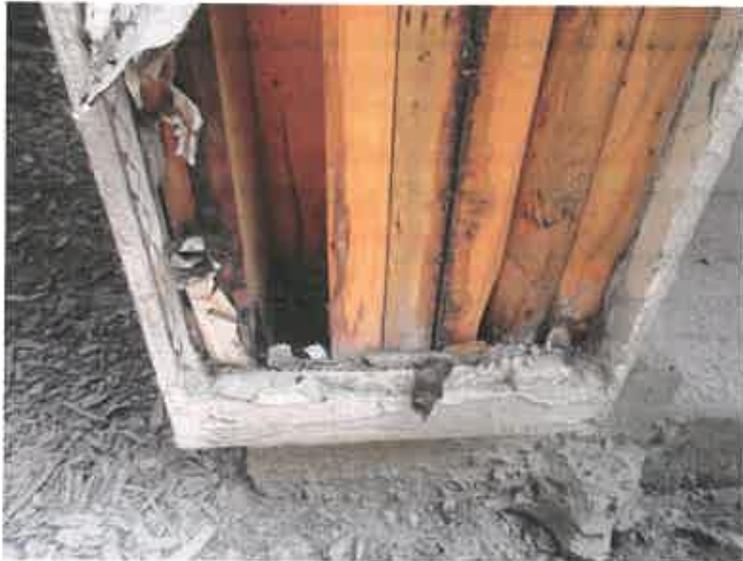
PHOTOGRAPH #170

**DESTRUCTIVE INVESTIGATION
OPENINGS – MARK 8
1st Floor Near Stair at Base**

No damage

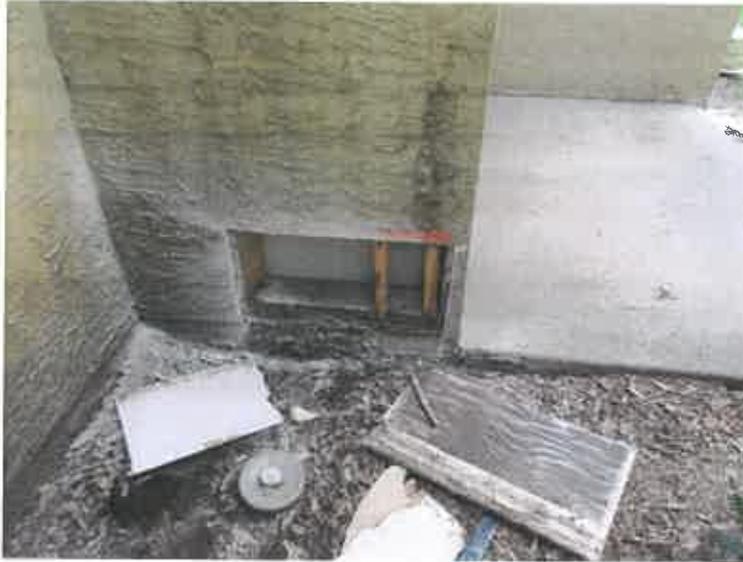
PHOTOGRAPH #171

**DESTRUCTIVE INVESTIGATION
OPENINGS – MARK 9
1st Floor Near Stair at Base**

No damage

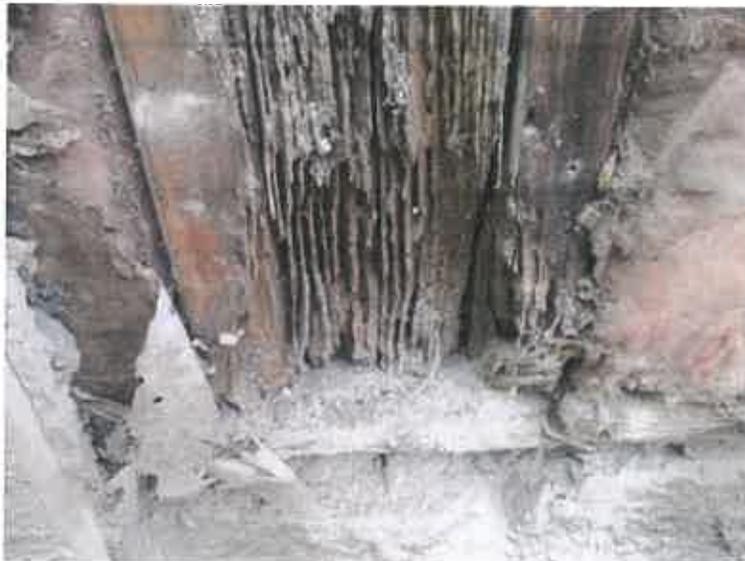
PHOTOGRAPH #172

**DESTRUCTIVE INVESTIGATION
OPENINGS – MARK 10
1st Floor Below Window**

Wood frame damage

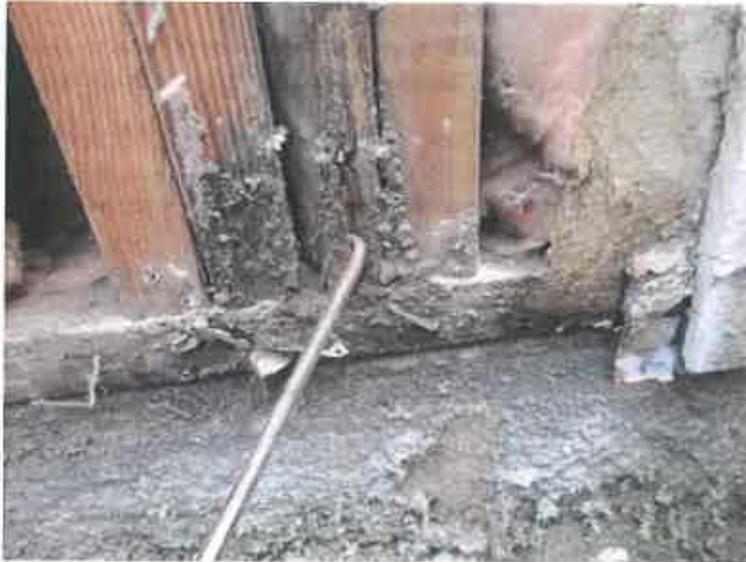
PHOTOGRAPH #173

**DESTRUCTIVE INVESTIGATION
OPENINGS – MARK 11
1st Floor Below Window**

Wood frame damage

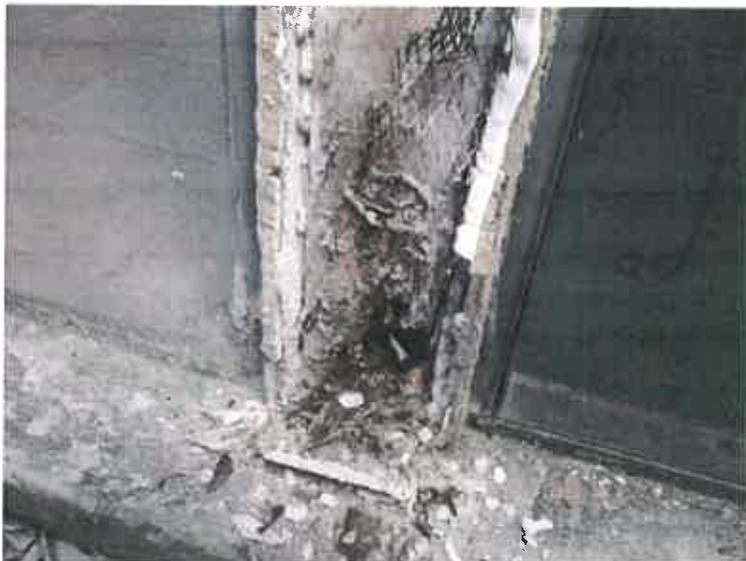
PHOTOGRAPH #174

**DESTRUCTIVE INVESTIGATION
OPENINGS – MARK 12
1st Floor Between Lanais**

Wood frame damage

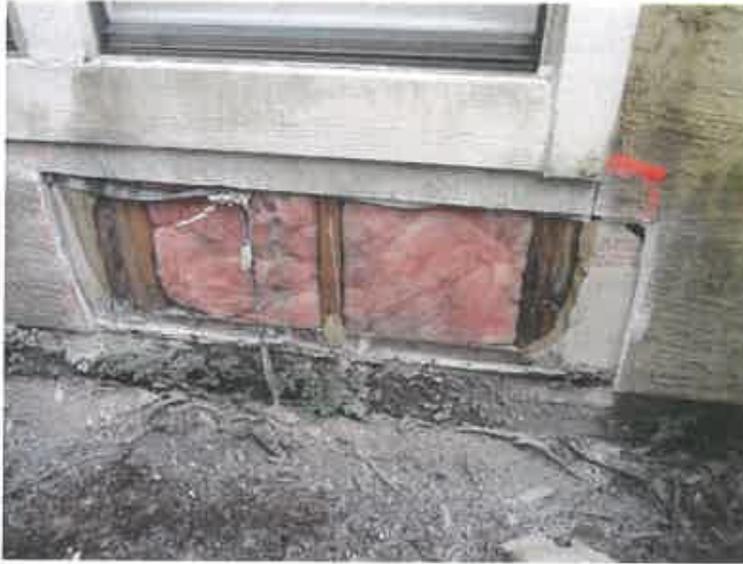
PHOTOGRAPH #175

**DESTRUCTIVE INVESTIGATION
OPENINGS – MARK 13
1st Floor Below Window**

No damage

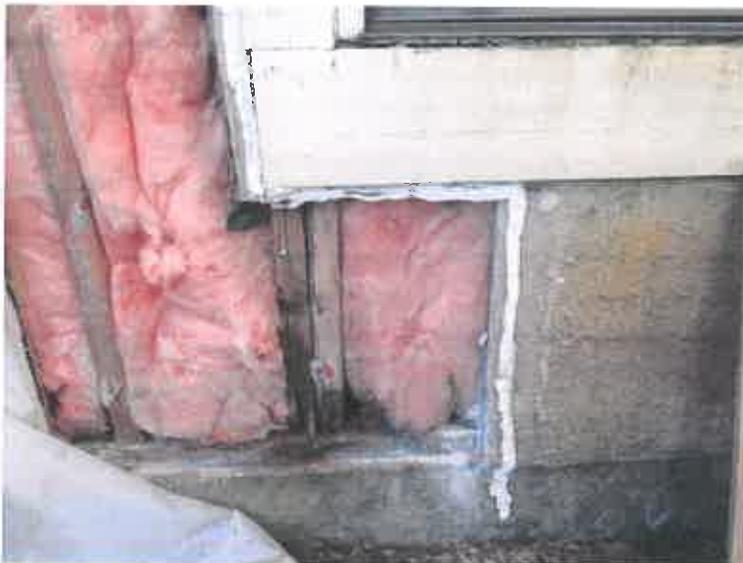
PHOTOGRAPH #176

**DESTRUCTIVE INVESTIGATION
OPENINGS – MARK 14
1st Floor Below Window**

Wood frame damage

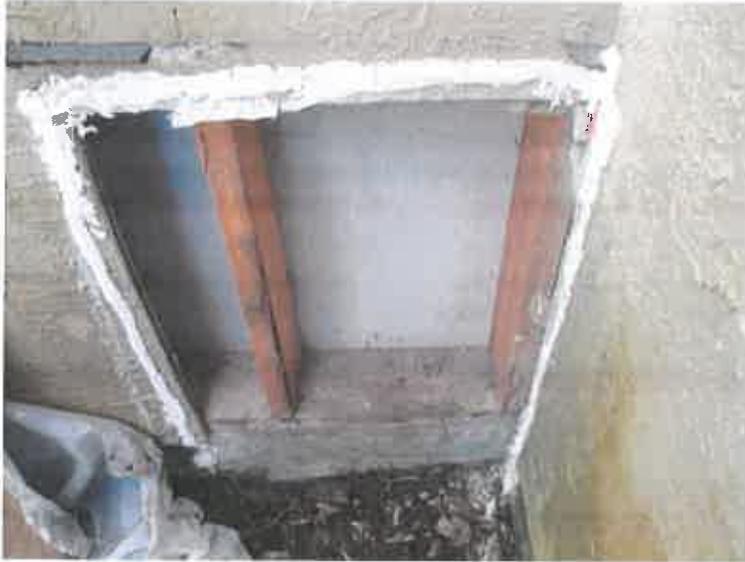
PHOTOGRAPH #177

**DESTRUCTIVE INVESTIGATION
OPENINGS – MARK 15
1st Floor Inside Corner**

No damage

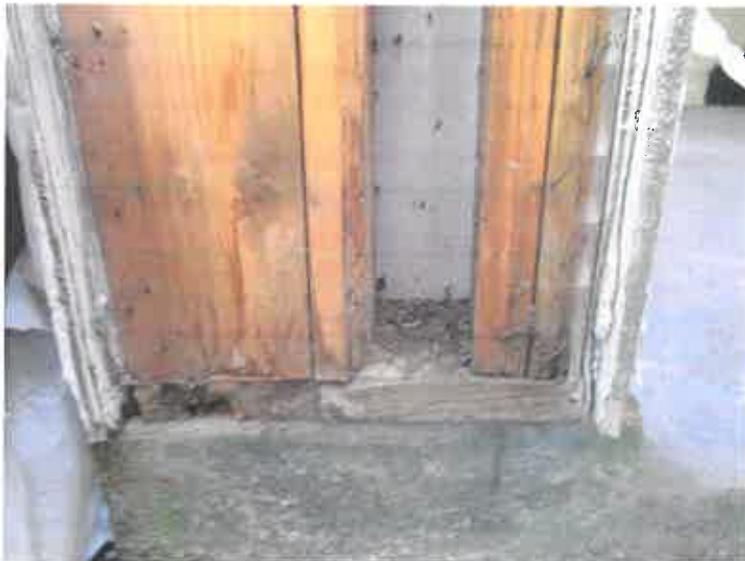
PHOTOGRAPH #178

**DESTRUCTIVE INVESTIGATION
OPENINGS – MARK 16
1st Floor Near Stair at Base**

No damage

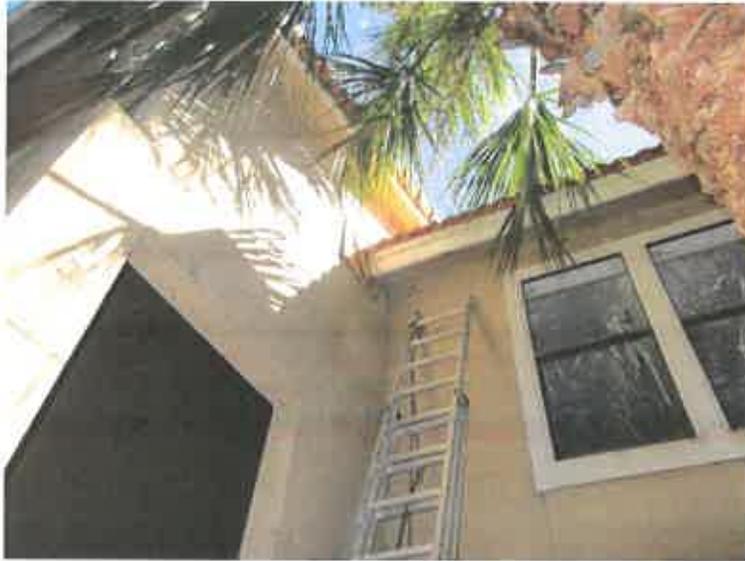
PHOTOGRAPH #179

**DESTRUCTIVE INVESTIGATION
OPENINGS – MARK 17
Roof to Wall Intersection**

No damage

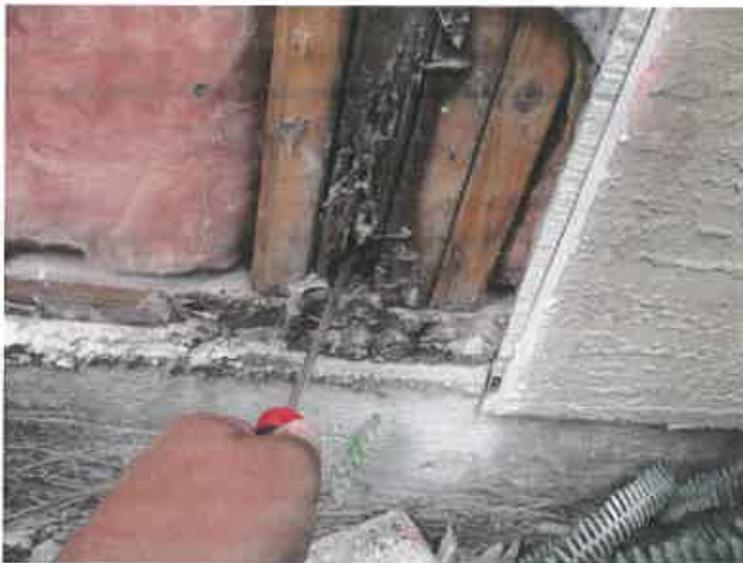
PHOTOGRAPH #180

**DESTRUCTIVE INVESTIGATION
OPENINGS – MARK 18
1st Floor Below Window**

Wood frame damage

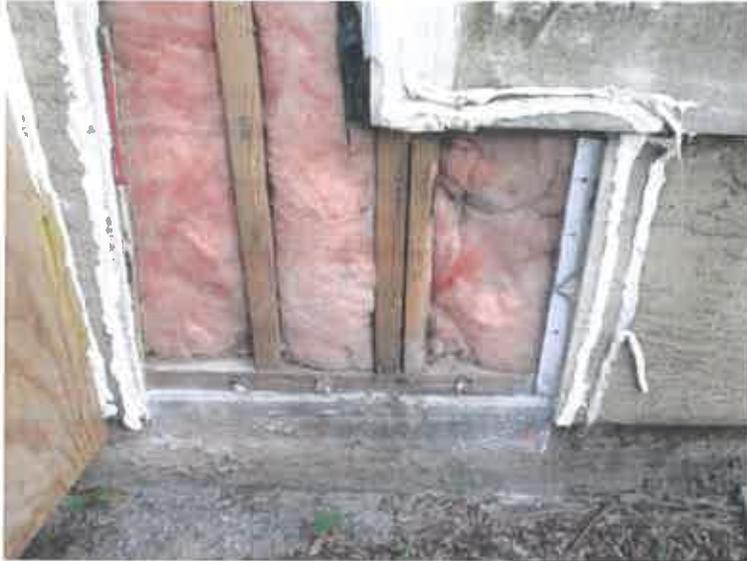
PHOTOGRAPH #181

**DESTRUCTIVE INVESTIGATION
OPENINGS – MARK 19
1st Floor Inside Corner**

No damage

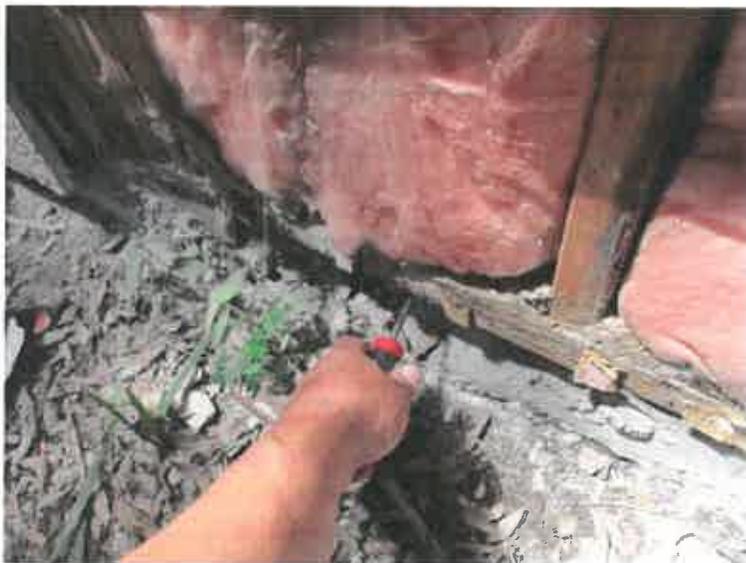
PHOTOGRAPH #182

**DESTRUCTIVE INVESTIGATION
OPENINGS – MARK 20
1st Floor Below Window**

No damage

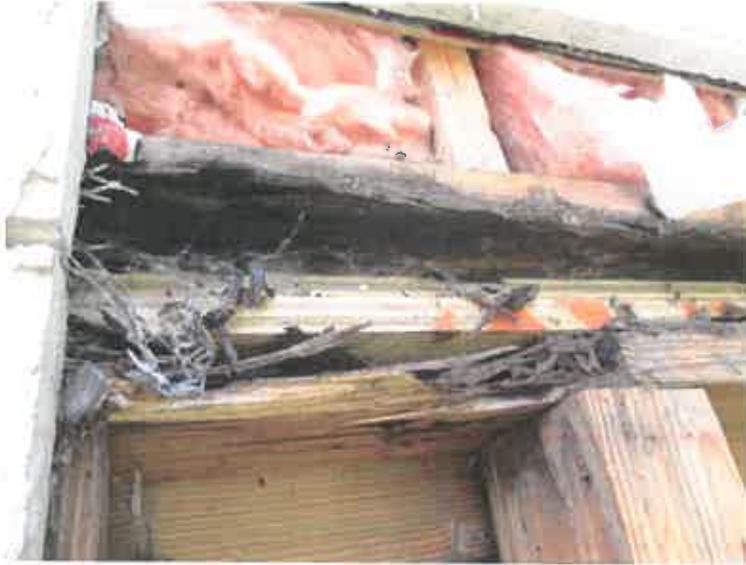
PHOTOGRAPH #183

**DESTRUCTIVE INVESTIGATION
OPENINGS – MARK 21
1st & 2nd Floor at Control Joint**

Wood frame damage

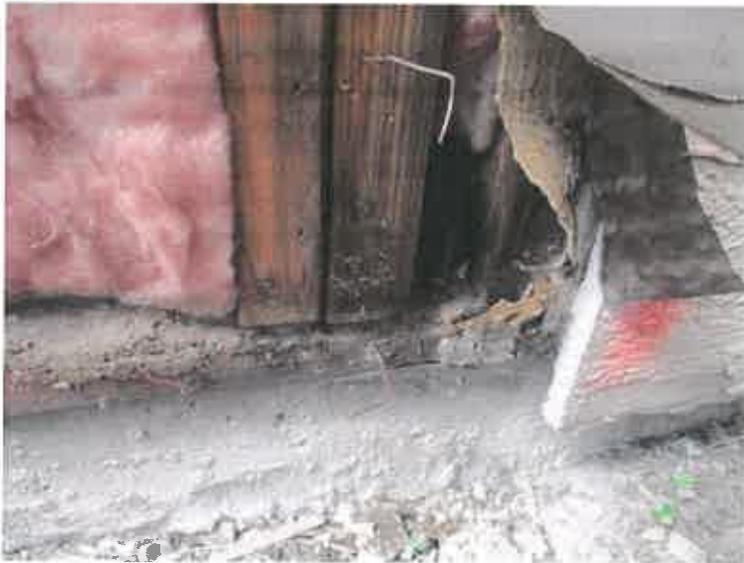
PHOTOGRAPH #184

**DESTRUCTIVE INVESTIGATION
OPENINGS – MARK 22
1st Floor Below Window**

No damage

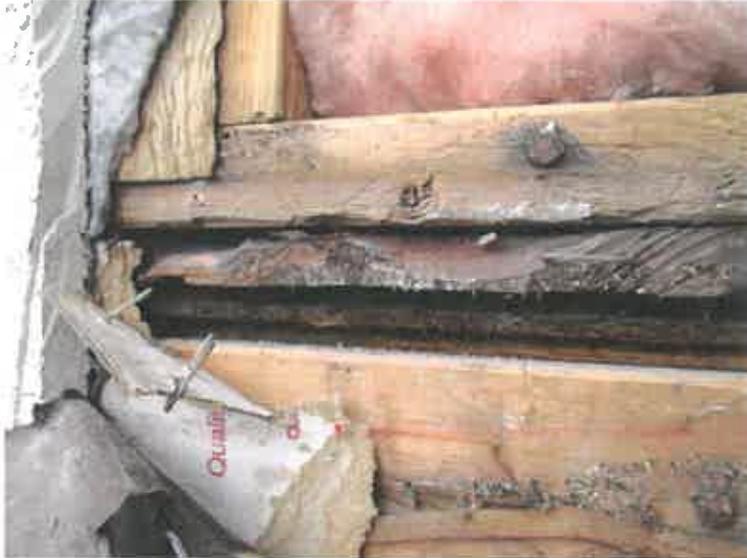
PHOTOGRAPH #185

**DESTRUCTIVE INVESTIGATION
OPENINGS – MARK 23
1st & 2nd Floor at Control Joint**

No damage

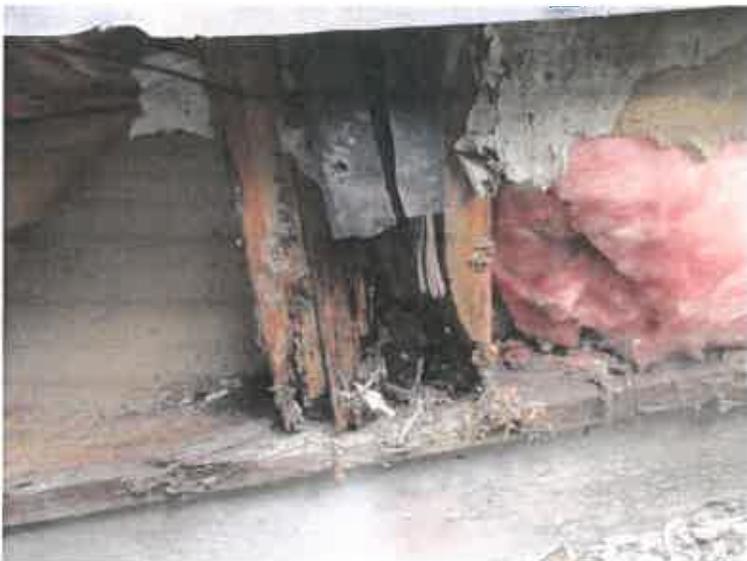
PHOTOGRAPH #186

**DESTRUCTIVE INVESTIGATION
OPENINGS – MARK 24
1st Floor Below Window**

Wood frame damage

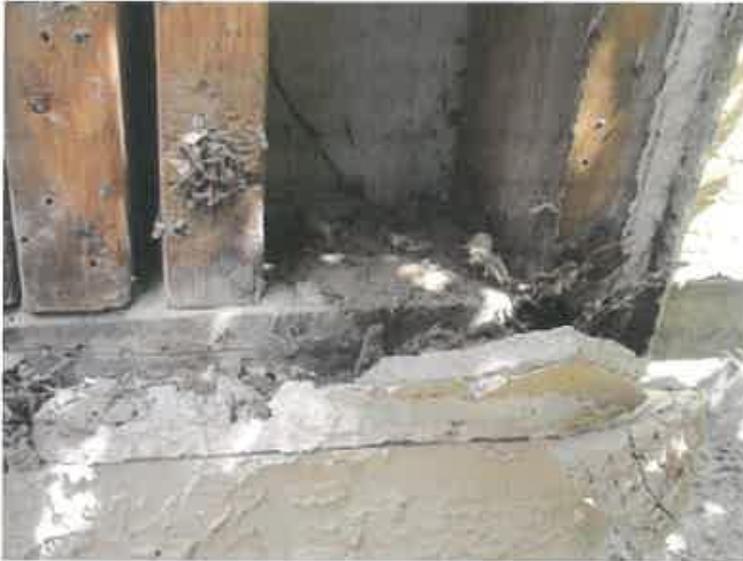
PHOTOGRAPH #187

**DESTRUCTIVE INVESTIGATION
OPENINGS – MARK 25
1st Floor Below Window**

No damage

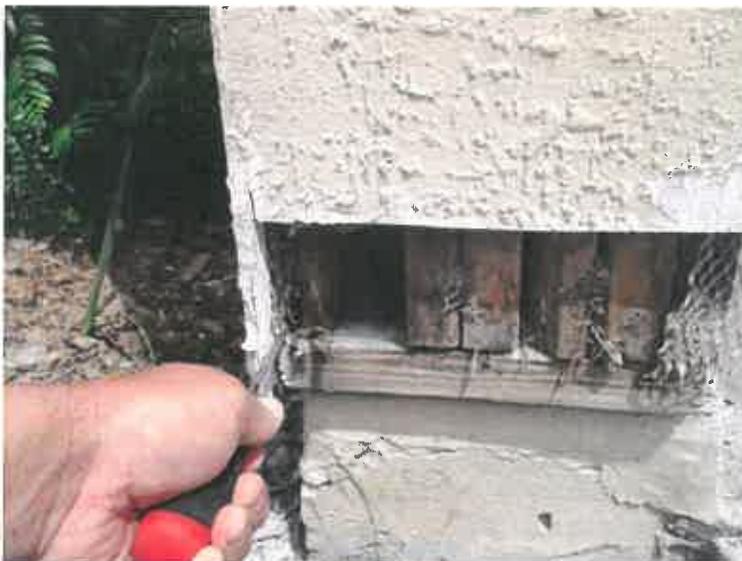
PHOTOGRAPH #188

**DESTRUCTIVE INVESTIGATION
OPENINGS – MARK 26
1st Floor Near Stair at Base**

Wood frame damage

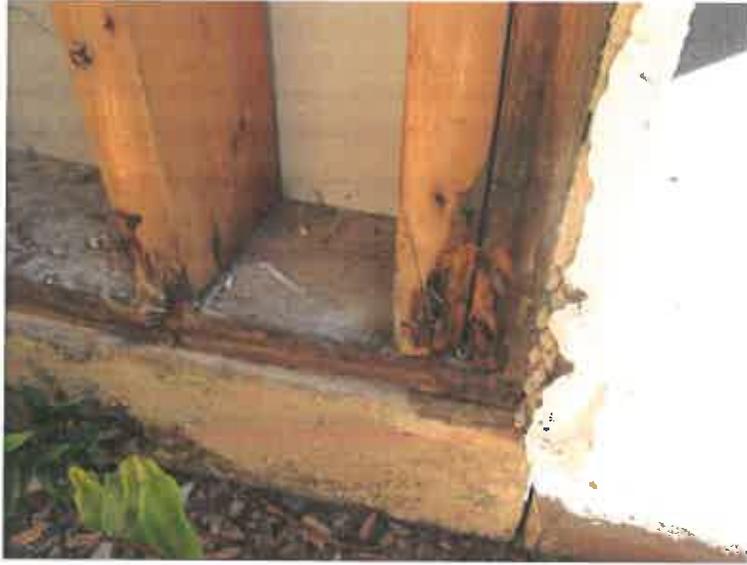
PHOTOGRAPH #189

**DESTRUCTIVE INVESTIGATION
OPENINGS – MARK 27
1st Floor Near Stair at Base**

Wood frame damage
