SUPPLEMENTAL DESTRUCTIVE INVESTIGATION

**Vintage Grand Condominium
4012 Crockers Lake Blvd.
Sarasota, FL 34238**

Project No. R1606-231

October 28, 2016

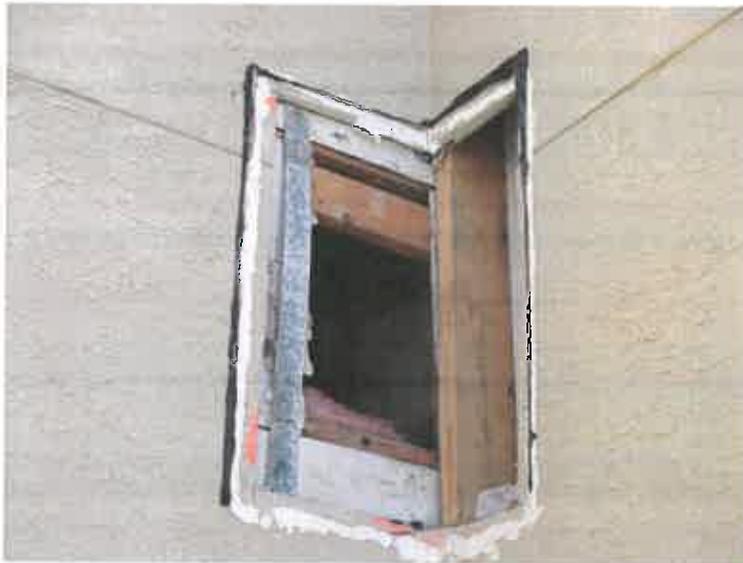
PHOTOGRAPH #190

**DESTRUCTIVE INVESTIGATION
OPENINGS – MARK 28
1st & 2nd Floor Inside Corner**

No damage

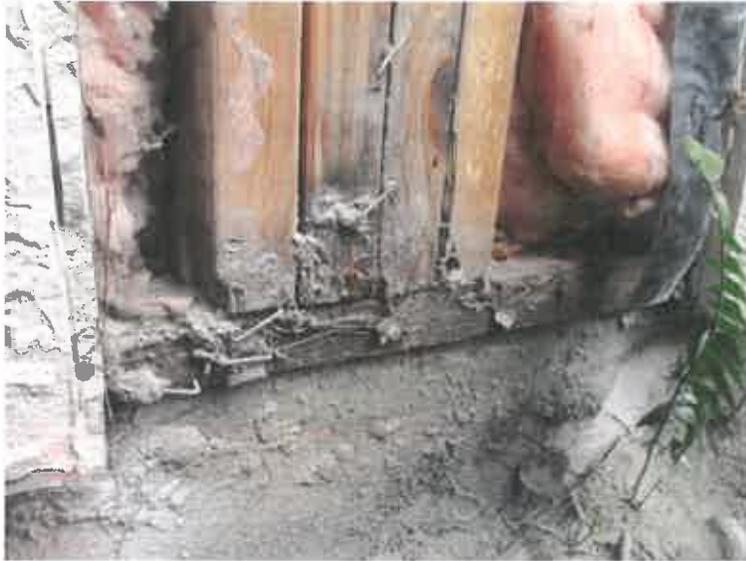
PHOTOGRAPH #191

**DESTRUCTIVE INVESTIGATION
OPENINGS – MARK 29
1st Floor Below Window**

Wood frame damage

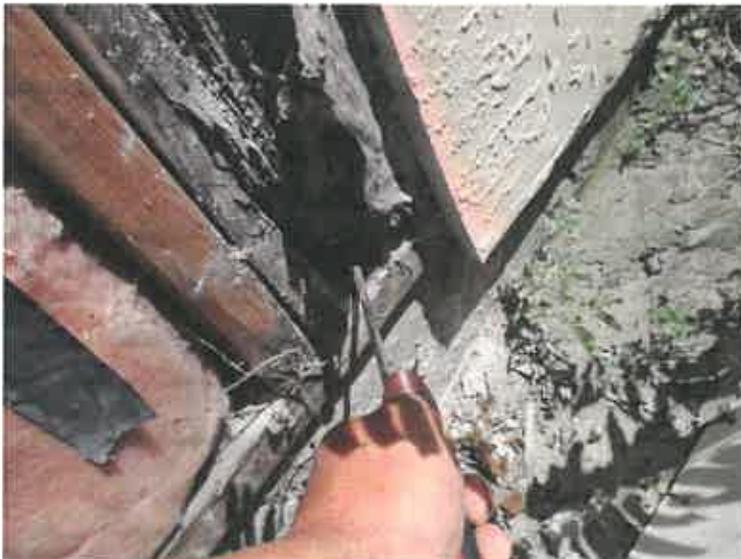
PHOTOGRAPH #192

**DESTRUCTIVE INVESTIGATION
OPENINGS – MARK 30
1st Floor Below Window**

Wood frame damage

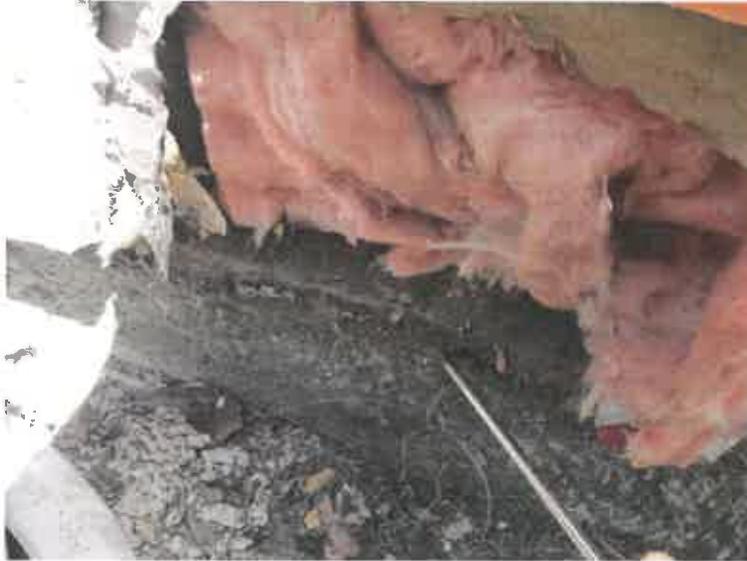
PHOTOGRAPH #193

**DESTRUCTIVE INVESTIGATION
OPENINGS – MARK 31
1st Floor Below Window**

Wood frame damage

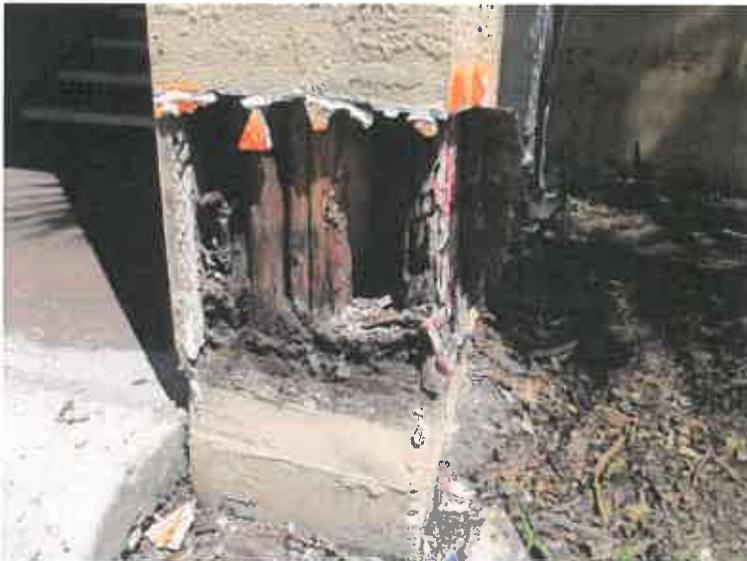
PHOTOGRAPH #194

**DESTRUCTIVE INVESTIGATION
OPENINGS – MARK 32
1st Floor Near Stair at Base**

Wood frame damage

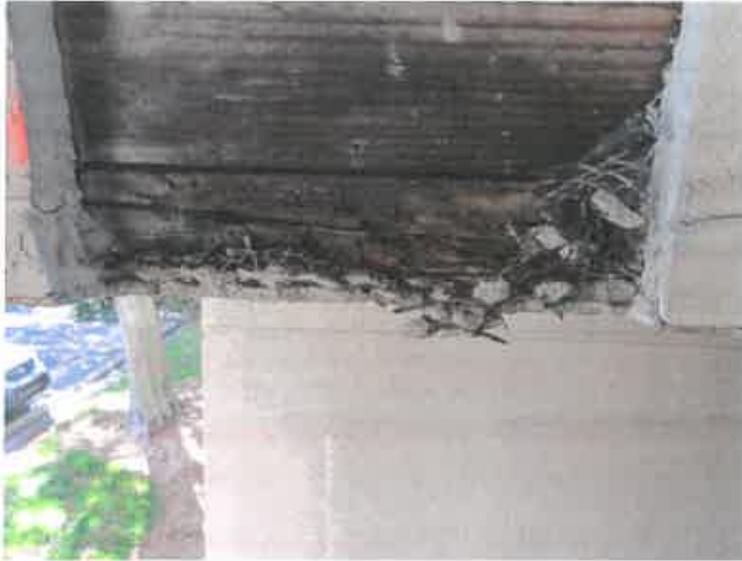
PHOTOGRAPH #195

**DESTRUCTIVE INVESTIGATION
OPENINGS – MARK 33
2nd Floor above Stairs**

Wood frame damage

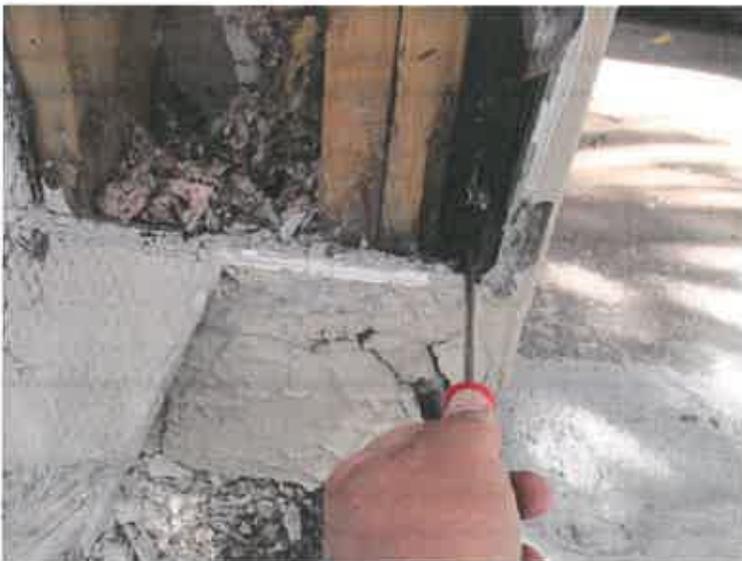
PHOTOGRAPH #196

**DESTRUCTIVE INVESTIGATION
OPENINGS – MARK 34
1st Floor Near Stair at Base**

Wood frame damage

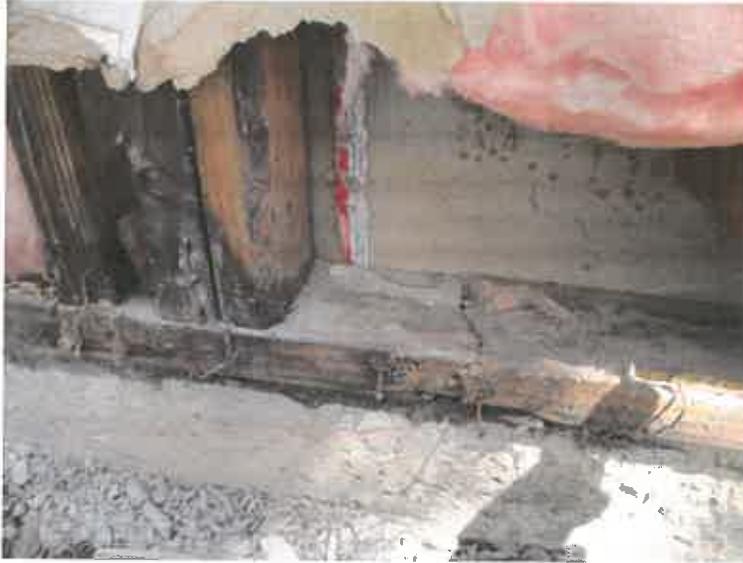
PHOTOGRAPH #197

**DESTRUCTIVE INVESTIGATION
OPENINGS – MARK 35
1st Floor Below Window**

No damage

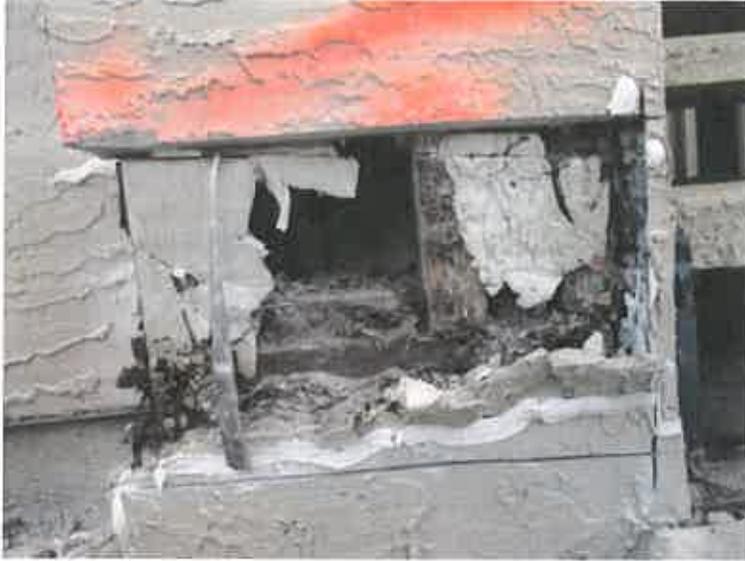
PHOTOGRAPH #198

**DESTRUCTIVE INVESTIGATION
OPENINGS – MARK 1
1st Floor Near Stair at Base**

Wood frame damage

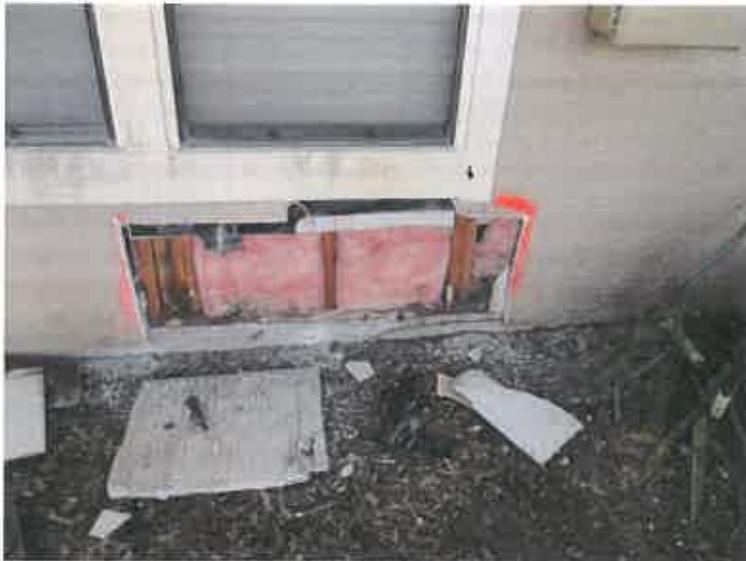
PHOTOGRAPH #199

**DESTRUCTIVE INVESTIGATION
OPENINGS – MARK 2
1st Floor Below Window**

No damage

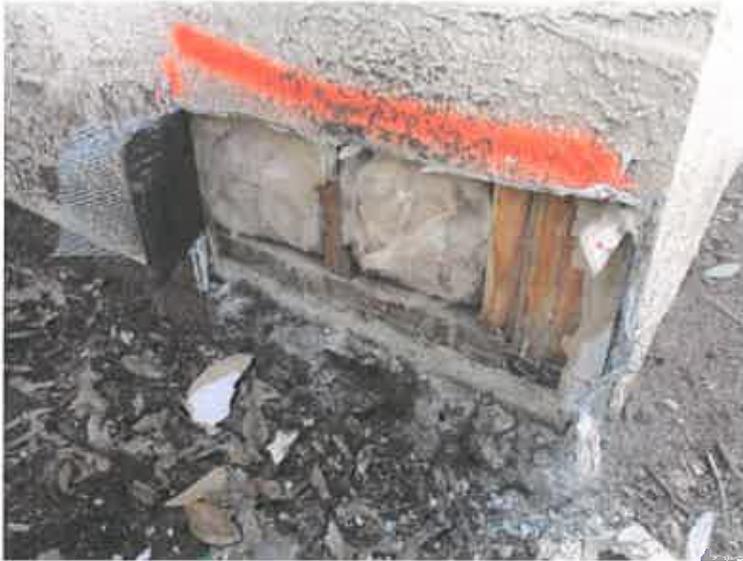
PHOTOGRAPH #200

**DESTRUCTIVE INVESTIGATION
OPENINGS – MARK 3
1st Floor at Outside Corner**

No damage

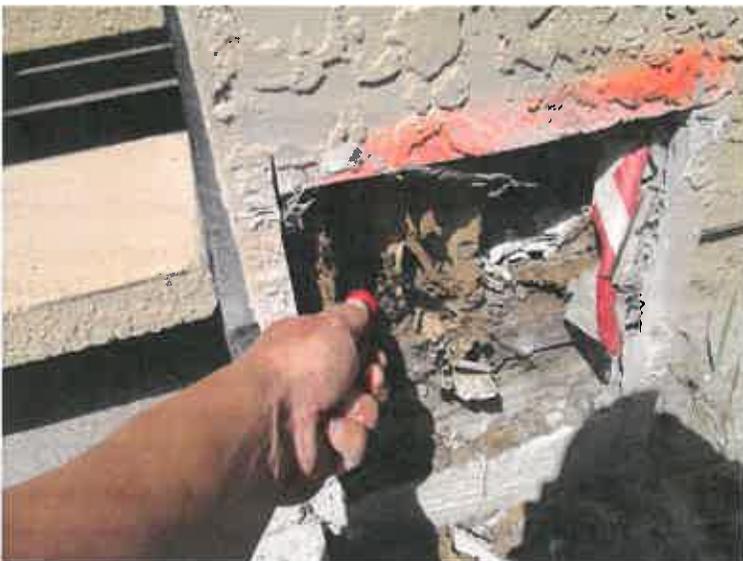
PHOTOGRAPH #201

**DESTRUCTIVE INVESTIGATION
OPENINGS – MARK 4
1st Floor Near Stair at Base**

Wood frame damage

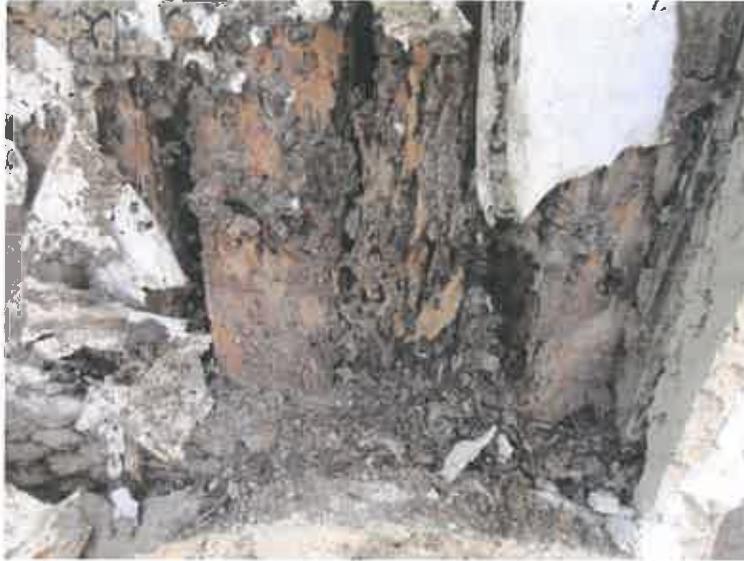
PHOTOGRAPH #202

**DESTRUCTIVE INVESTIGATION
OPENINGS – MARK 5
1st Floor Near Stair at Base**

Wood frame damage

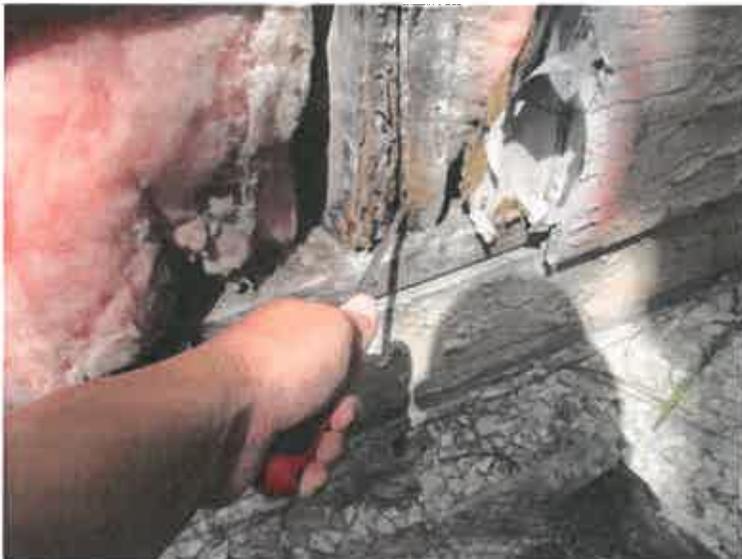
PHOTOGRAPH #203

**DESTRUCTIVE INVESTIGATION
OPENINGS – MARK 6
1st Floor Below Window**

Wood frame damage

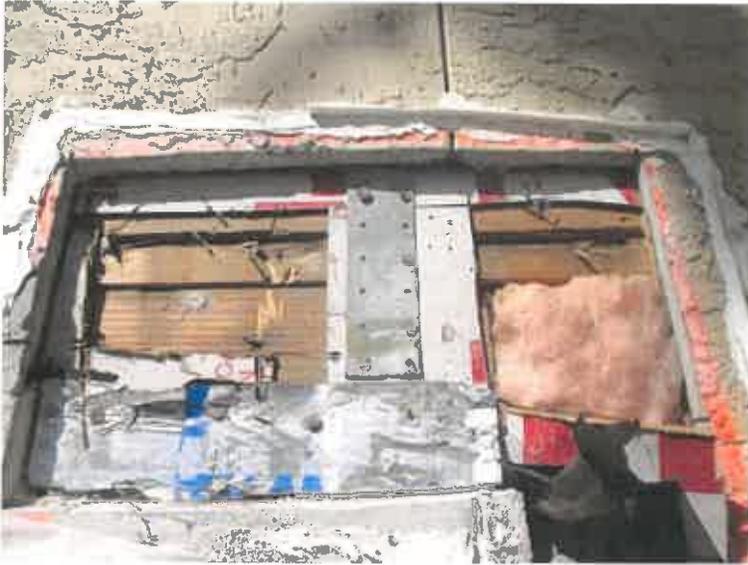
PHOTOGRAPH #204

**DESTRUCTIVE INVESTIGATION
OPENINGS – MARK 7
1st Floor Above Window**

No damage

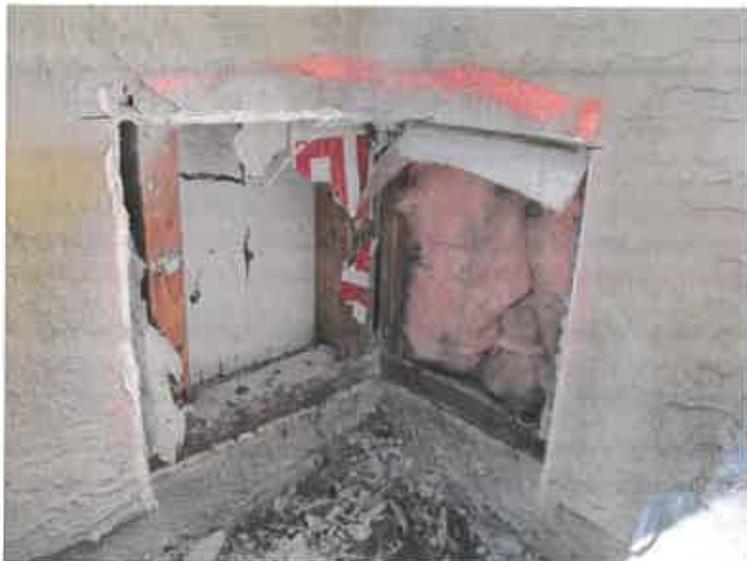
PHOTOGRAPH #205

**DESTRUCTIVE INVESTIGATION
OPENINGS – MARK 8
1st Floor Inside Corner**

No damage

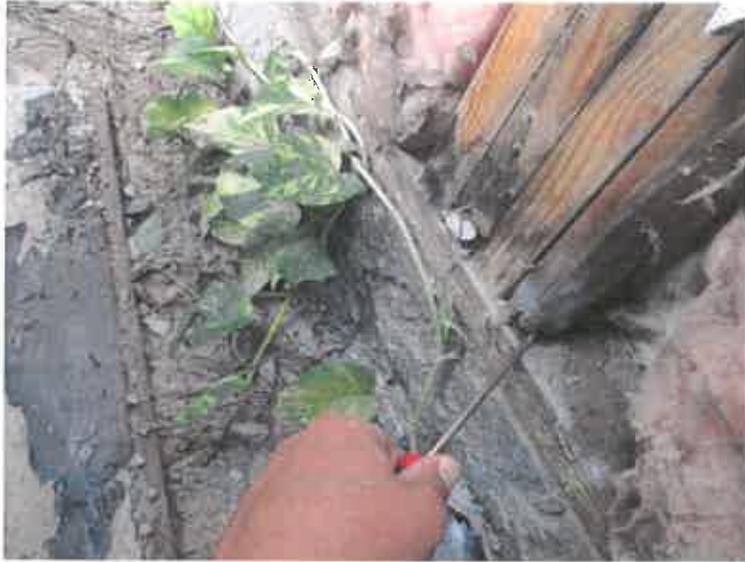
PHOTOGRAPH #206

**DESTRUCTIVE INVESTIGATION
OPENINGS – MARK 9
1st Floor Below Window**

Wood frame damage

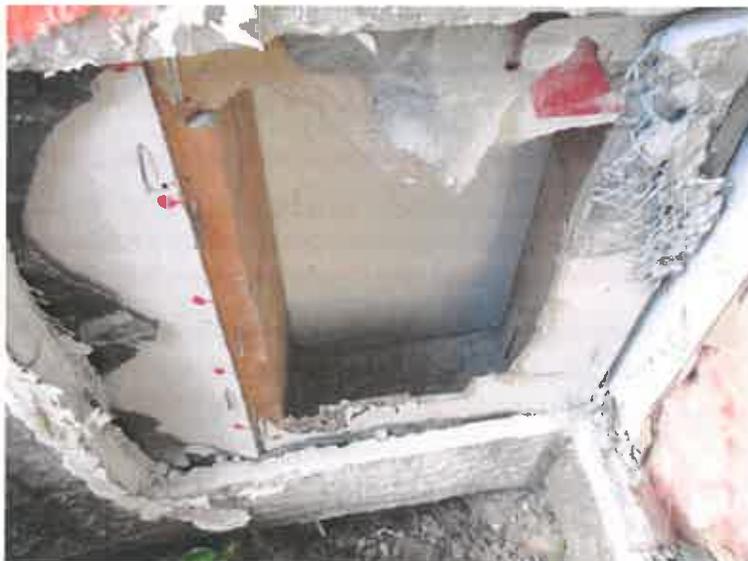
PHOTOGRAPH #207

**DESTRUCTIVE INVESTIGATION
OPENINGS – MARK 10
1st Floor Inside Corner**

No damage

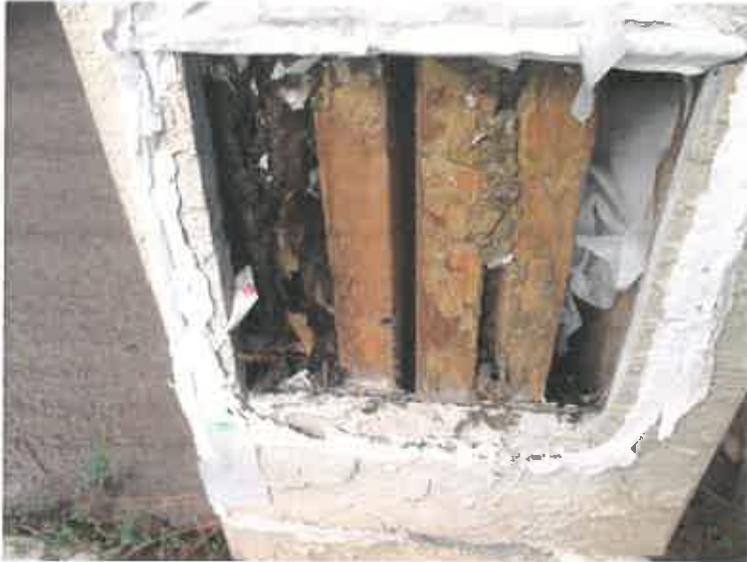
PHOTOGRAPH #208

**DESTRUCTIVE INVESTIGATION
OPENINGS – MARK 11
1st Floor Near Stair at Base**

Wood frame damage

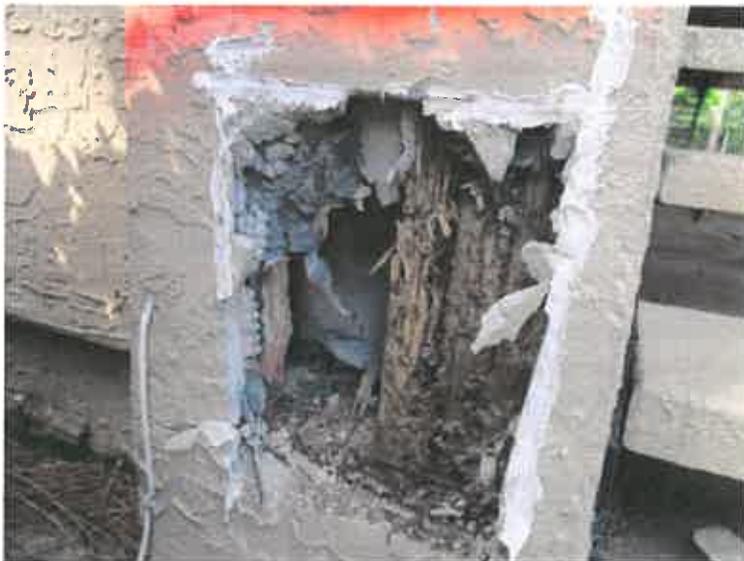
PHOTOGRAPH #209

**DESTRUCTIVE INVESTIGATION
OPENINGS – MARK 12
1st Floor Near Stair at Base**

Wood frame damage

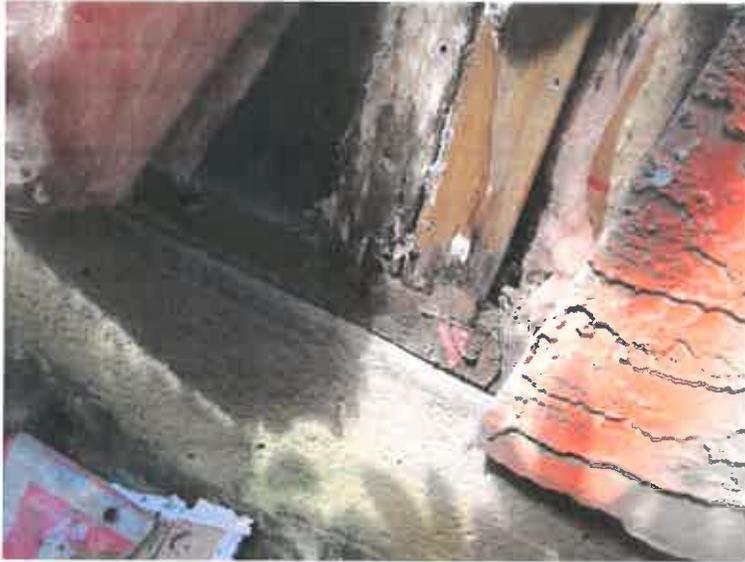
PHOTOGRAPH #210

**DESTRUCTIVE INVESTIGATION
OPENINGS – MARK 13
1st Floor Below Window**

Wood frame damage

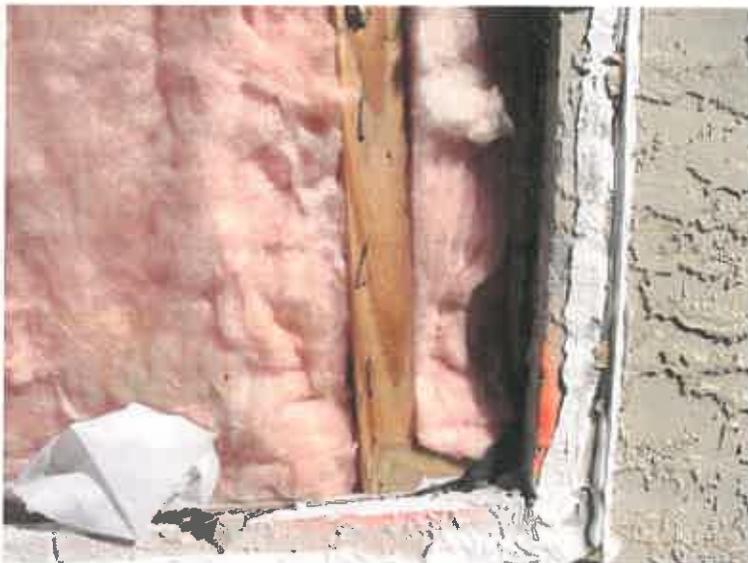
PHOTOGRAPH #211

**DESTRUCTIVE INVESTIGATION
OPENINGS – MARK 14
1st Floor adjacent to Window**

No damage

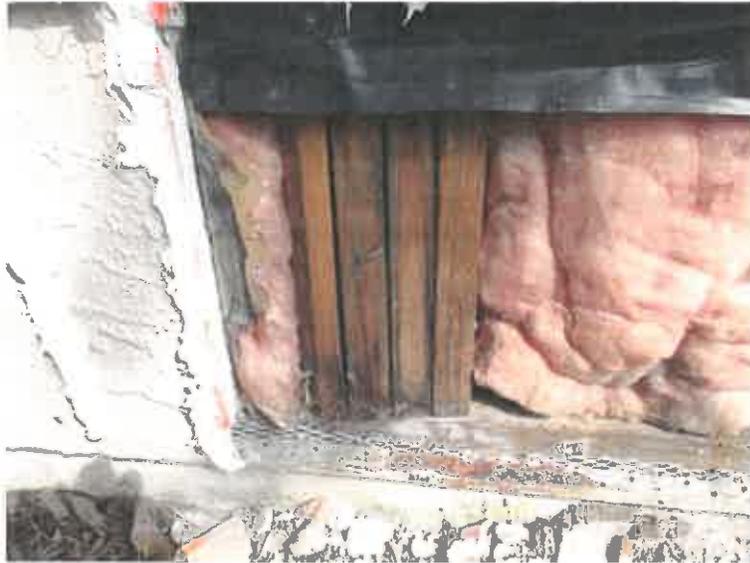
PHOTOGRAPH #212

**DESTRUCTIVE INVESTIGATION
OPENINGS – MARK 15
1st Floor Below Window**

No damage

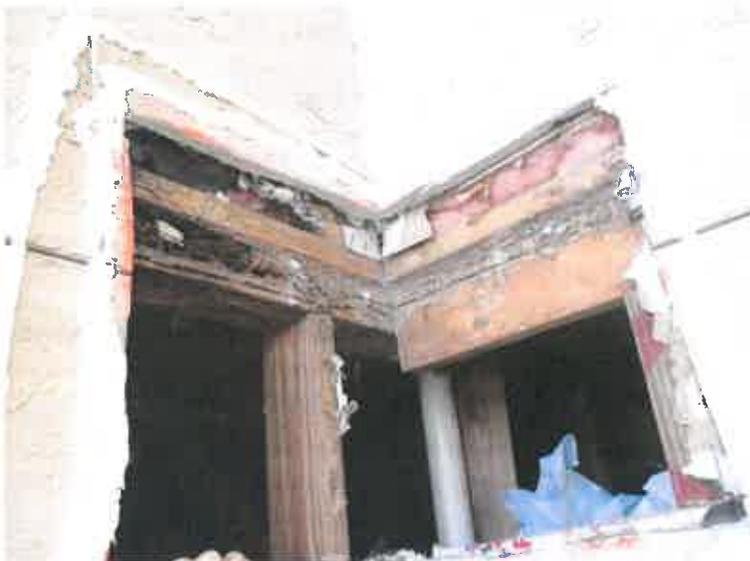
PHOTOGRAPH #213

**DESTRUCTIVE INVESTIGATION
OPENINGS – MARK 16
1st & 2nd Floor Inside Corner**

Wood frame damage

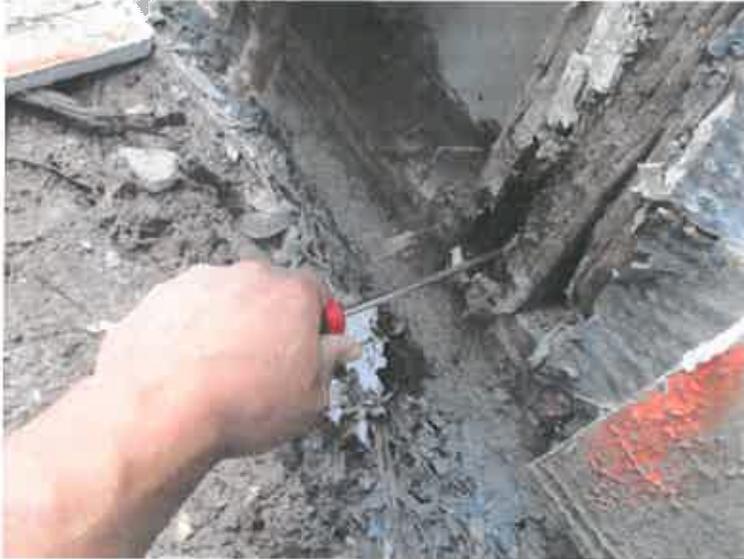
PHOTOGRAPH #214

**DESTRUCTIVE INVESTIGATION
OPENINGS – MARK 17
1st Floor Below Window**

Wood frame damage

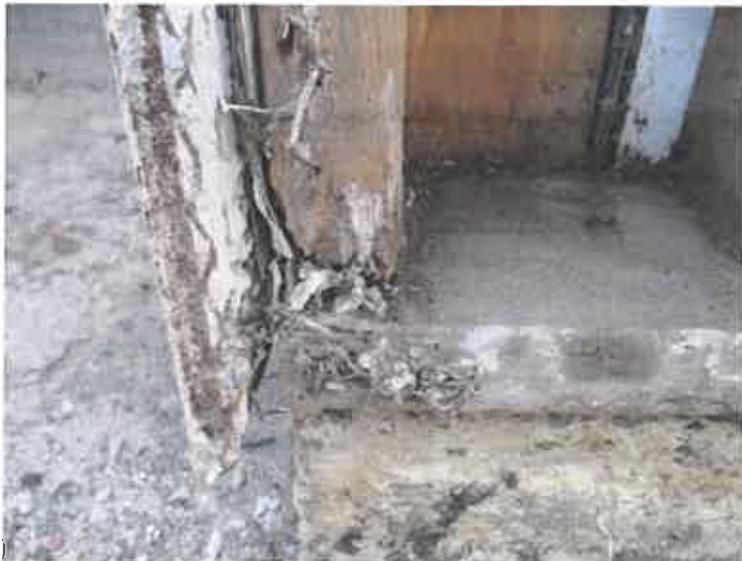
PHOTOGRAPH #215

**DESTRUCTIVE INVESTIGATION
OPENINGS – MARK 18
1st Floor Near Stair at Base**

Wood frame damage

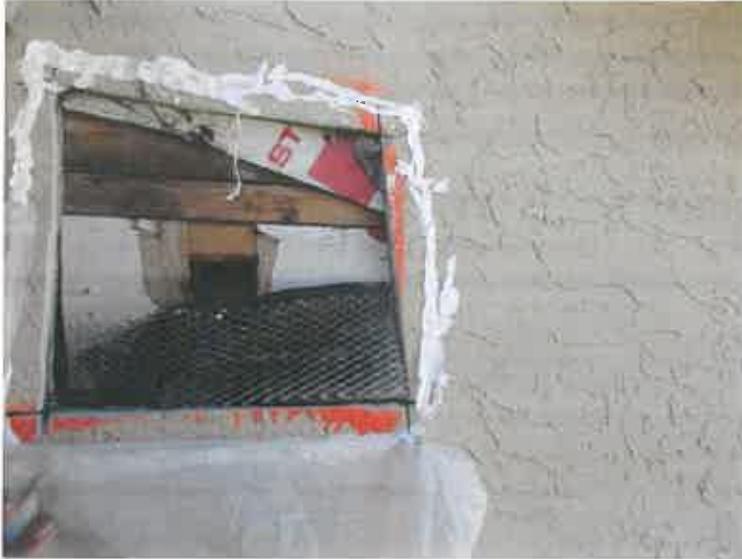
PHOTOGRAPH #216

**DESTRUCTIVE INVESTIGATION
OPENINGS – MARK 19
Roof to Wall Intersection**

No damage

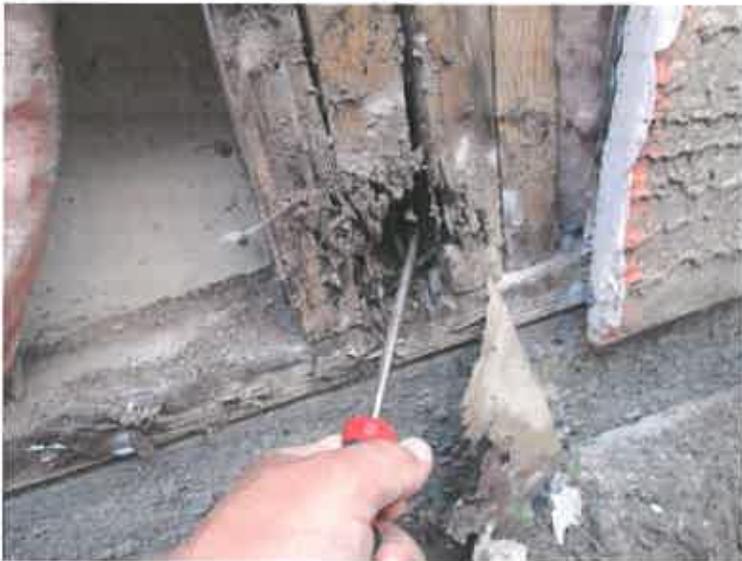
PHOTOGRAPH #217

**DESTRUCTIVE INVESTIGATION
OPENINGS – MARK 20
1st Floor Below Window**

Wood frame damage

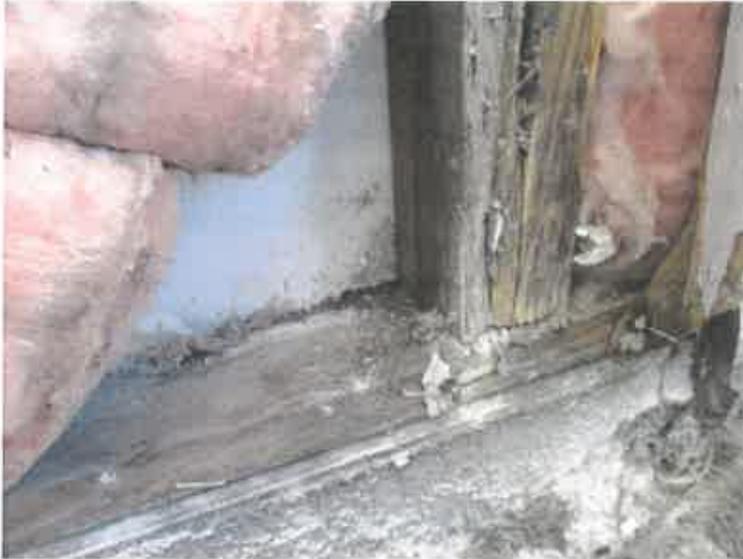
PHOTOGRAPH #218

**DESTRUCTIVE INVESTIGATION
OPENINGS – MARK 21
1st Floor Below Window**

Wood frame damage

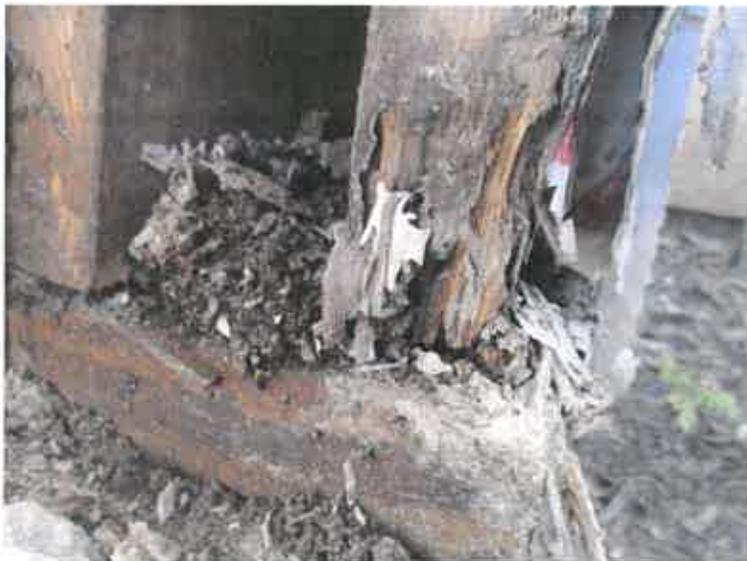
PHOTOGRAPH #219

**DESTRUCTIVE INVESTIGATION
OPENINGS – MARK 22
1st Floor Near Stair at Base**

Wood frame damage

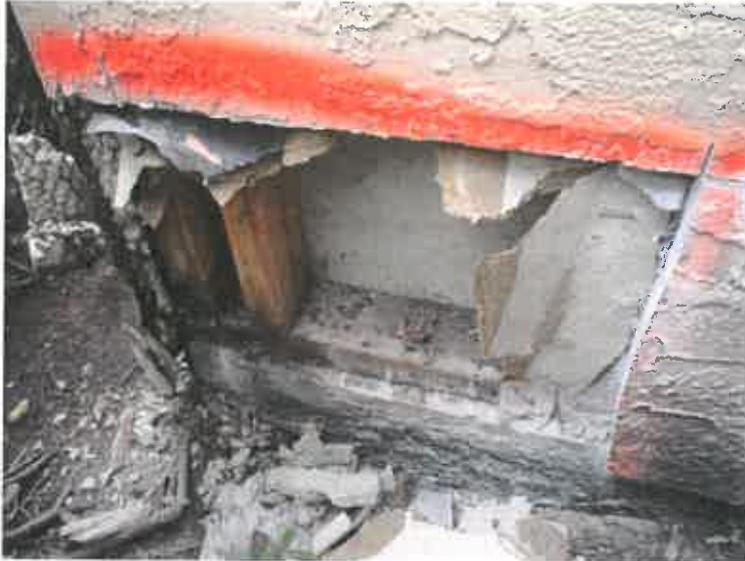
PHOTOGRAPH #220

**DESTRUCTIVE INVESTIGATION
OPENINGS – MARK 1
1st Floor Outside Corner**

Wood frame damage

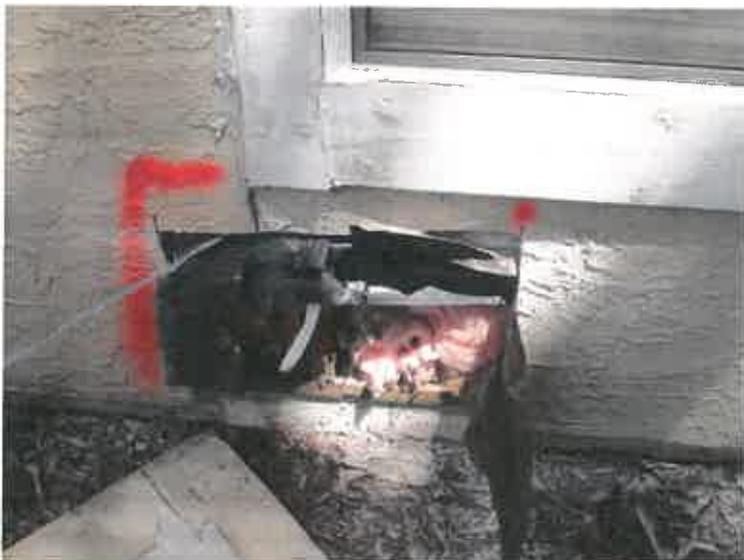
PHOTOGRAPH #221

**DESTRUCTIVE INVESTIGATION
OPENINGS – MARK 2
1st Floor Below Window**

No damage

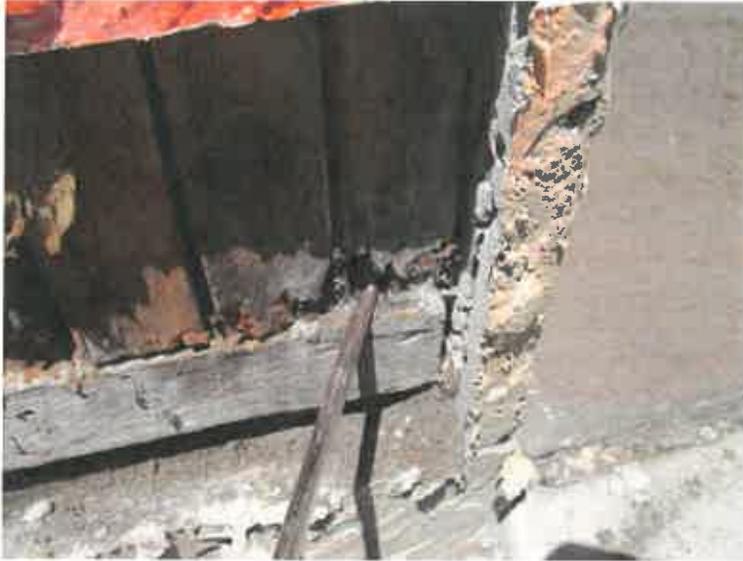
PHOTOGRAPH #222

**DESTRUCTIVE INVESTIGATION
OPENINGS – MARK 3
1st Floor Near Stair at Base**

Wood frame damage

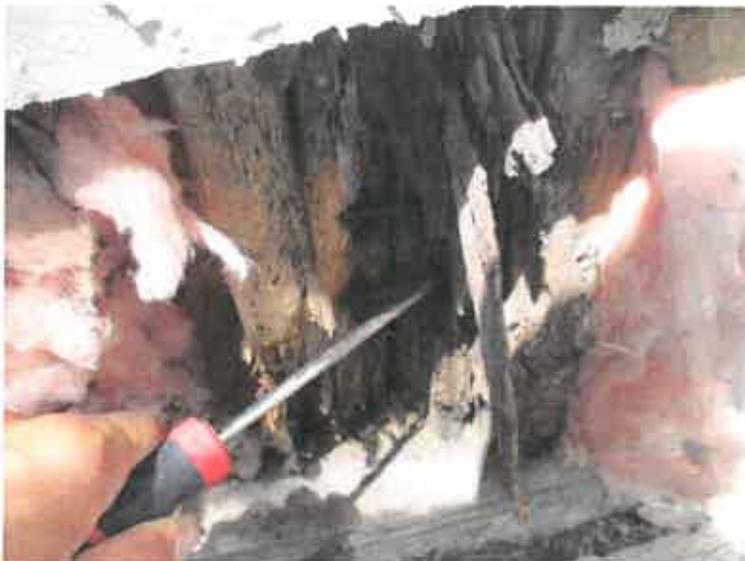
PHOTOGRAPH #223

**DESTRUCTIVE INVESTIGATION
OPENINGS – MARK 4
1st Floor Below Window**

Wood frame damage

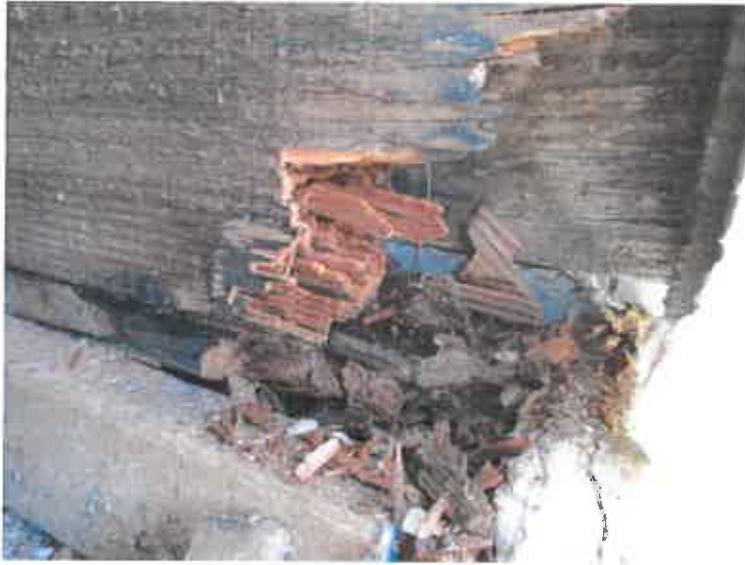
PHOTOGRAPH #224

**DESTRUCTIVE INVESTIGATION
OPENINGS – MARK 5
2nd Floor Adjacent to Balcony**

Wood frame damage

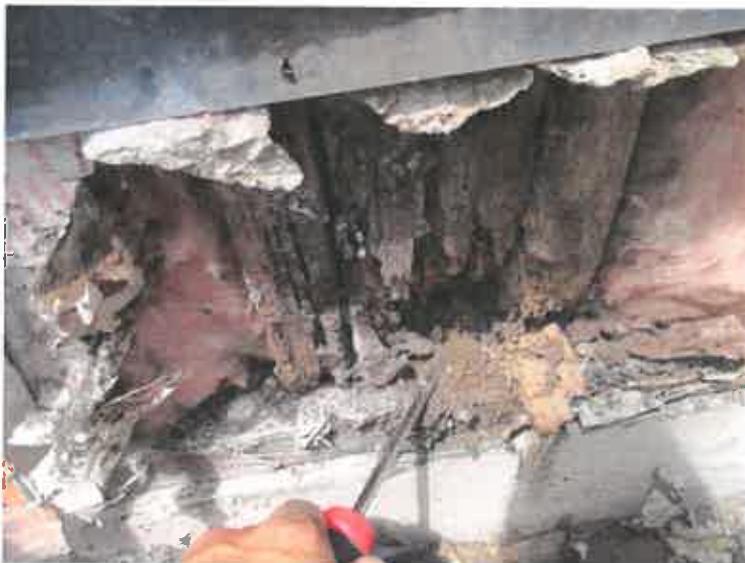
PHOTOGRAPH #225

**DESTRUCTIVE INVESTIGATION
OPENINGS – MARK 6
1st Floor Below Window**

Wood frame damage

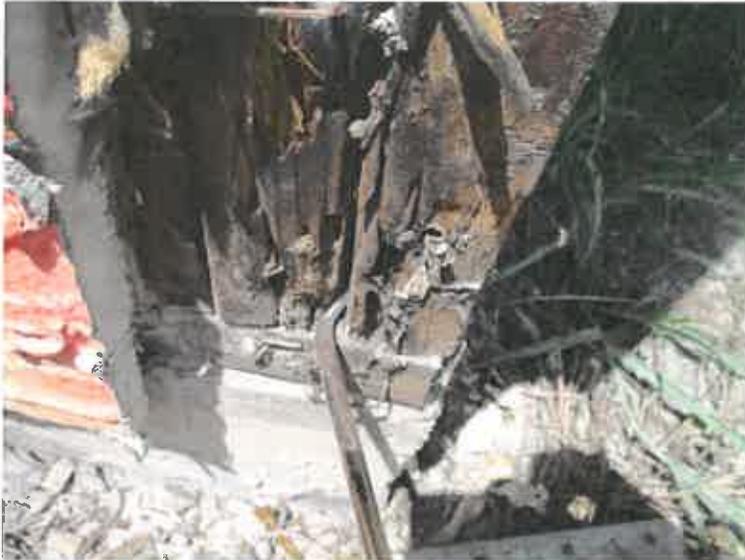
PHOTOGRAPH #226

**DESTRUCTIVE INVESTIGATION
OPENINGS – MARK 7
1st Floor Outside Corner**

Wood frame damage

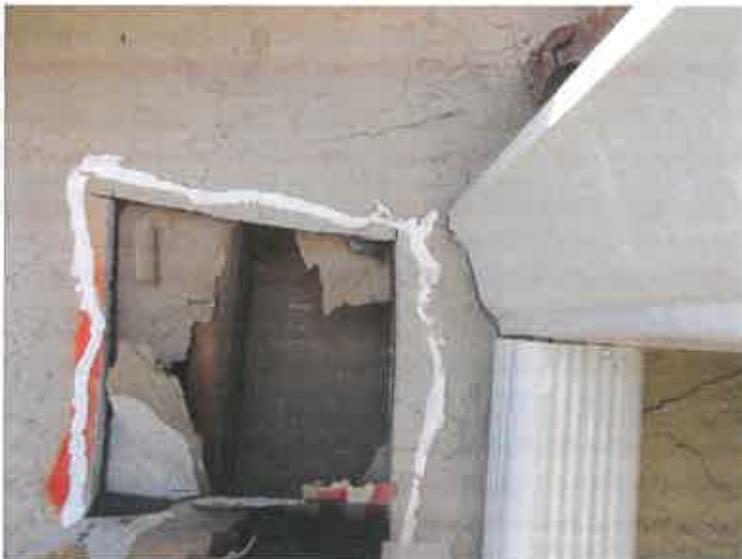
PHOTOGRAPH #227

**DESTRUCTIVE INVESTIGATION
OPENINGS – MARK 8
Roof to Wall Intersection**

No damage

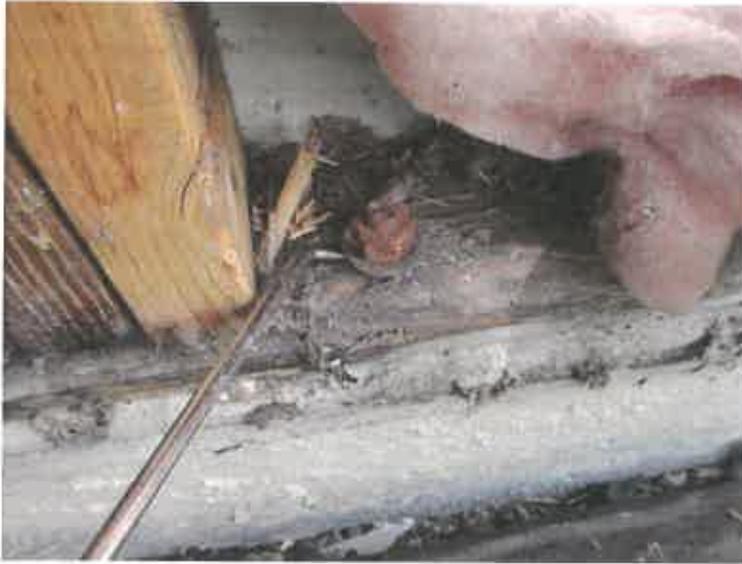
PHOTOGRAPH #228

**DESTRUCTIVE INVESTIGATION
OPENINGS – MARK 9
1st Floor Below Window**

Wood frame damage

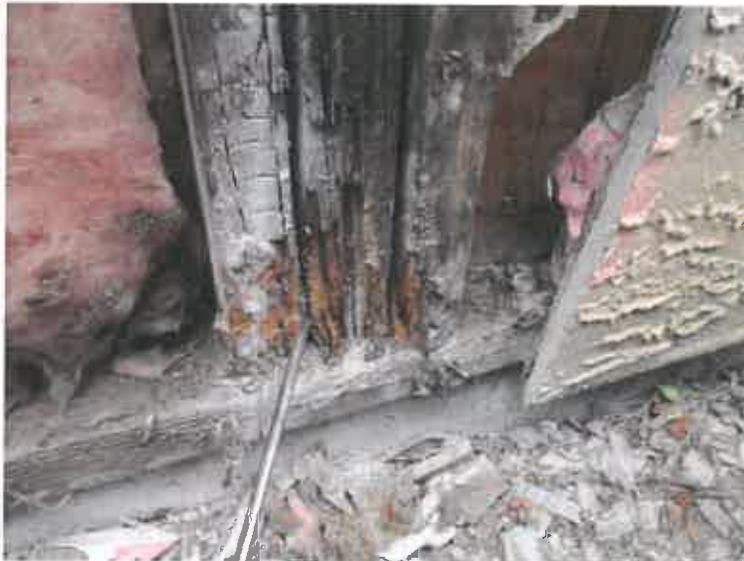
PHOTOGRAPH #229

**DESTRUCTIVE INVESTIGATION
OPENINGS – MARK 10
1st Floor Below Window**

Wood frame damage

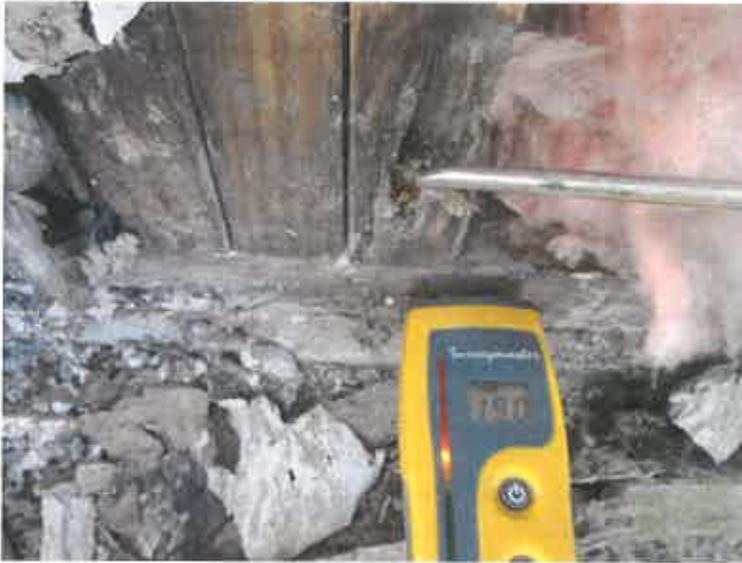
PHOTOGRAPH #230

**DESTRUCTIVE INVESTIGATION
OPENINGS – MARK 11
1st Floor Below Window**

Wood frame damage

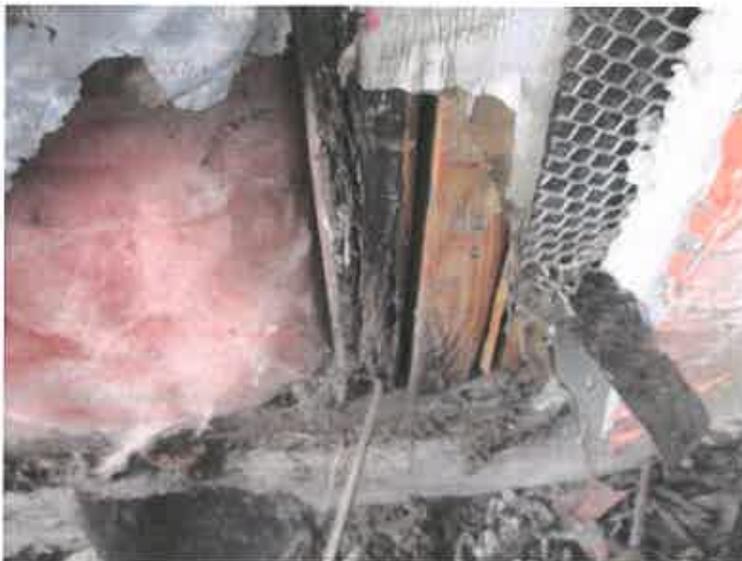
PHOTOGRAPH #231

**DESTRUCTIVE INVESTIGATION
OPENINGS – MARK 12
1st Floor Below Window**

Wood frame damage

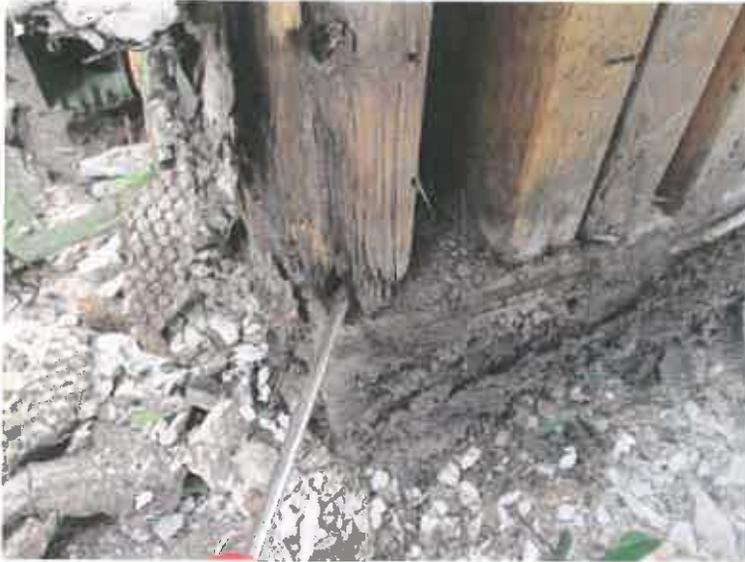
PHOTOGRAPH #232

**DESTRUCTIVE INVESTIGATION
OPENINGS – MARK 13
1st Floor Near Stair at Base**

Wood frame damage

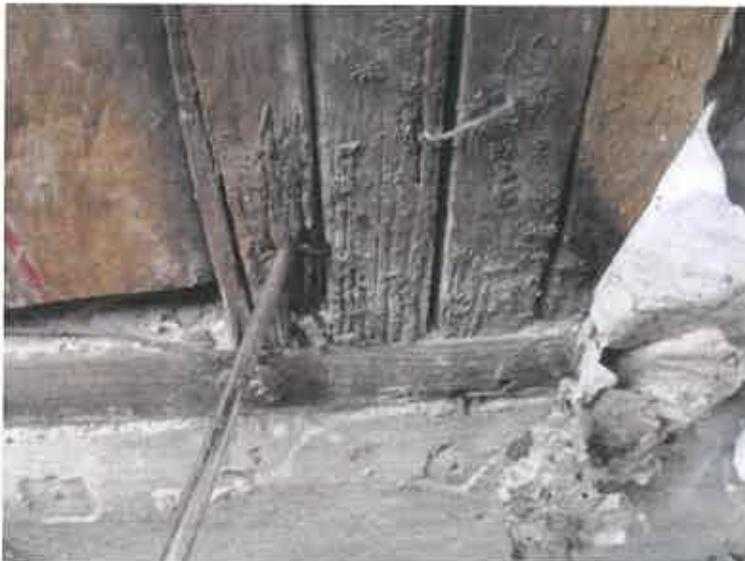
PHOTOGRAPH #233

**DESTRUCTIVE INVESTIGATION
OPENINGS – MARK 14
1st Floor Below Window**

Wood frame damage

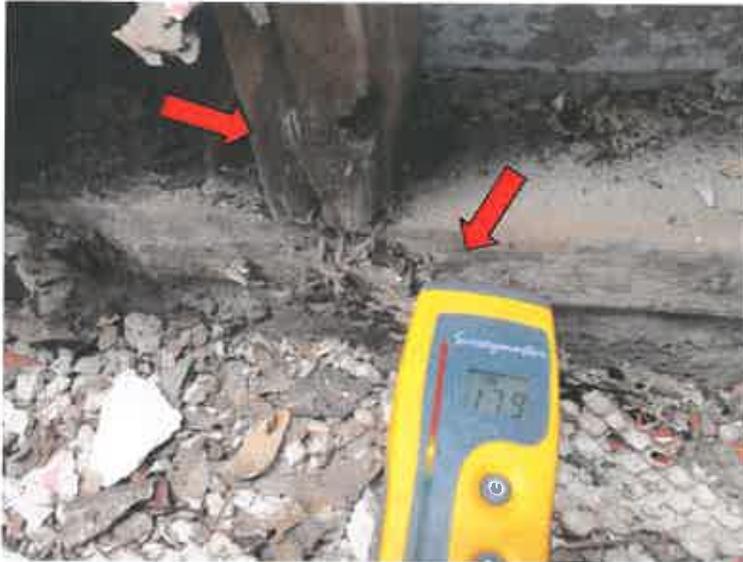
PHOTOGRAPH #234

**DESTRUCTIVE INVESTIGATION
OPENINGS – MARK 15
1st Floor Between Lanais**

Wet framing, water stains on studs

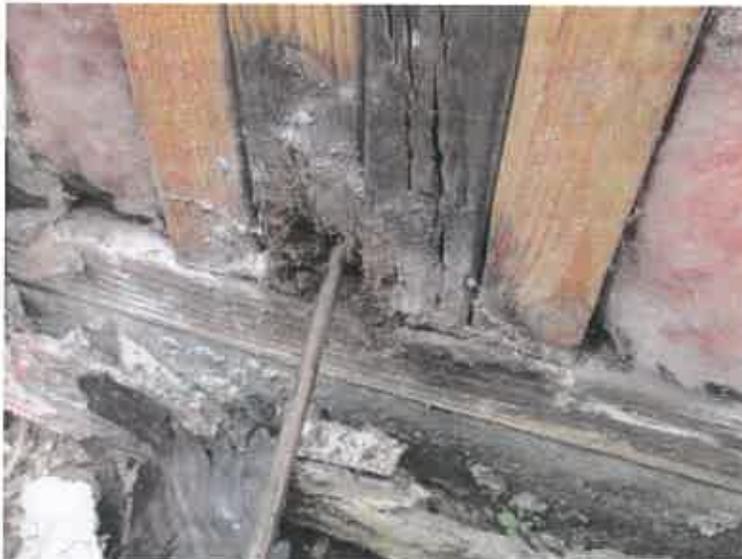
PHOTOGRAPH #235

**DESTRUCTIVE INVESTIGATION
OPENINGS – MARK 16
1st Floor Below Window**

Wood frame damage

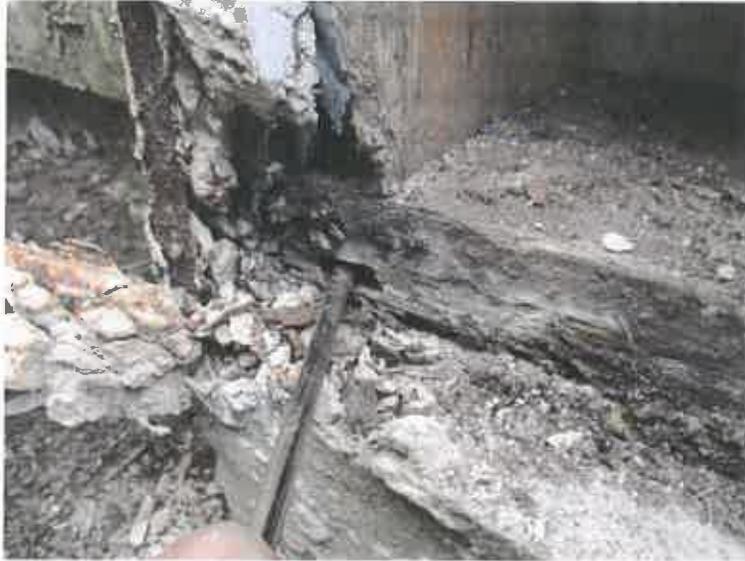
PHOTOGRAPH #236

**DESTRUCTIVE INVESTIGATION
OPENINGS – MARK 17
1st Floor Near Stair at Base**

Wood frame damage

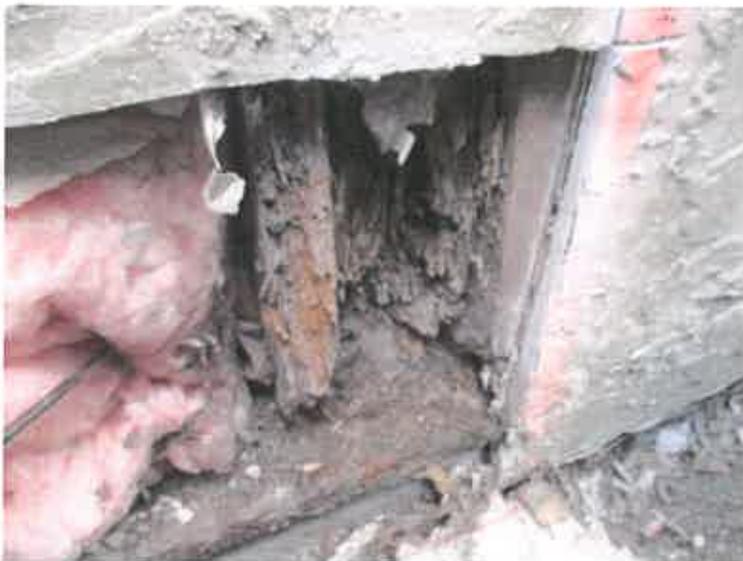
PHOTOGRAPH #237

**DESTRUCTIVE INVESTIGATION
OPENINGS – MARK 18
1st Floor Below Window**

Wood frame damage

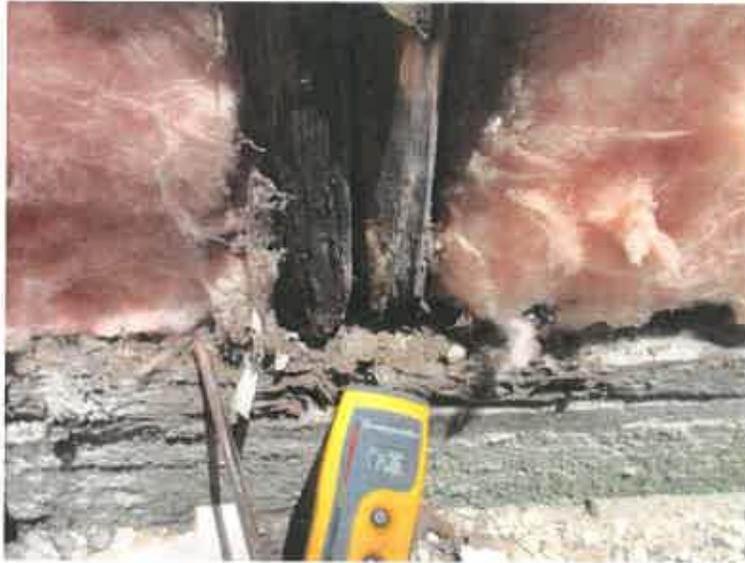
PHOTOGRAPH #238

**DESTRUCTIVE INVESTIGATION
OPENINGS – MARK 1
1st Floor Below Window**

Wood frame damage

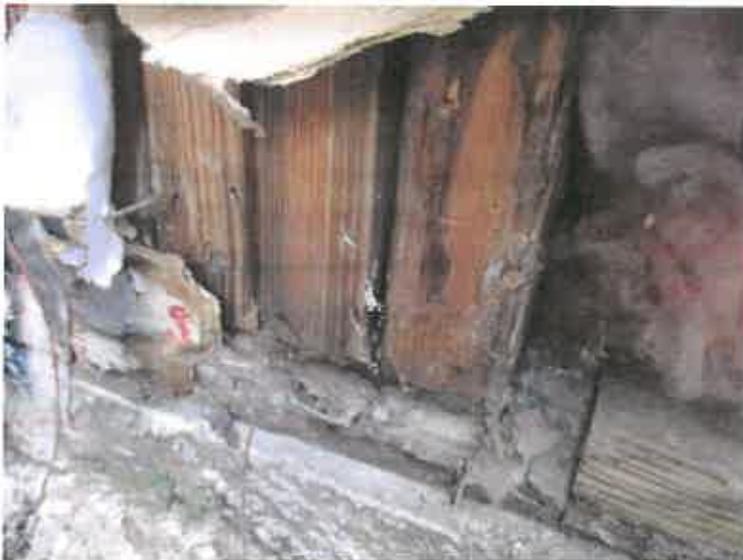
PHOTOGRAPH #239

**DESTRUCTIVE INVESTIGATION
OPENINGS – MARK 2
1st Floor Below Window**

No damage

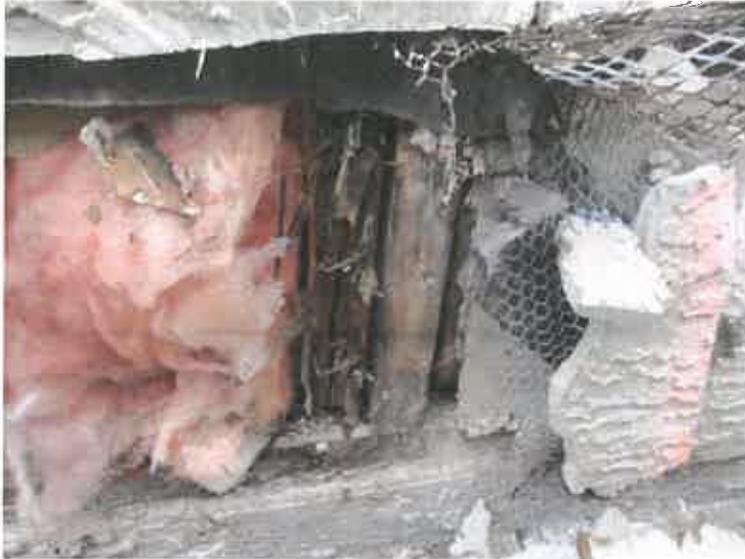
PHOTOGRAPH #240

**DESTRUCTIVE INVESTIGATION
OPENINGS – MARK 3
1st Floor Below Window**

Wood frame damage
