SUPPLEMENTAL DESTRUCTIVE INVESTIGATION

**Vintage Grand Condominium
4012 Crockers Lake Blvd.
Sarasota, FL 34238**

Project No. R1606-231

October 28, 2016

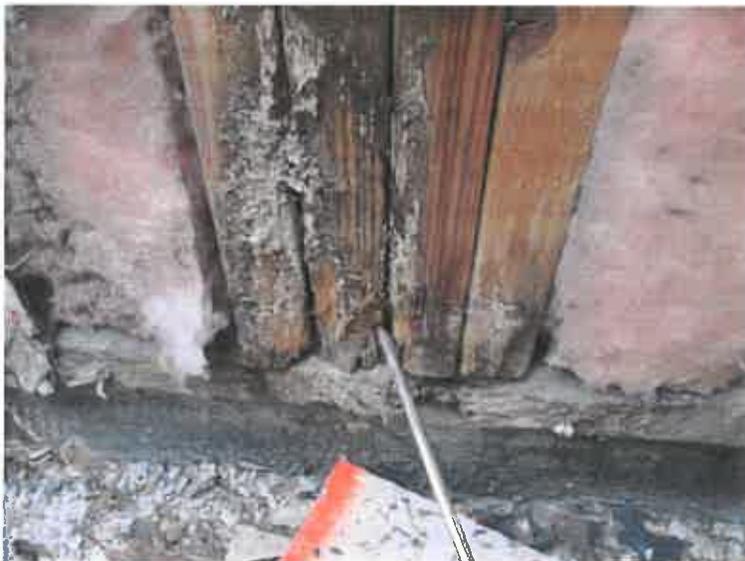
PHOTOGRAPH #241

**DESTRUCTIVE INVESTIGATION
OPENINGS – MARK 4
1st Floor Below Window**

Wood frame damage

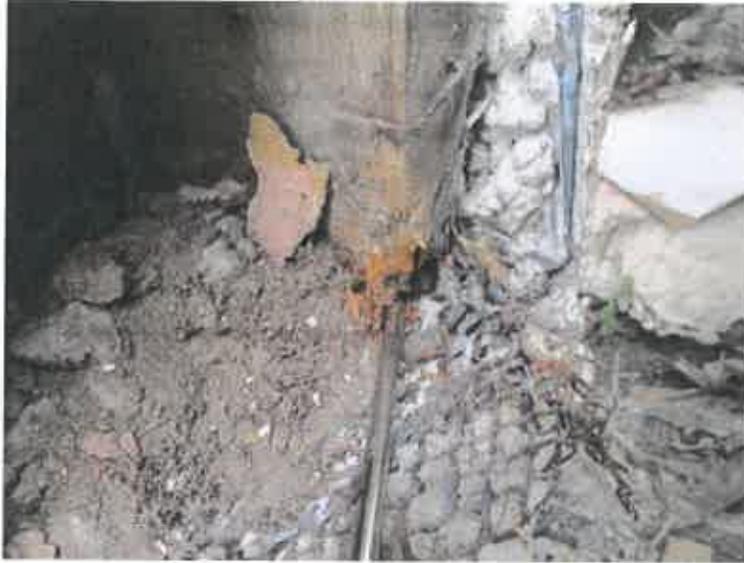
PHOTOGRAPH #242

**DESTRUCTIVE INVESTIGATION
OPENINGS – MARK 5
1st Floor Near Stair at Base**

Wood frame damage

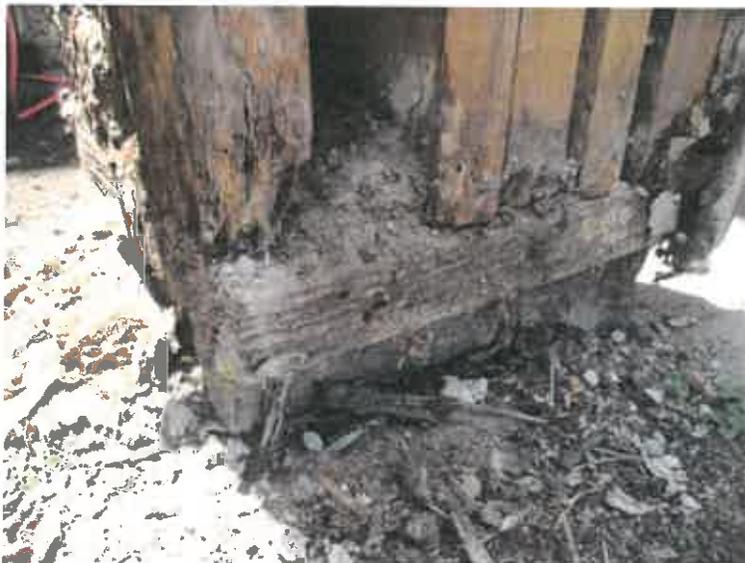
PHOTOGRAPH #243

**DESTRUCTIVE INVESTIGATION
OPENINGS – MARK 6
1st Floor Near Stair at Base**

Wood frame damage

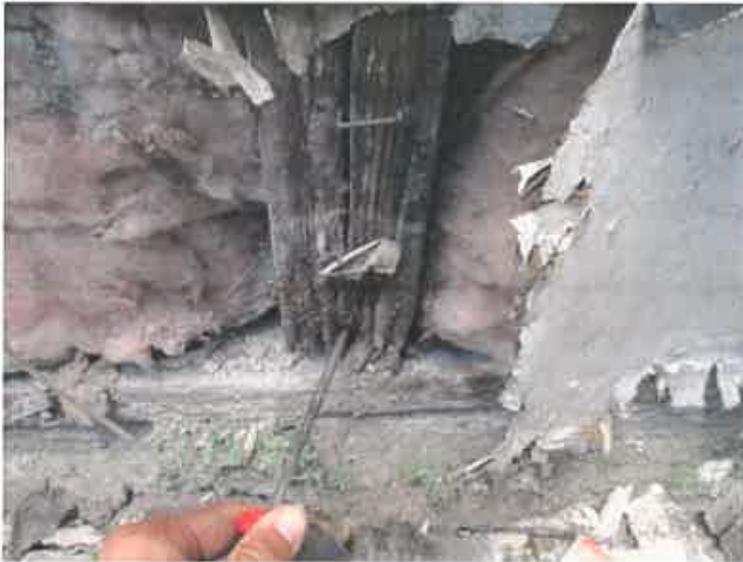
PHOTOGRAPH #244

**DESTRUCTIVE INVESTIGATION
OPENINGS – MARK 7
1st Floor Below Window**

Wood frame damage

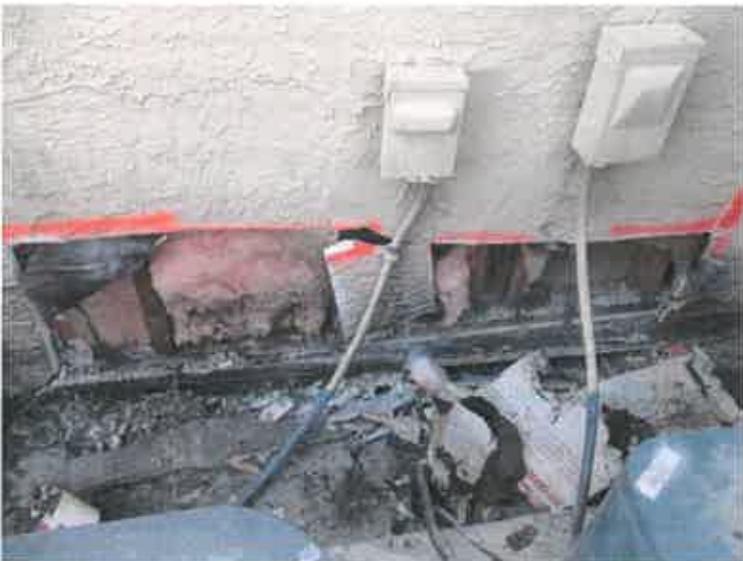
PHOTOGRAPH #245

**DESTRUCTIVE INVESTIGATION
OPENINGS – MARK 8
1st Floor Near AC Units**

No damage

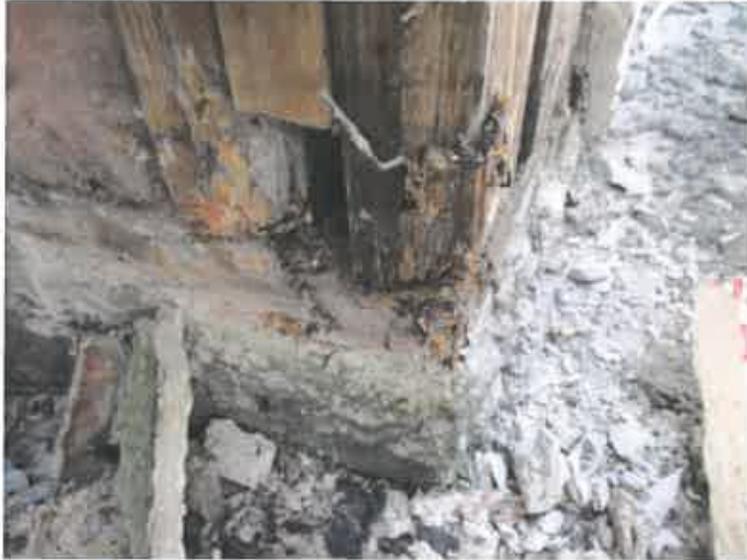
PHOTOGRAPH #246

**DESTRUCTIVE INVESTIGATION
OPENINGS – MARK 9
1st Floor Outside Corner**

Wood frame damage

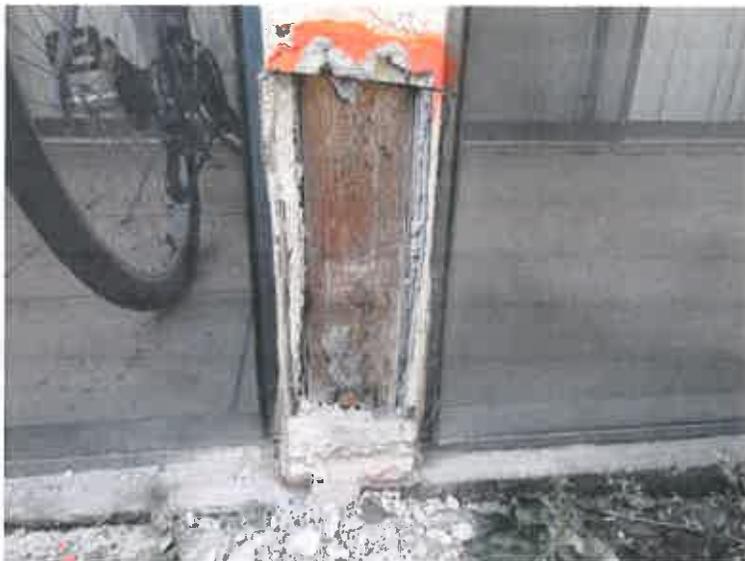
PHOTOGRAPH #247

**DESTRUCTIVE INVESTIGATION
OPENINGS – MARK 10
1st Floor Between Lanais**

Wood frame damage

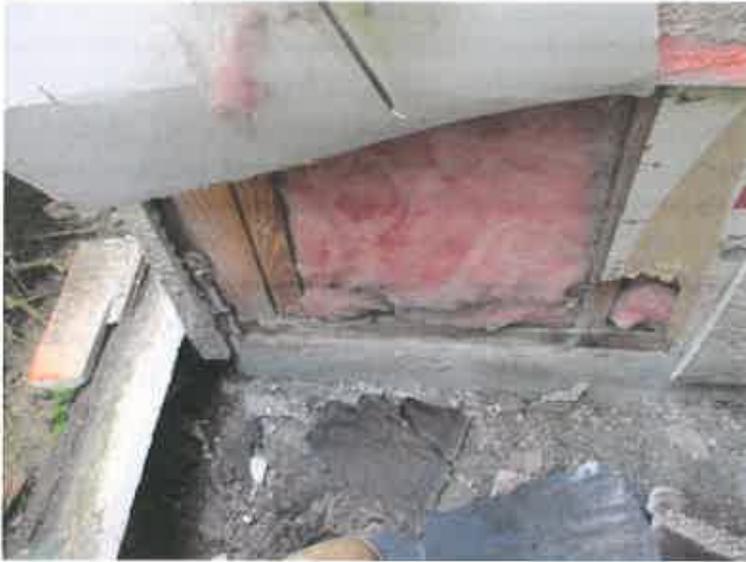
PHOTOGRAPH #248

**DESTRUCTIVE INVESTIGATION
OPENINGS – MARK 11
1st Floor Outside Corner**

No damage

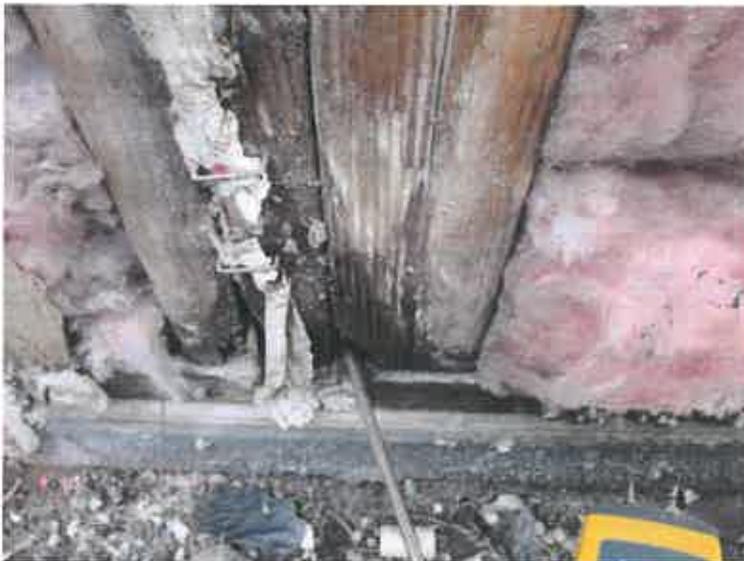
PHOTOGRAPH #249

**DESTRUCTIVE INVESTIGATION
OPENINGS – MARK 12
1st Floor Below Window**

Wood frame damage

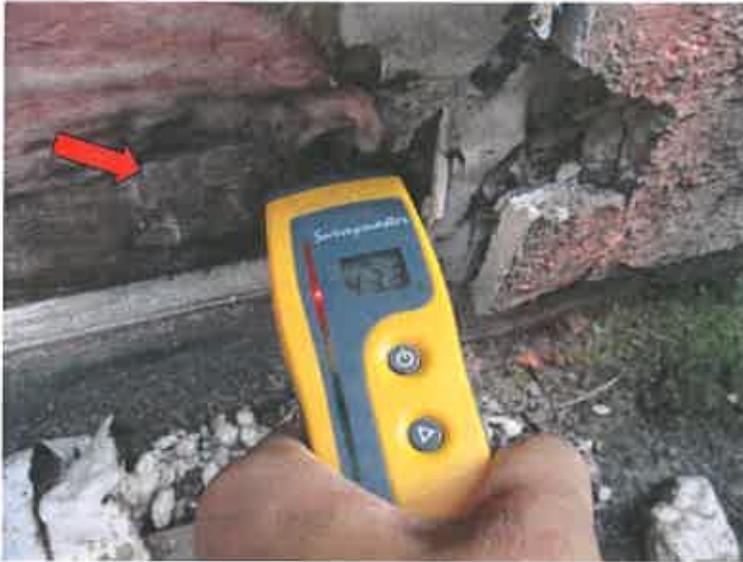
PHOTOGRAPH #250

**DESTRUCTIVE INVESTIGATION
OPENINGS – MARK 13
1st Floor Near AC Units**

Wet framing, water stains on studs

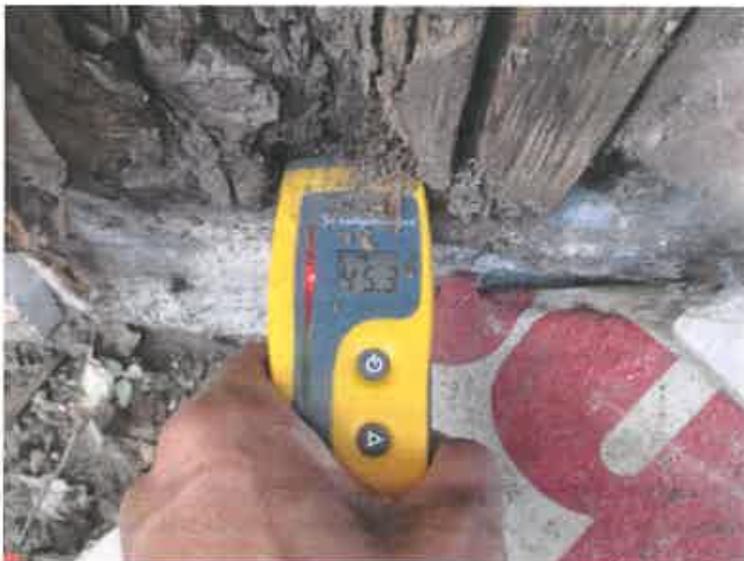
PHOTOGRAPH #251

**DESTRUCTIVE INVESTIGATION
OPENINGS – MARK 14
1st Floor Below Window**

Wood frame damage

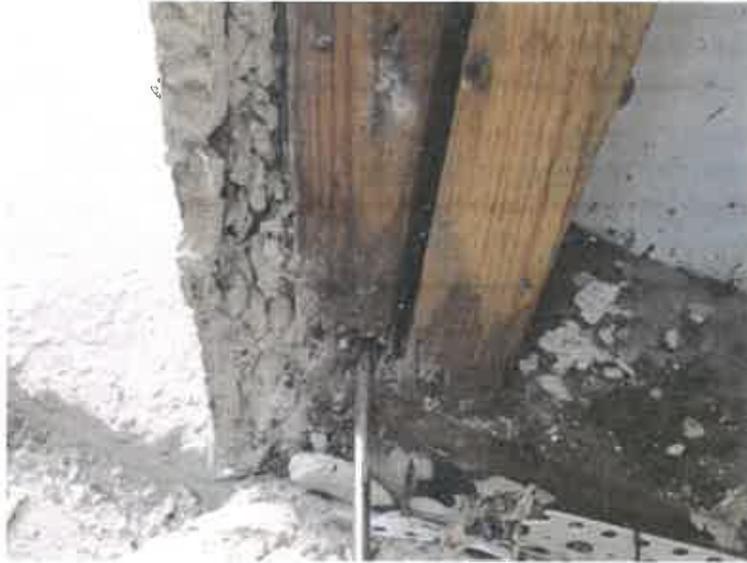
PHOTOGRAPH #252

**DESTRUCTIVE INVESTIGATION
OPENINGS – MARK 15
1st Floor Inside Corner**

Wood frame damage

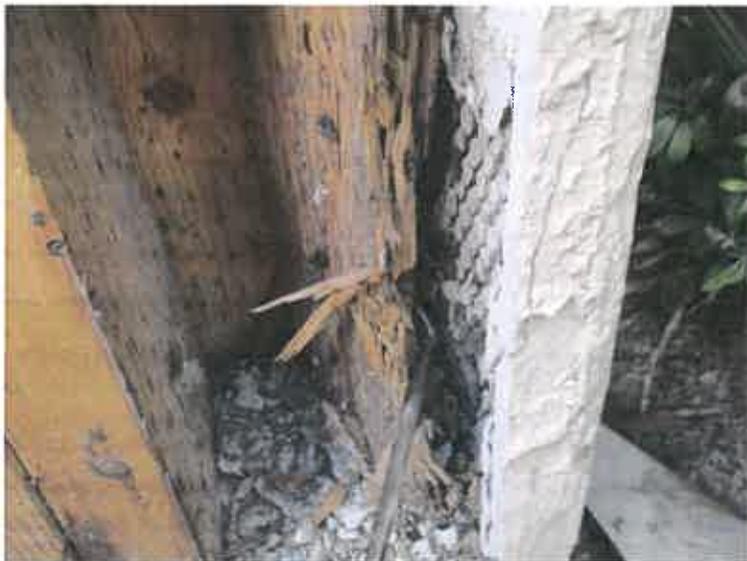
PHOTOGRAPH #253

**DESTRUCTIVE INVESTIGATION
OPENINGS – MARK 16
1st Floor Near Stair at Base**

Wood frame damage

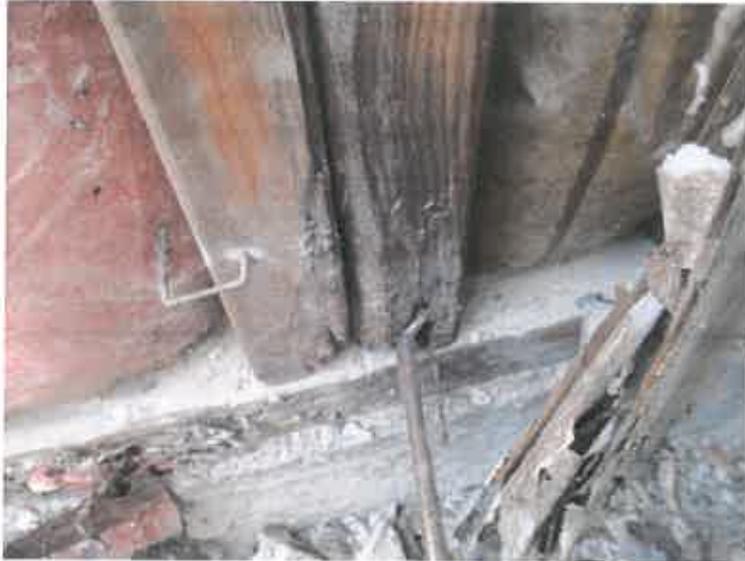
PHOTOGRAPH #254

**DESTRUCTIVE INVESTIGATION
OPENINGS – MARK 17
1st Floor Below Window**

Wood frame damage

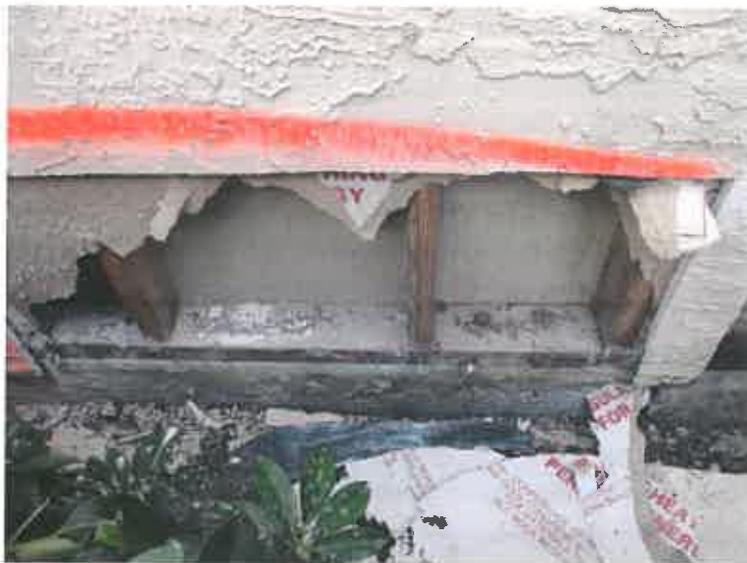
PHOTOGRAPH #255

**DESTRUCTIVE INVESTIGATION
OPENINGS – MARK 18
1st Floor Adjacent to Window**

No damage

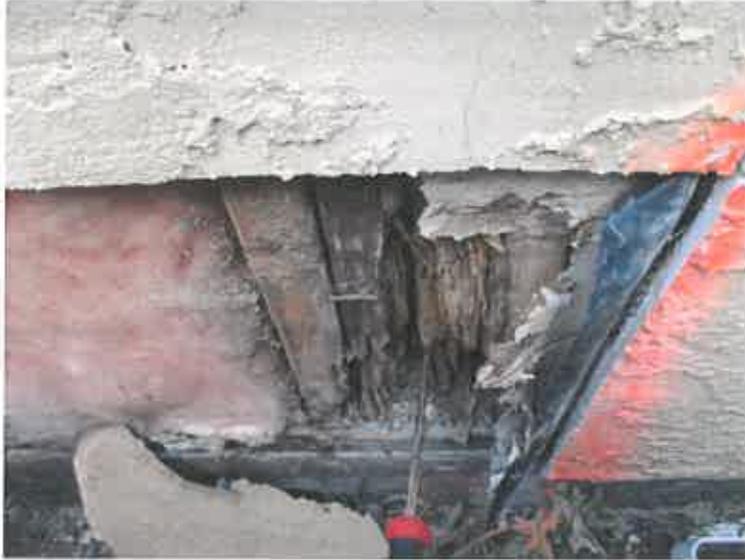
PHOTOGRAPH #256

**DESTRUCTIVE INVESTIGATION
OPENINGS – MARK 19
1st Floor Below Window**

Wood frame damage

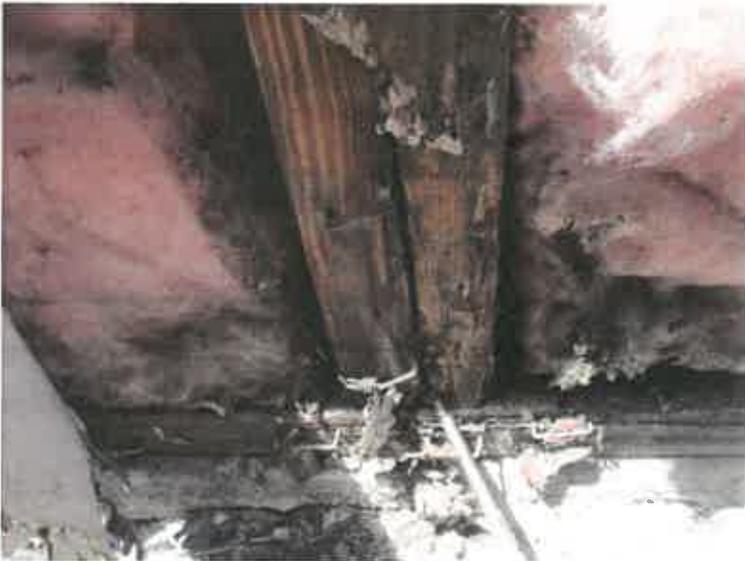
PHOTOGRAPH #257

**DESTRUCTIVE INVESTIGATION
OPENINGS – MARK 20
1st Floor Below Window**

Wood frame damage

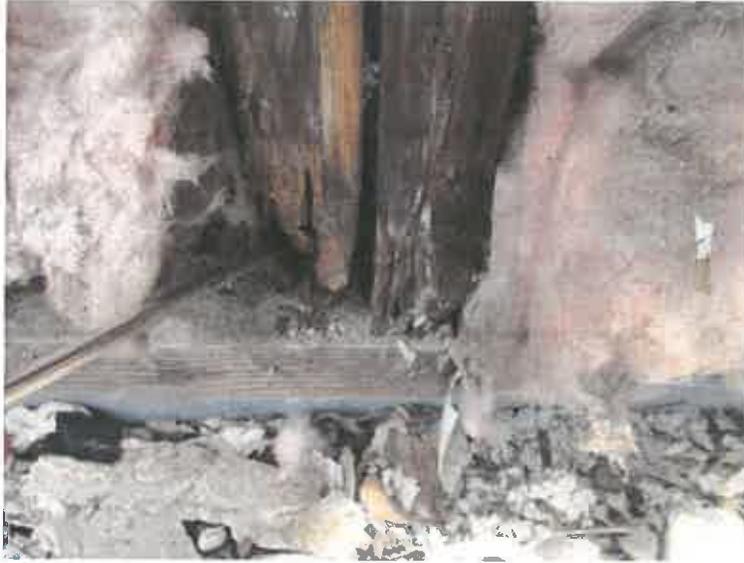
PHOTOGRAPH #258

**DESTRUCTIVE INVESTIGATION
OPENINGS – MARK 21
1st Floor Below Window**

Wood frame damage

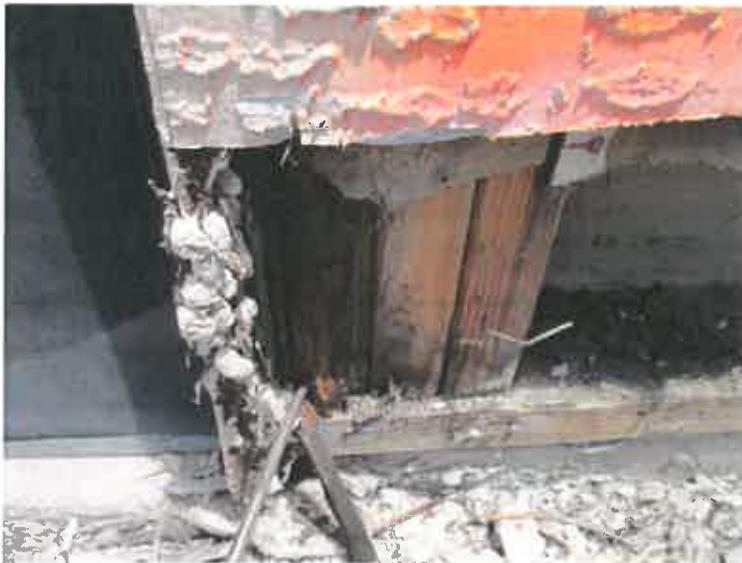
PHOTOGRAPH #259

**DESTRUCTIVE INVESTIGATION
OPENINGS – MARK 22
1st Floor Near Stair at Base**

Wood frame damage

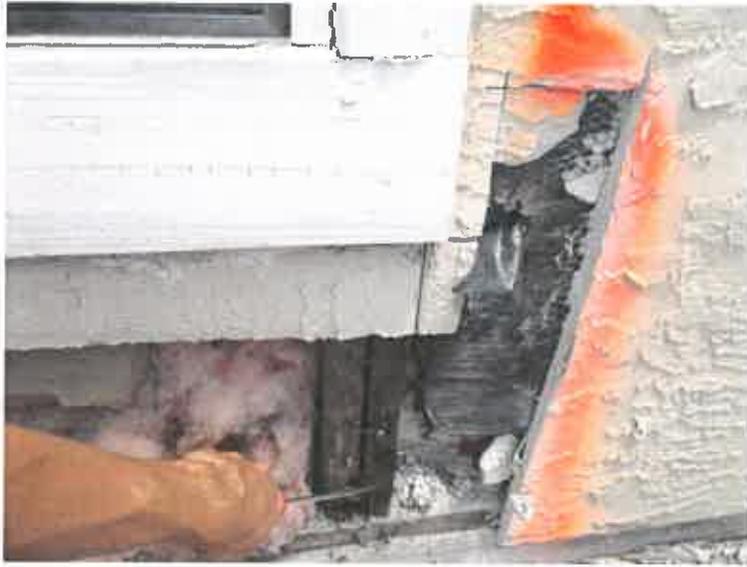
PHOTOGRAPH #260

**DESTRUCTIVE INVESTIGATION
OPENINGS – MARK 23
1st Floor Below Window**

Wood frame damage

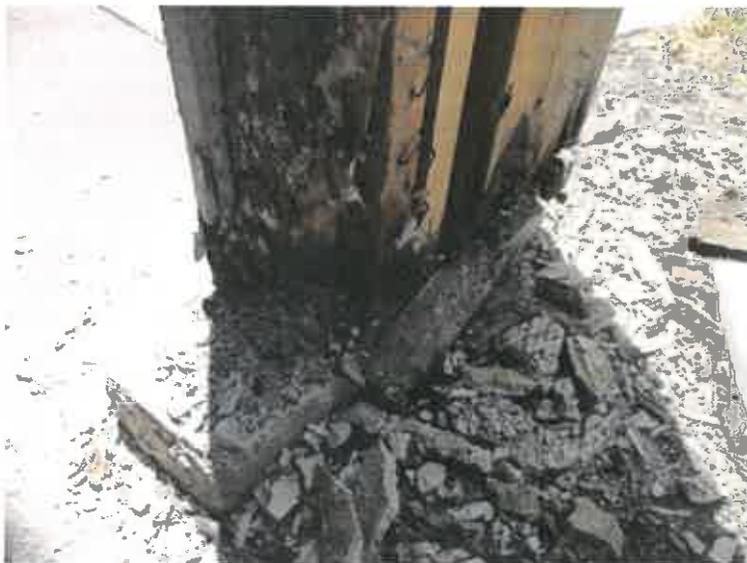
PHOTOGRAPH #261

**DESTRUCTIVE INVESTIGATION
OPENINGS – MARK 24
1st Floor Near Stair at Base**

Wood frame damage

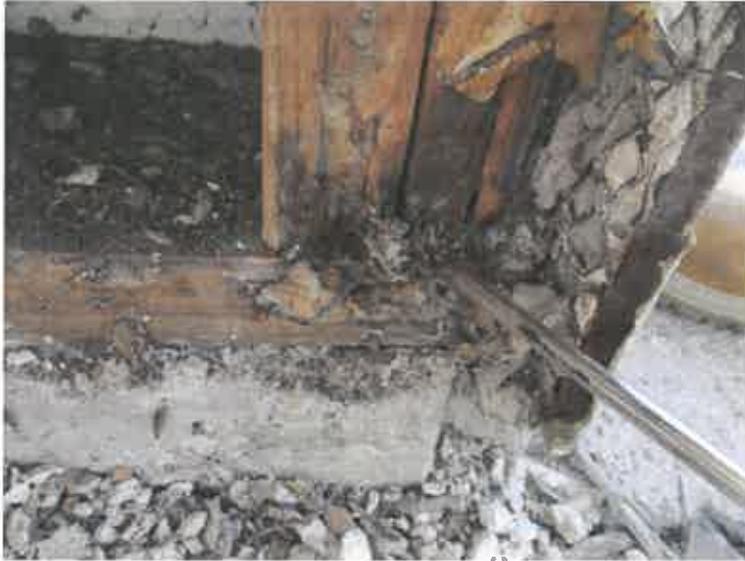
PHOTOGRAPH #262

**DESTRUCTIVE INVESTIGATION
OPENINGS – MARK 25
1st Floor Near Stair at Base**

Wood frame damage

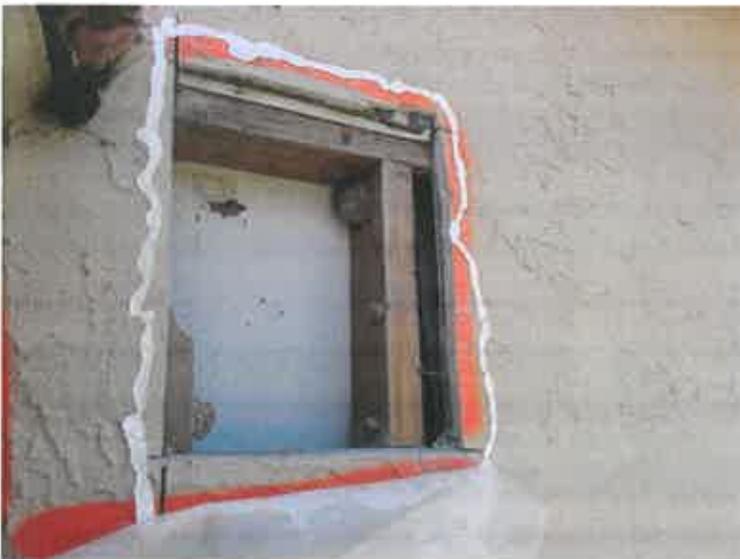
PHOTOGRAPH #263

**DESTRUCTIVE INVESTIGATION
OPENINGS – MARK 26
Roof to Wall Intersection**

No damage

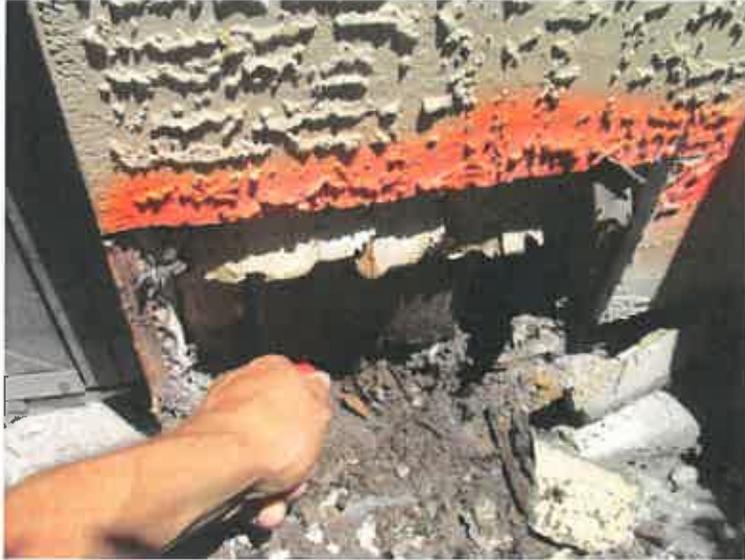
PHOTOGRAPH #264

**DESTRUCTIVE INVESTIGATION
OPENINGS – MARK 27
1st Floor Adjacent to Lanai**

Wood frame damage

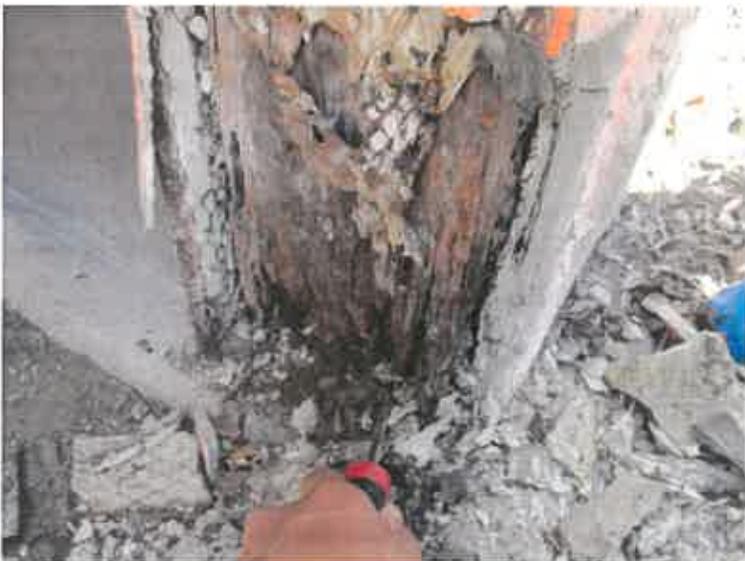
PHOTOGRAPH #265

**DESTRUCTIVE INVESTIGATION
OPENINGS – MARK 28
1st Floor Near Stair at Base**

Wood frame damage

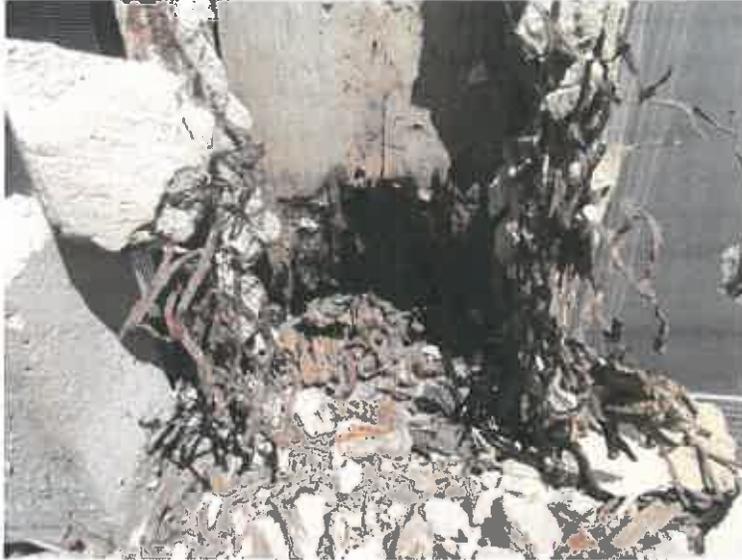
PHOTOGRAPH #266

**DESTRUCTIVE INVESTIGATION
OPENINGS – MARK 29
1st Floor Between Lanais**

Wood frame damage

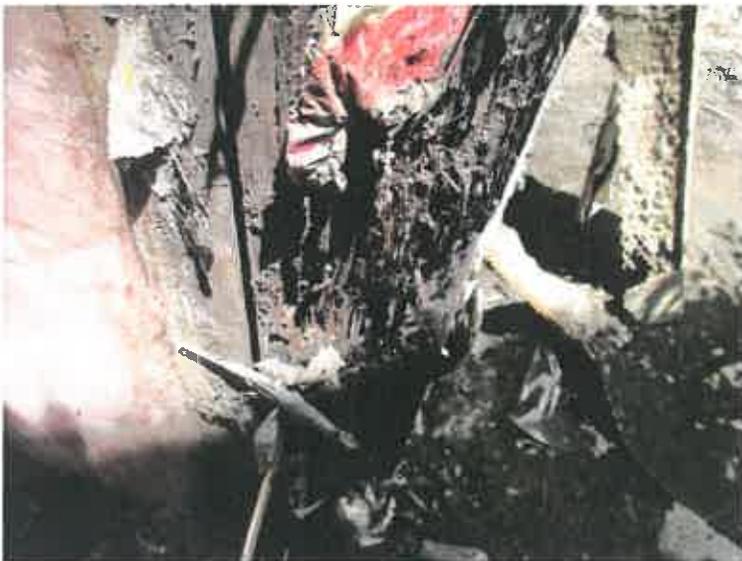
PHOTOGRAPH #267

**DESTRUCTIVE INVESTIGATION
OPENINGS – MARK 30
1st Floor Outside Corner**

Wood frame damage

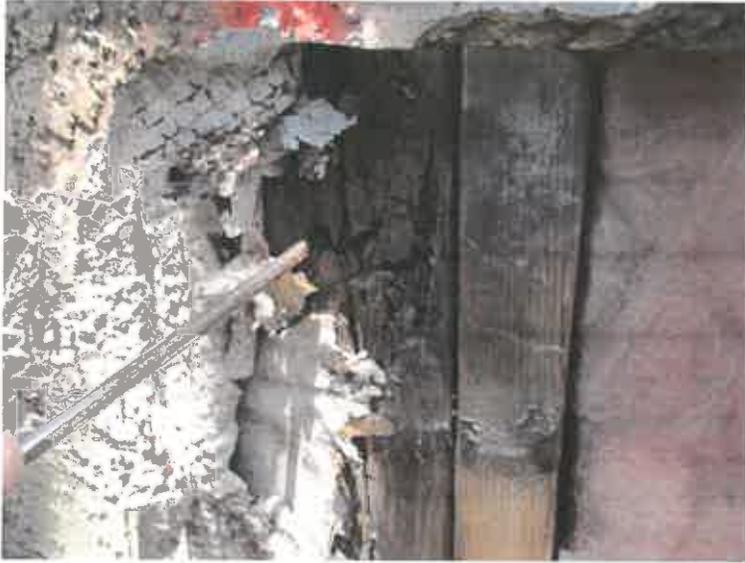
PHOTOGRAPH #268

**DESTRUCTIVE INVESTIGATION
OPENINGS – MARK 31
1st Floor Below Window**

Wood frame damage

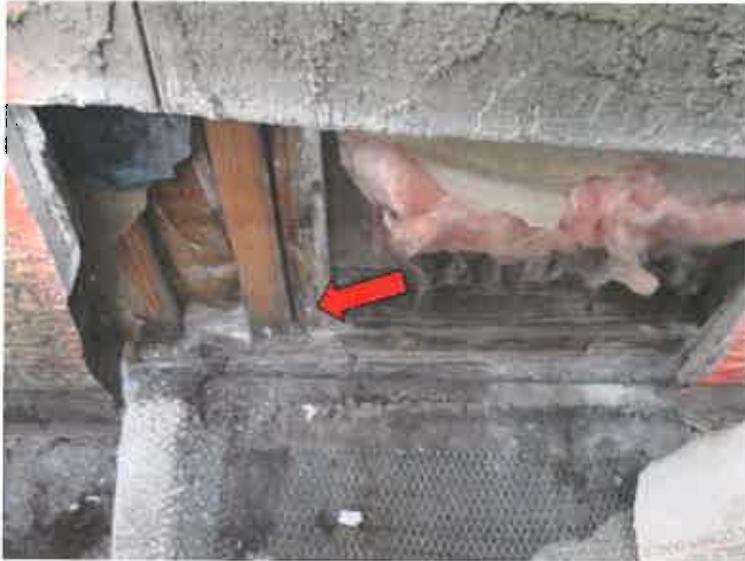
PHOTOGRAPH #269

**DESTRUCTIVE INVESTIGATION
OPENINGS – MARK 1
1st Floor Below Window**

Wood frame damage

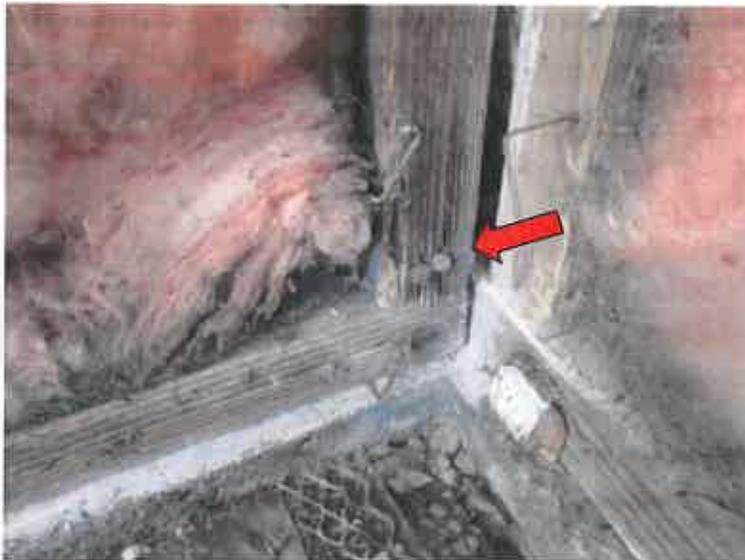
PHOTOGRAPH #270

**DESTRUCTIVE INVESTIGATION
OPENINGS – MARK 2
1st Floor Inside Corner**

Wood frame damage

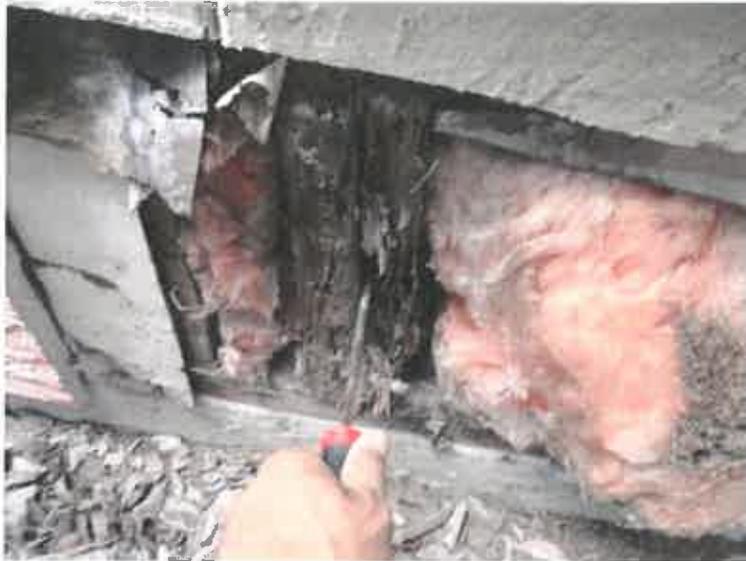
PHOTOGRAPH #271

**DESTRUCTIVE INVESTIGATION
OPENINGS – MARK 3
1st Floor Below Window**

Wood frame damage

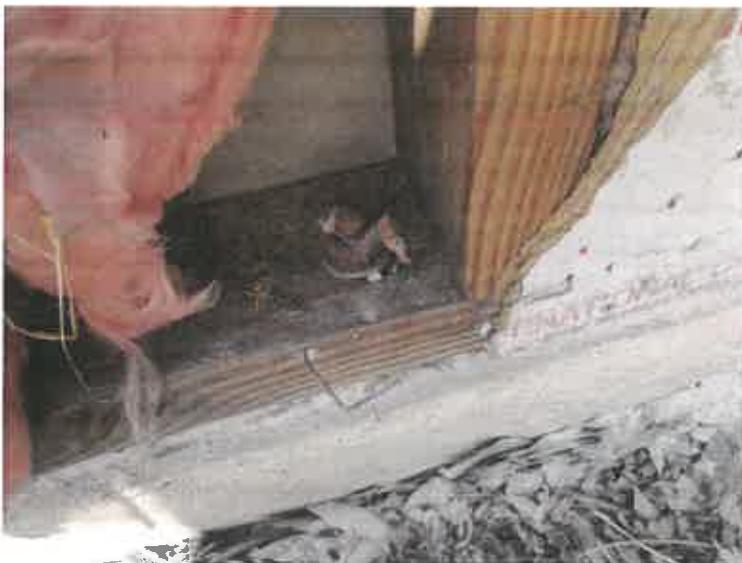
PHOTOGRAPH #272

**DESTRUCTIVE INVESTIGATION
OPENINGS – MARK 4
1st Floor Outside Corner**

No damage

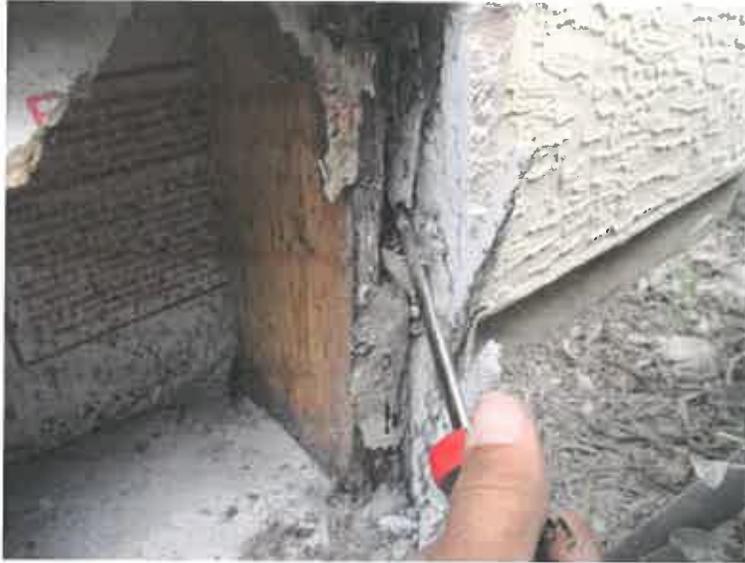
PHOTOGRAPH #273

**DESTRUCTIVE INVESTIGATION
OPENINGS – MARK 5
1st Floor Near Stair at Base**

Wood frame damage

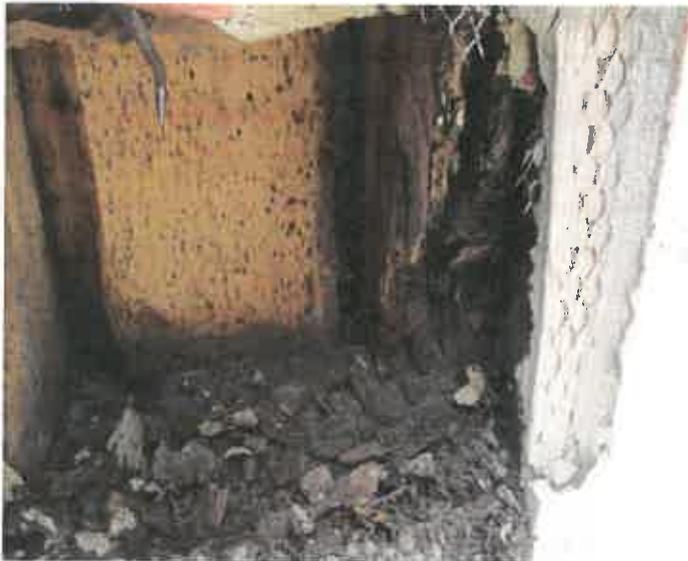
PHOTOGRAPH #274

**DESTRUCTIVE INVESTIGATION
OPENINGS – MARK 6
1st Floor Near Stair at Base**

Wood frame damage

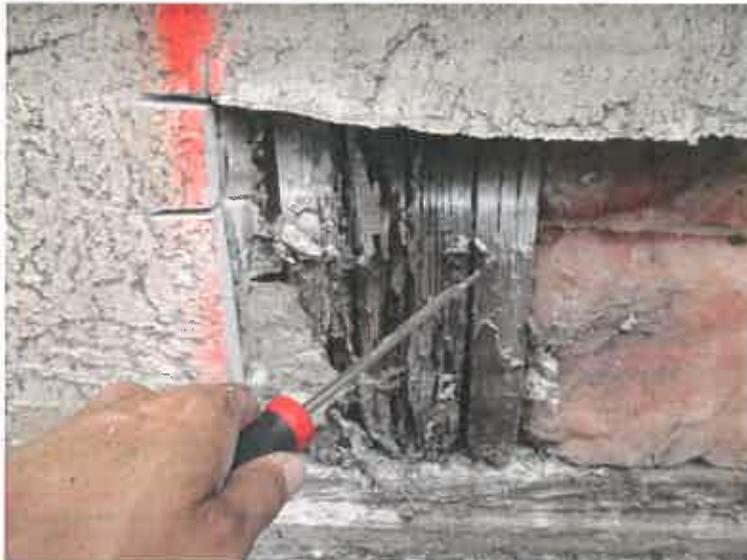
PHOTOGRAPH #275

**DESTRUCTIVE INVESTIGATION
OPENINGS – MARK 7
1st Floor Below Window**

Wood frame damage

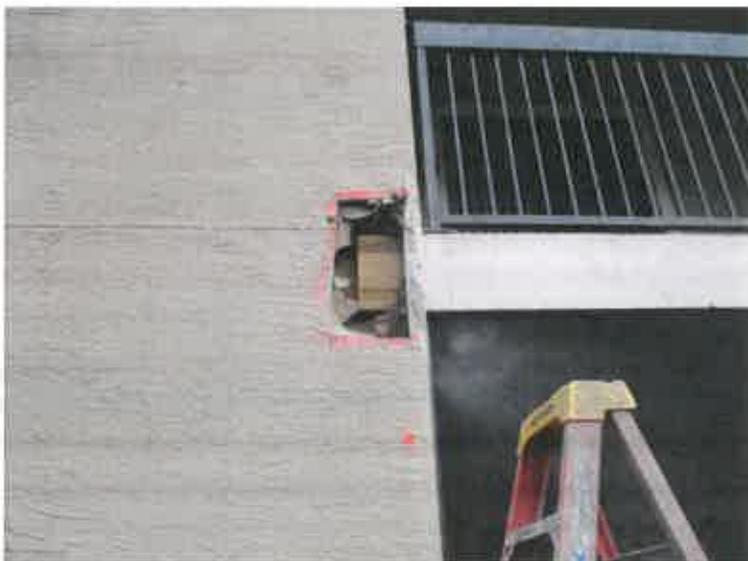
PHOTOGRAPH #276

**DESTRUCTIVE INVESTIGATION
OPENINGS – MARK 8
2nd Floor Adjacent to Balcony**

No damage

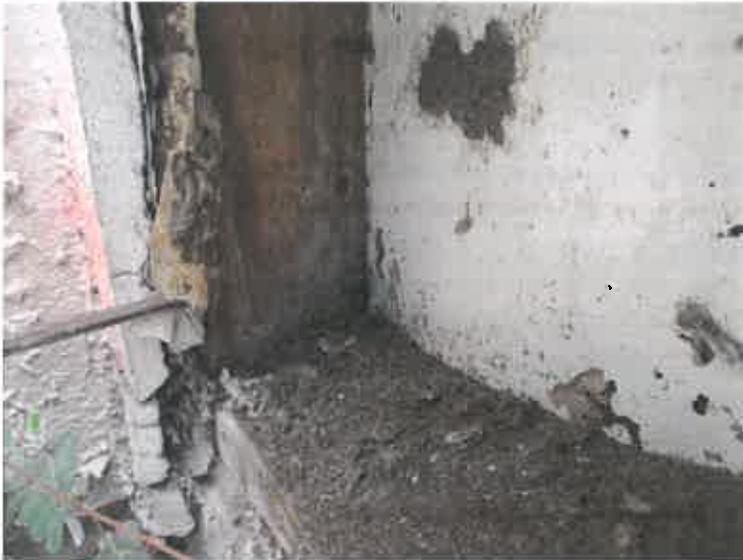
PHOTOGRAPH #277

**DESTRUCTIVE INVESTIGATION
OPENINGS – MARK 9
1st Floor Inside Corner**

Wood frame damage

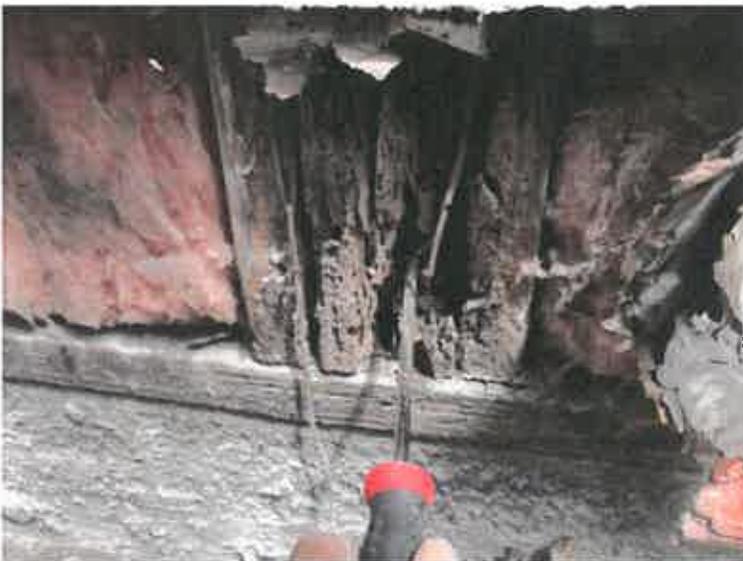
PHOTOGRAPH #278

**DESTRUCTIVE INVESTIGATION
OPENINGS – MARK 10
1st Floor Below Window**

Wood frame damage

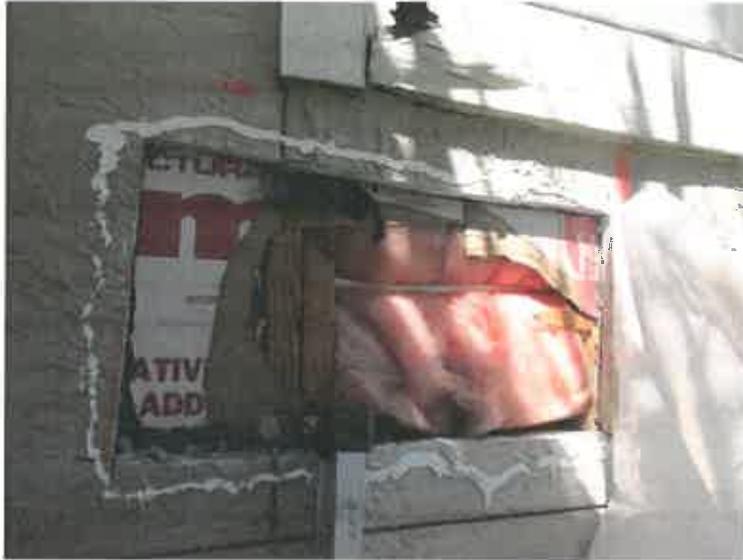
PHOTOGRAPH #279

**DESTRUCTIVE INVESTIGATION
OPENINGS – MARK 11
2nd Floor Below Window**

No damage

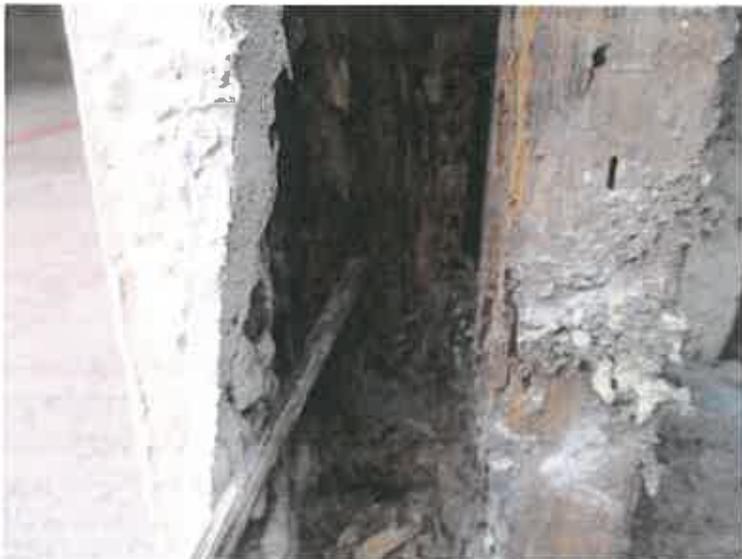
PHOTOGRAPH #280

**DESTRUCTIVE INVESTIGATION
OPENINGS – MARK 12
1st Floor Near Stair at Base**

Wood frame damage

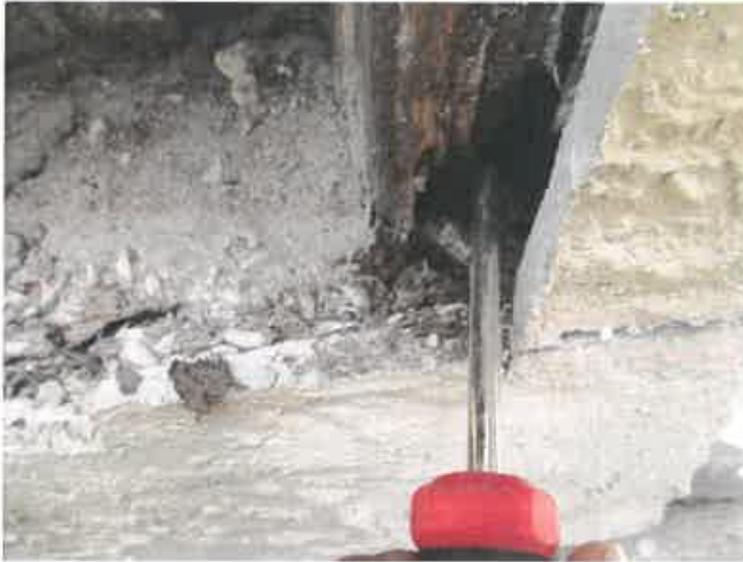
PHOTOGRAPH #281

**DESTRUCTIVE INVESTIGATION
OPENINGS – MARK 13
1st Floor Near Stair at Base**

Wood frame damage

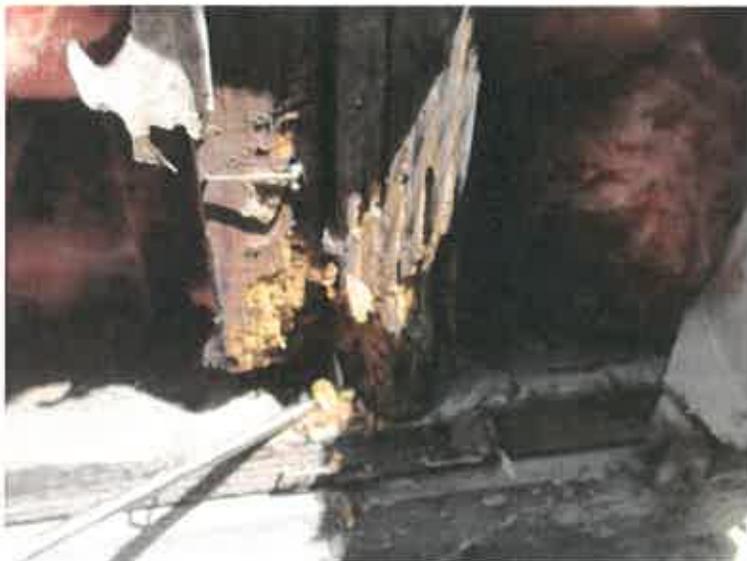
PHOTOGRAPH #282

**DESTRUCTIVE INVESTIGATION
OPENINGS – MARK 14
1st Floor Below Window**

Wood frame damage

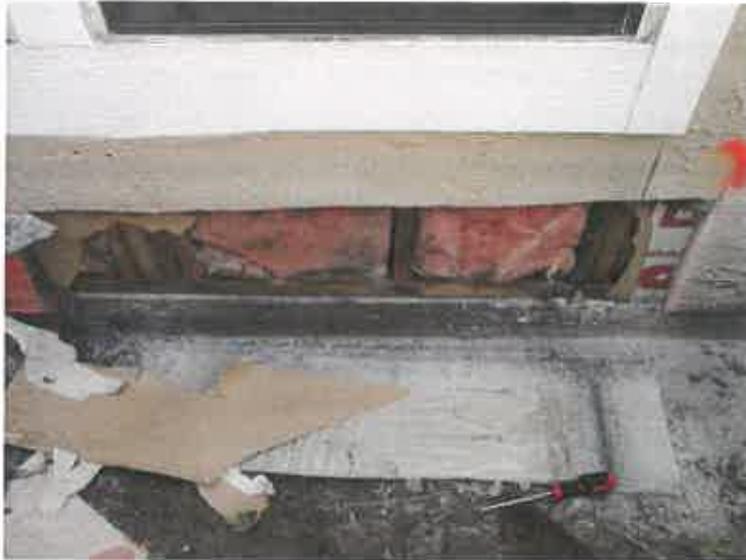
PHOTOGRAPH #283

**DESTRUCTIVE INVESTIGATION
OPENINGS – MARK 15
1st Floor Below Window**

No damage

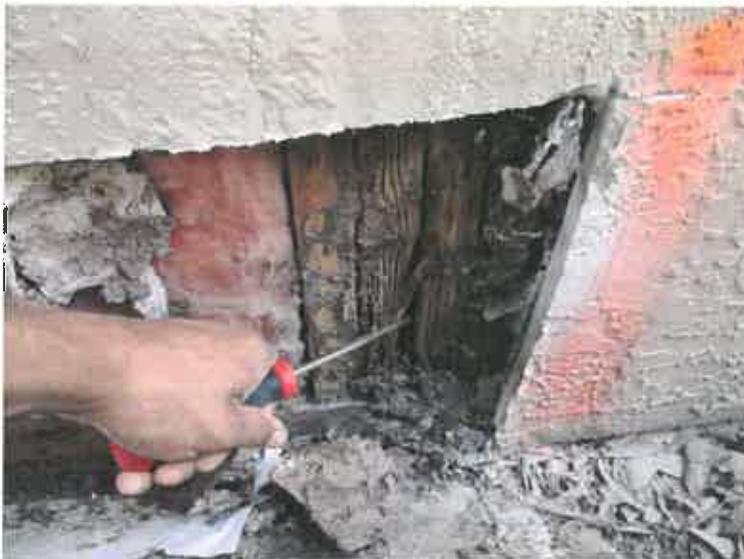
PHOTOGRAPH #284

**DESTRUCTIVE INVESTIGATION
OPENINGS – MARK 16
1st Floor Below Window**

Wood frame damage

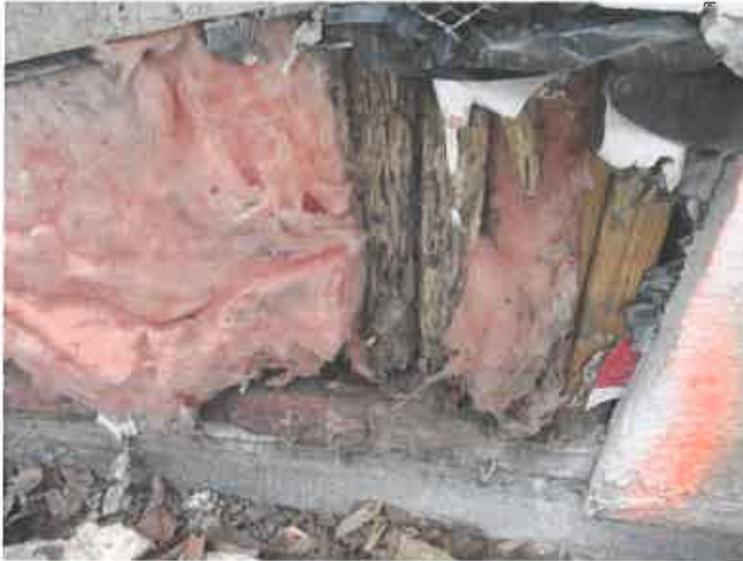
PHOTOGRAPH #285

**DESTRUCTIVE INVESTIGATION
OPENINGS – MARK 17
1st Floor Below Window**

Wood frame damage

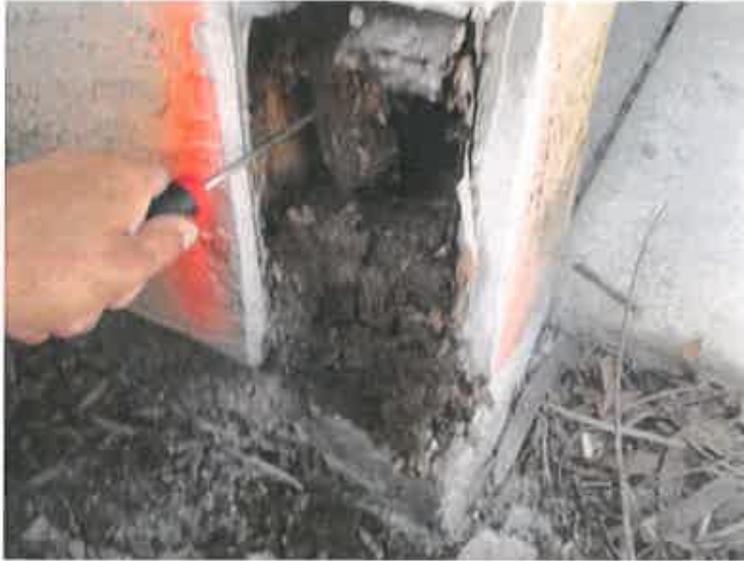
PHOTOGRAPH #287

**DESTRUCTIVE INVESTIGATION
OPENINGS – MARK 19
1st Floor Near Stair at Base**

Wood frame damage

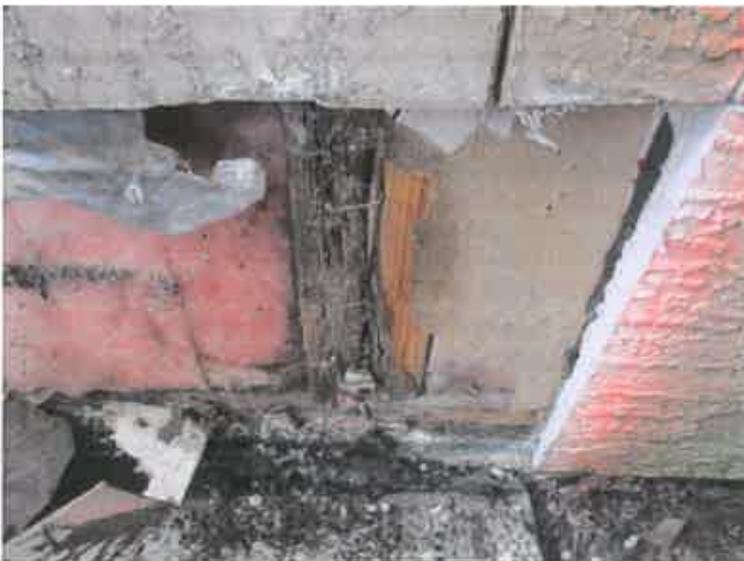
PHOTOGRAPH #288

**DESTRUCTIVE INVESTIGATION
OPENINGS – MARK 20
1st Floor Below Window**

Wood frame damage

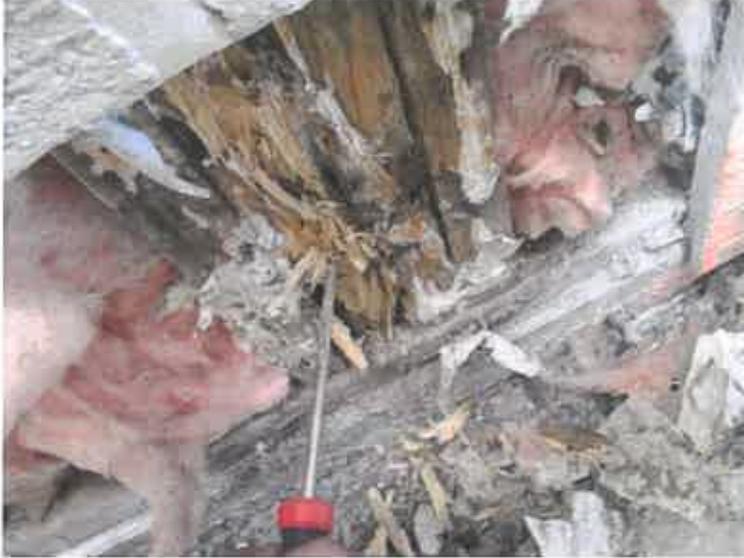
PHOTOGRAPH #289

**DESTRUCTIVE INVESTIGATION
OPENINGS – MARK 21
1st Floor Below Window**

Wood frame damage

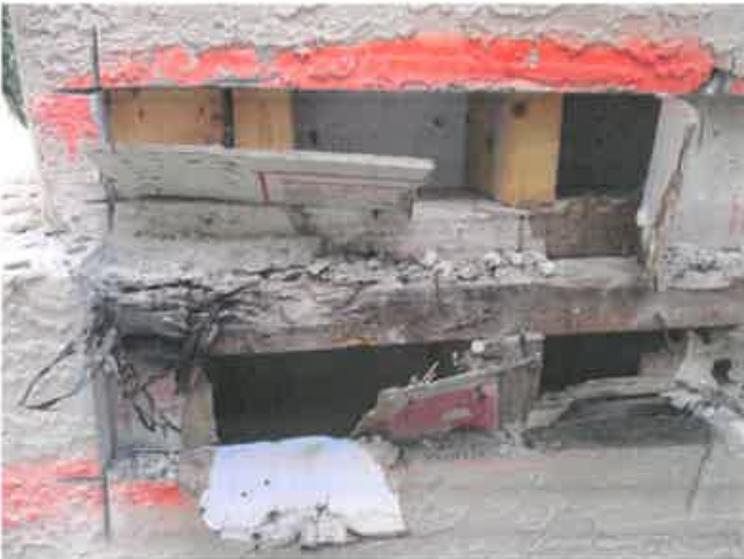
PHOTOGRAPH #290

**DESTRUCTIVE INVESTIGATION
OPENINGS – MARK 22
2nd Floor Above Stairs**

Wood frame damage

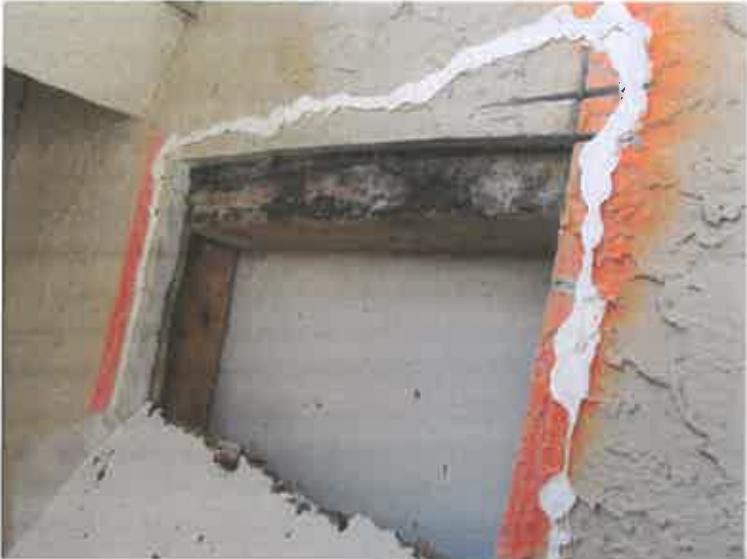
PHOTOGRAPH #291

**DESTRUCTIVE INVESTIGATION
OPENINGS – MARK 23
Roof to Wall Intersection**

Wood frame damage

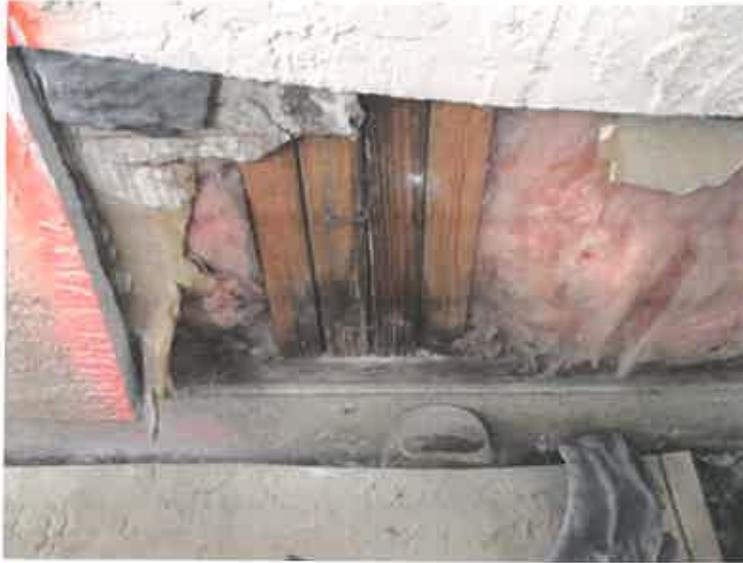
PHOTOGRAPH #292

**DESTRUCTIVE INVESTIGATION
OPENINGS – MARK 1
1st Floor Below Window**

No damage

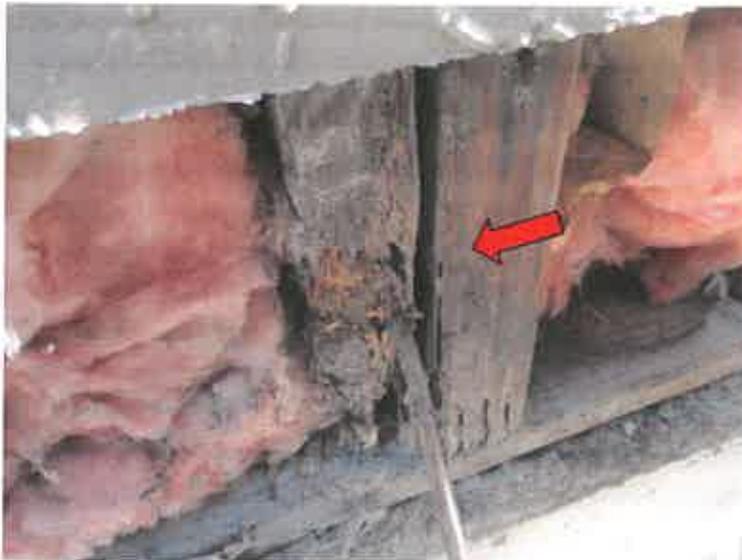
PHOTOGRAPH #293

**DESTRUCTIVE INVESTIGATION
OPENINGS – MARK 2
1st Floor Below Window**

Wood frame damage
