SUPPLEMENTAL DESTRUCTIVE INVESTIGATION

**Vintage Grand Condominium
4012 Crockers Lake Blvd.
Sarasota, FL 34238**

Project No. R1606-231

October 28, 2016

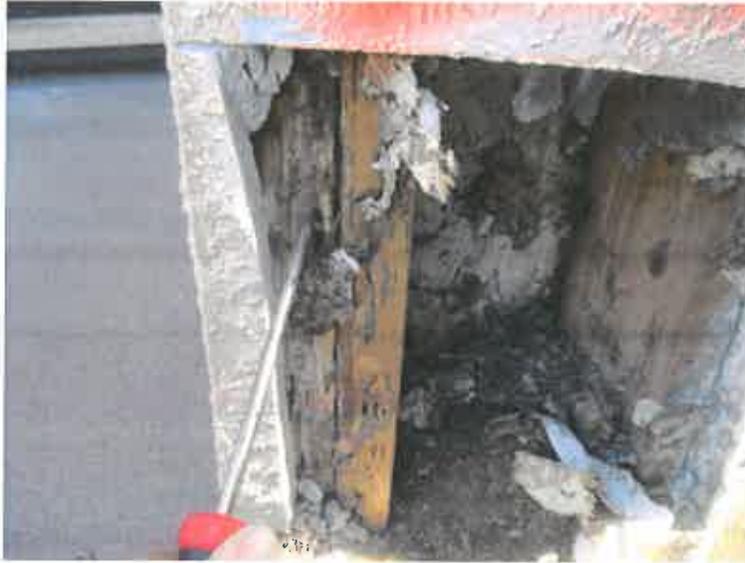
PHOTOGRAPH #294

**DESTRUCTIVE INVESTIGATION
OPENINGS – MARK 3
1st Floor Near Stair at Base**

Wood frame damage

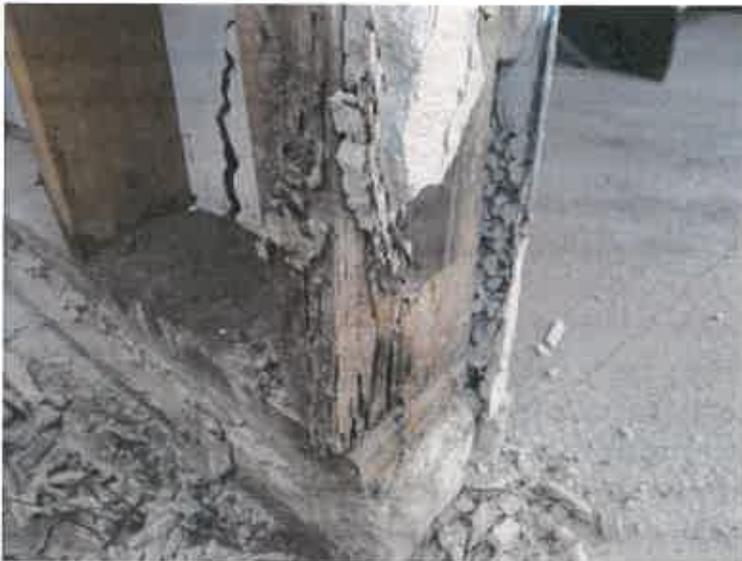
PHOTOGRAPH #295

**DESTRUCTIVE INVESTIGATION
OPENINGS – MARK 4
1st Floor Near Stair at Base**

Wood frame damage

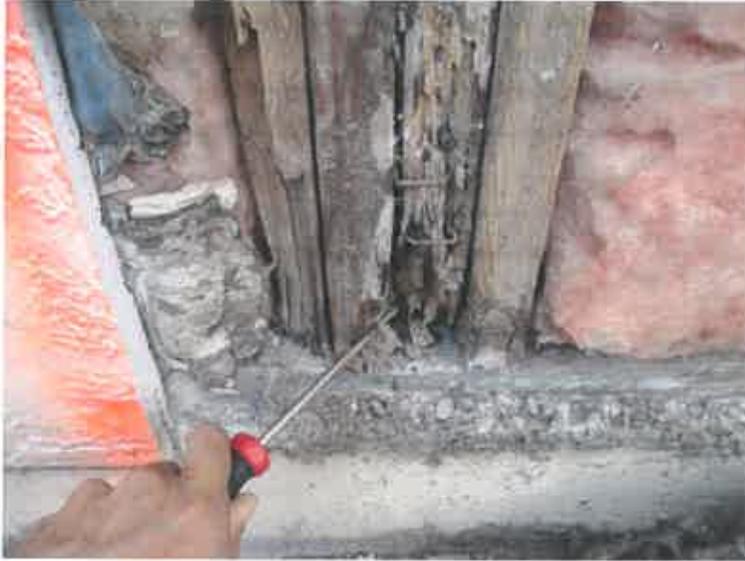
PHOTOGRAPH #296

**DESTRUCTIVE INVESTIGATION
OPENINGS – MARK 5
1st Floor Below Window**

Wood frame damage

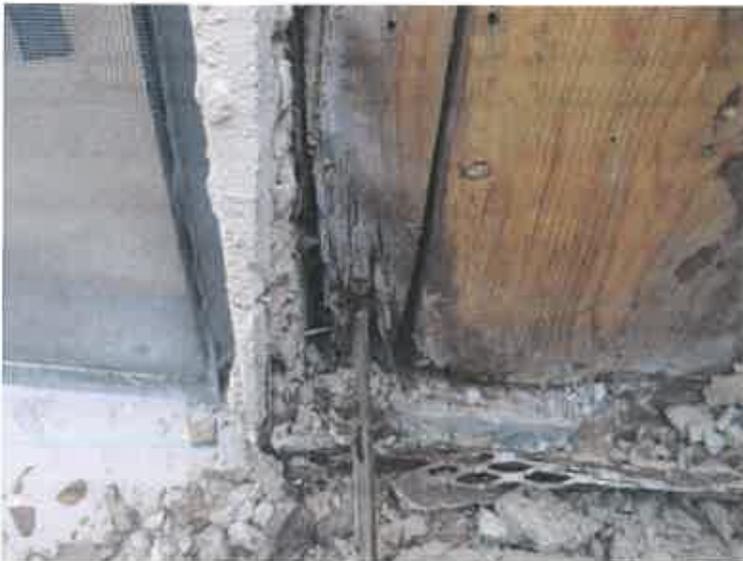
PHOTOGRAPH #297

**DESTRUCTIVE INVESTIGATION
OPENINGS – MARK 6
1st Floor Adjacent to Lanai**

Wood frame damage

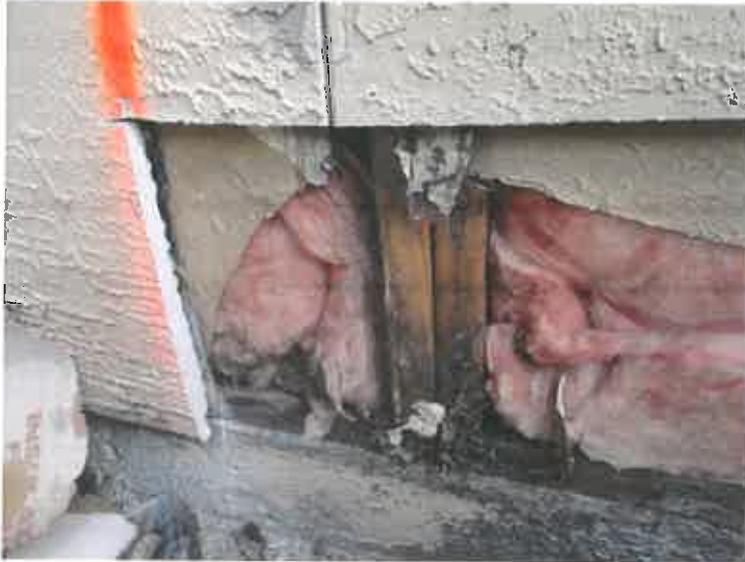
PHOTOGRAPH #298

**DESTRUCTIVE INVESTIGATION
OPENINGS – MARK 7
1st Floor Below Window**

Wood frame damage

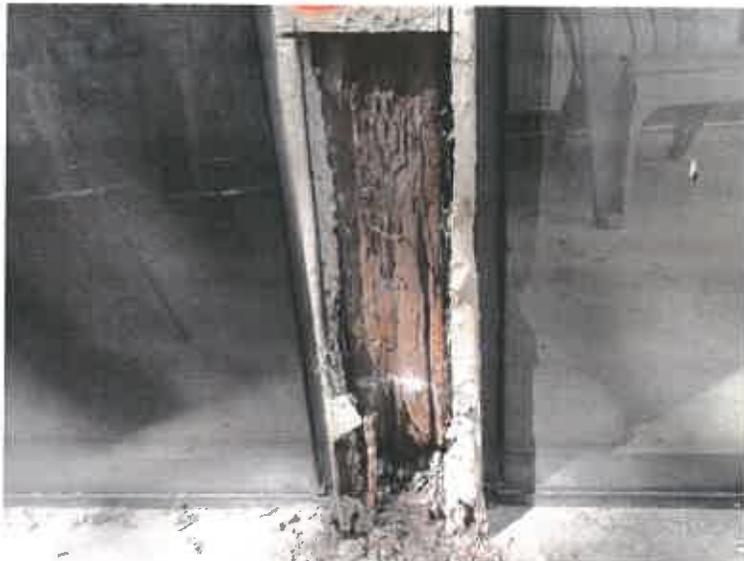
PHOTOGRAPH #299

**DESTRUCTIVE INVESTIGATION
OPENINGS – MARK 8
1st Floor Between Lanais**

Wood frame damage

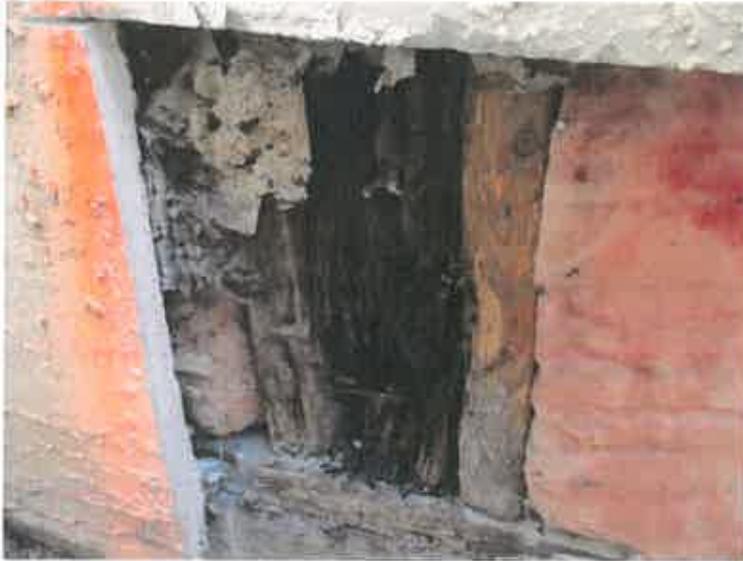
PHOTOGRAPH #300

**DESTRUCTIVE INVESTIGATION
OPENINGS – MARK 9
1st Floor Below Window**

Wood frame damage

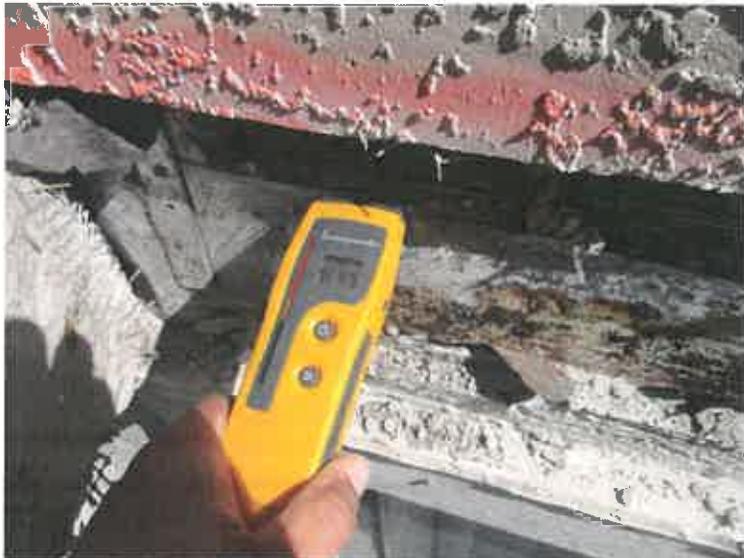
PHOTOGRAPH #301

**DESTRUCTIVE INVESTIGATION
OPENINGS – MARK 10
1st Floor Above Window**

Wood frame damage, high moisture

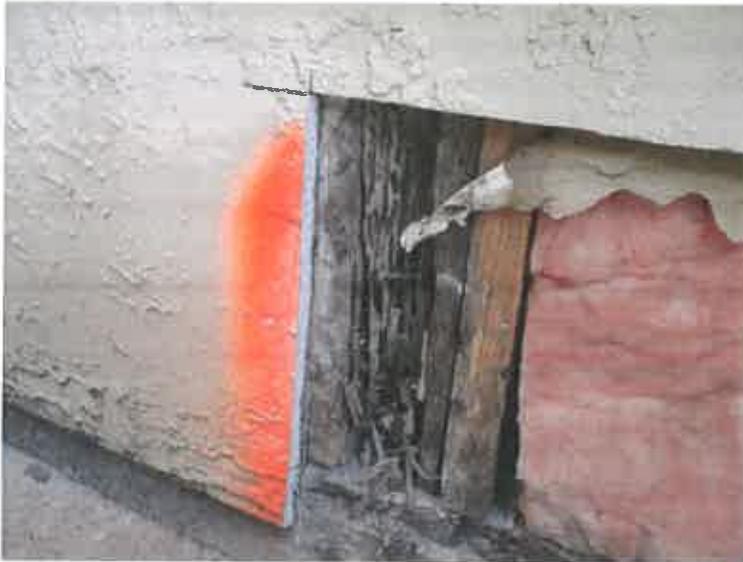
PHOTOGRAPH #302

**DESTRUCTIVE INVESTIGATION
OPENINGS – MARK 11
1st Floor Below Window**

Wood frame damage

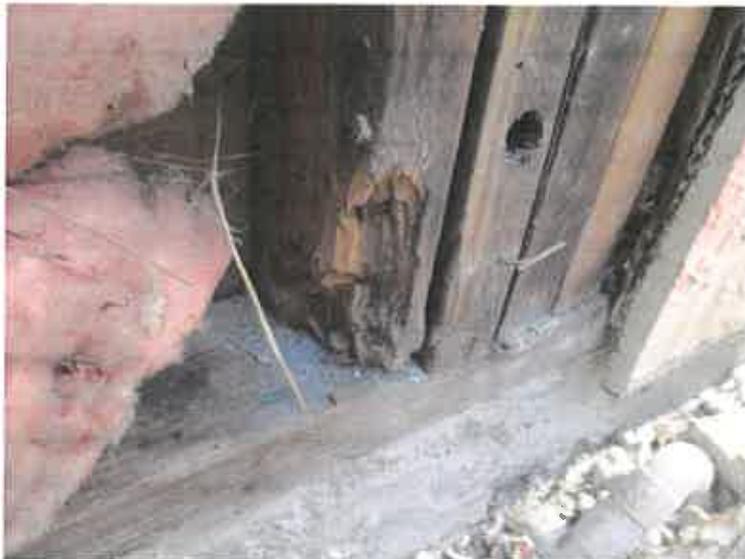
PHOTOGRAPH #303

**DESTRUCTIVE INVESTIGATION
OPENINGS – MARK 12
1st Floor Below Window**

Wood frame damage

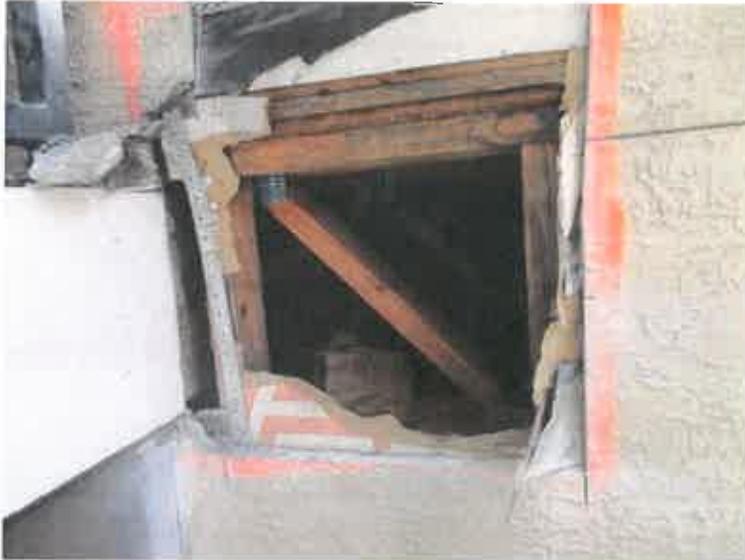
PHOTOGRAPH #304

**DESTRUCTIVE INVESTIGATION
OPENINGS – MARK 13
2nd Floor Adjacent to Balcony**

No damage

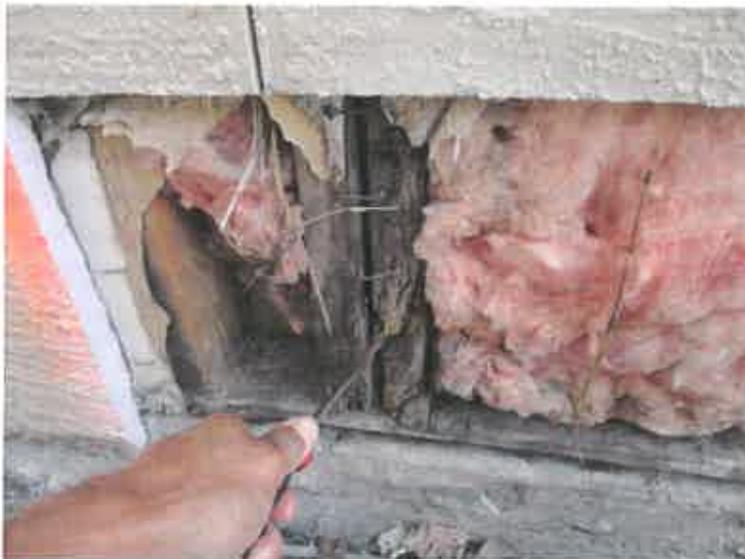
PHOTOGRAPH #305

**DESTRUCTIVE INVESTIGATION
OPENINGS – MARK 14
1st Floor Below Window**

Wood frame damage

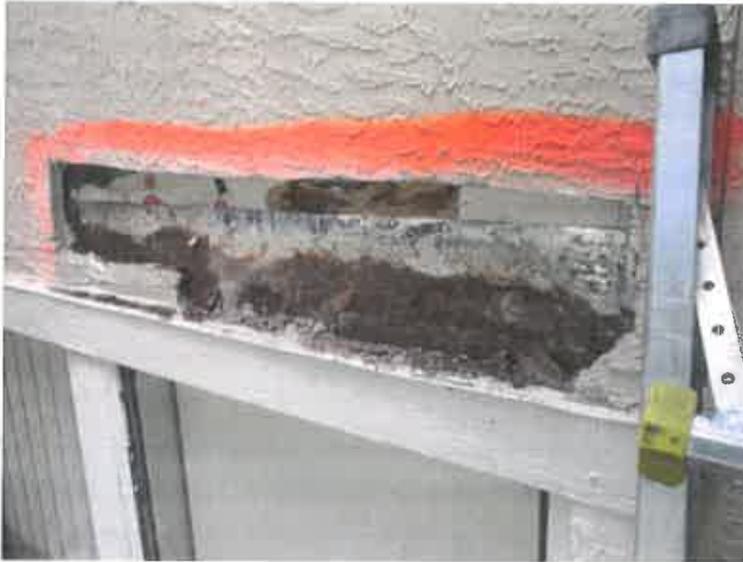
PHOTOGRAPH #306

**DESTRUCTIVE INVESTIGATION
OPENINGS – MARK 15
1st Floor Above Window**

No damage, corroded flashing

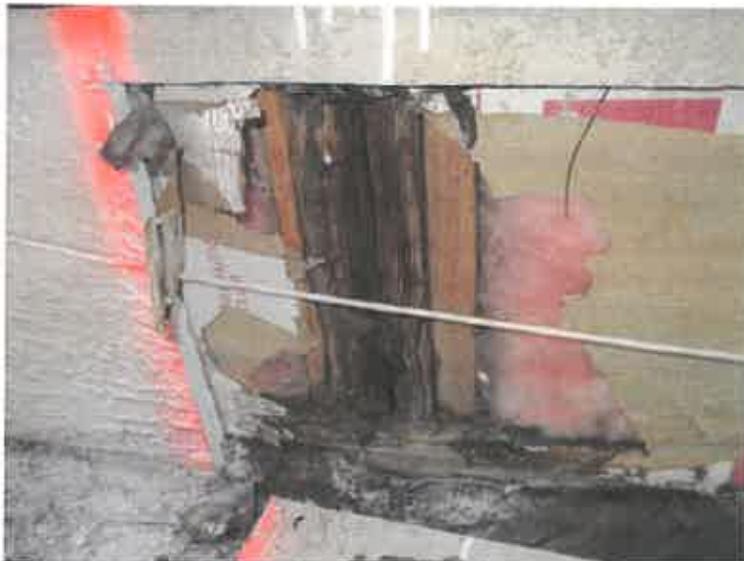
PHOTOGRAPH #307

**DESTRUCTIVE INVESTIGATION
OPENINGS – MARK 16
1st Floor Below Window**

Wood frame damage

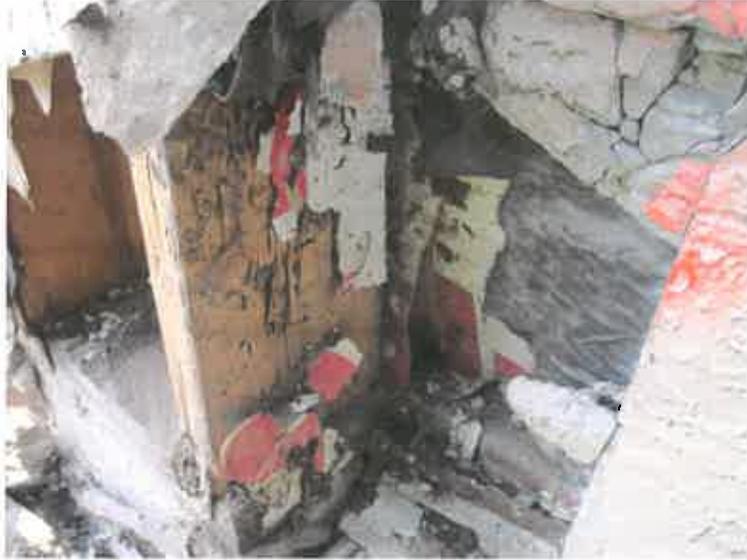
PHOTOGRAPH #308

**DESTRUCTIVE INVESTIGATION
OPENINGS – MARK 17
1st Floor Near Stair at Base**

Wood frame damage

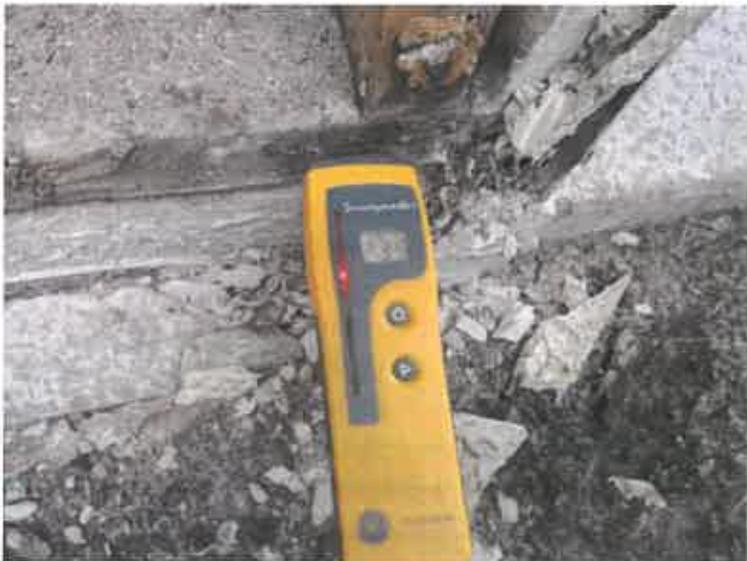
PHOTOGRAPH #309

**DESTRUCTIVE INVESTIGATION
OPENINGS – MARK 18
1st Floor Near Stair at Base**

Wood frame damage, high moisture

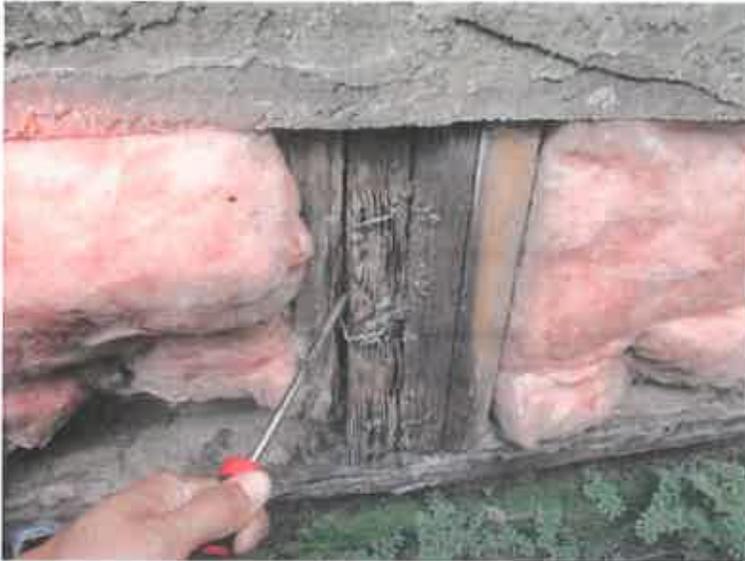
PHOTOGRAPH #310

**DESTRUCTIVE INVESTIGATION
OPENINGS – MARK 19
1st Floor Below Window**

Wood frame damage

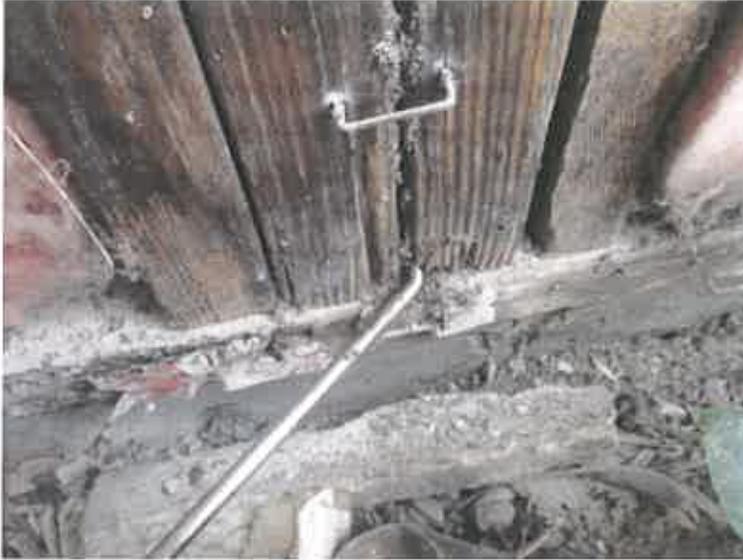
PHOTOGRAPH #312

**DESTRUCTIVE INVESTIGATION
OPENINGS – MARK 21
1st Floor Below Window**

Wood frame damage

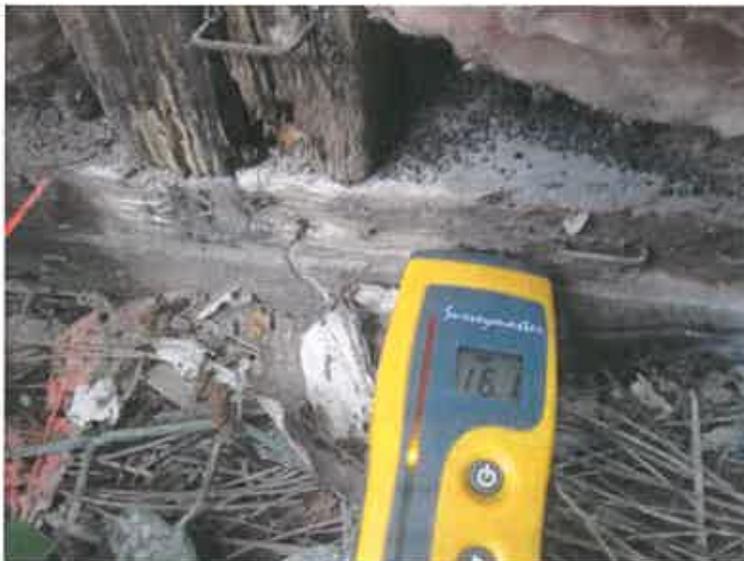
PHOTOGRAPH #313

**DESTRUCTIVE INVESTIGATION
OPENINGS – MARK 22
1st Floor Below Window**

Wood frame damage

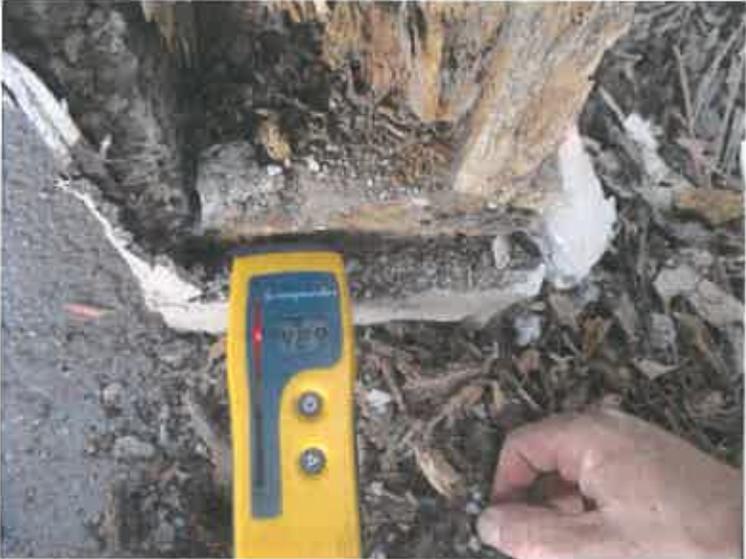
PHOTOGRAPH #314

**DESTRUCTIVE INVESTIGATION
OPENINGS – MARK 23
1st Floor Near Stair at Base**

Wood frame damage, high moisture

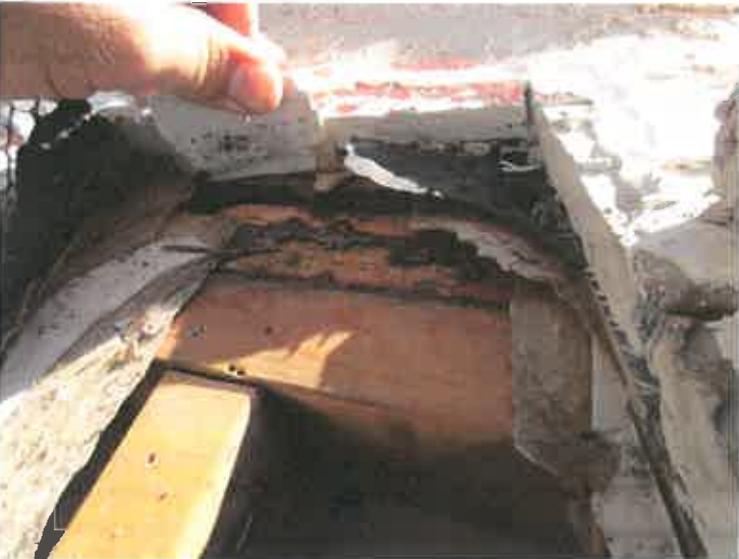
PHOTOGRAPH #315

**DESTRUCTIVE INVESTIGATION
OPENINGS – MARK 24
Roof to Wall Intersection**

No damage

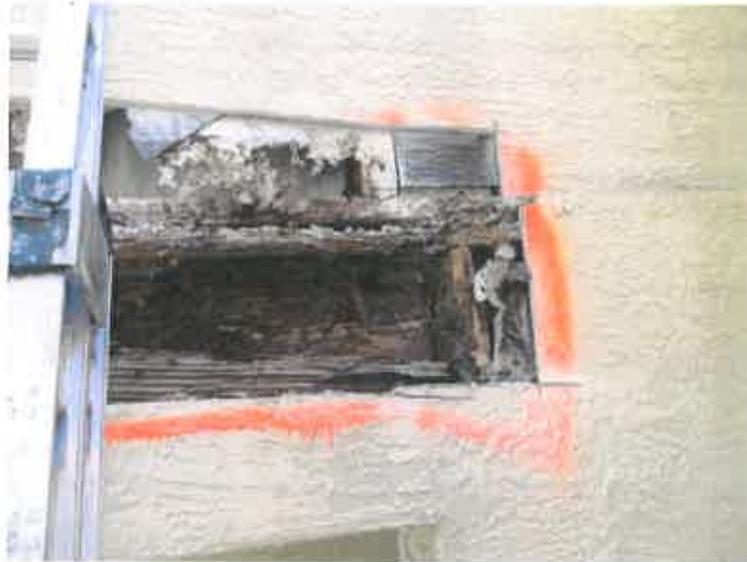
PHOTOGRAPH #316

**DESTRUCTIVE INVESTIGATION
OPENINGS – MARK 25
2nd Floor Above Stairs**

Wood frame damage

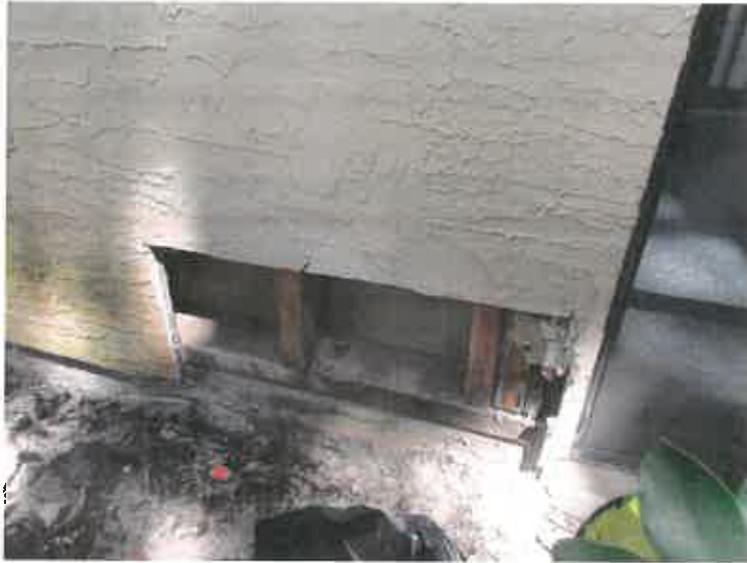
PHOTOGRAPH #317

**DESTRUCTIVE INVESTIGATION
OPENINGS – MARK 1
1st Floor Adjacent to Lanai**

No damage

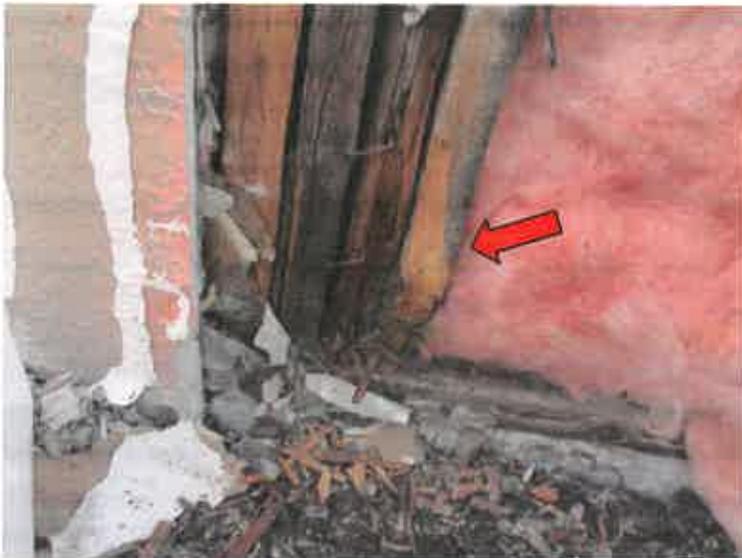
PHOTOGRAPH #318

**DESTRUCTIVE INVESTIGATION
OPENINGS – MARK 2
1st Floor Below Window**

Wood frame damage

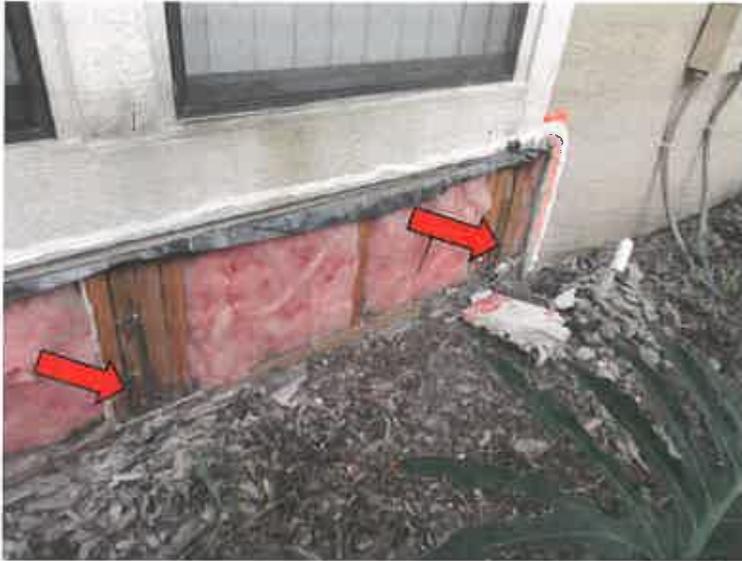
PHOTOGRAPH #319

**DESTRUCTIVE INVESTIGATION
OPENINGS – MARK 3
1st Floor Below Window**

Water stains on studs

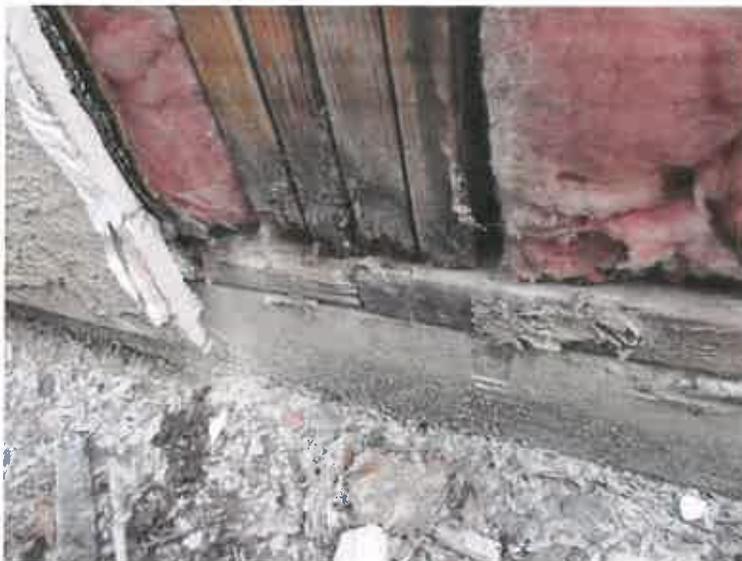
PHOTOGRAPH #320

**DESTRUCTIVE INVESTIGATION
OPENINGS – MARK 4
1st Floor Below Window**

Wood frame damage

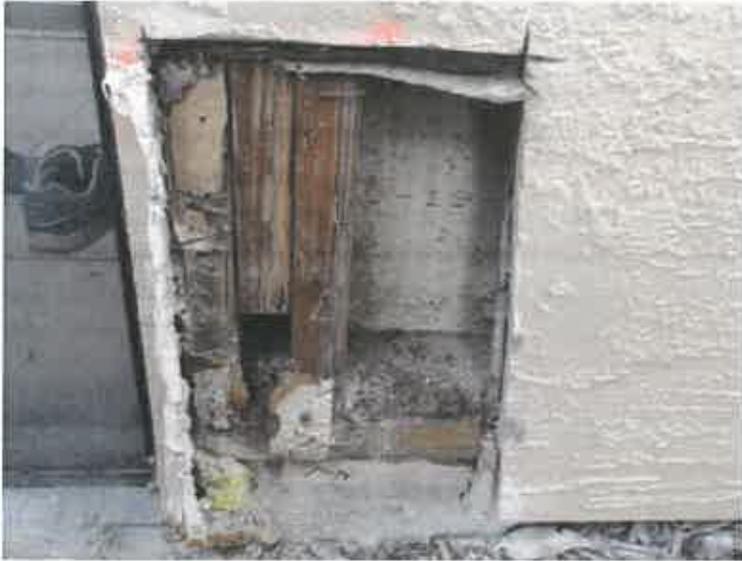
PHOTOGRAPH #321

**DESTRUCTIVE INVESTIGATION
OPENINGS – MARK 5
1st Floor Adjacent to Lanai**

Wood frame damage

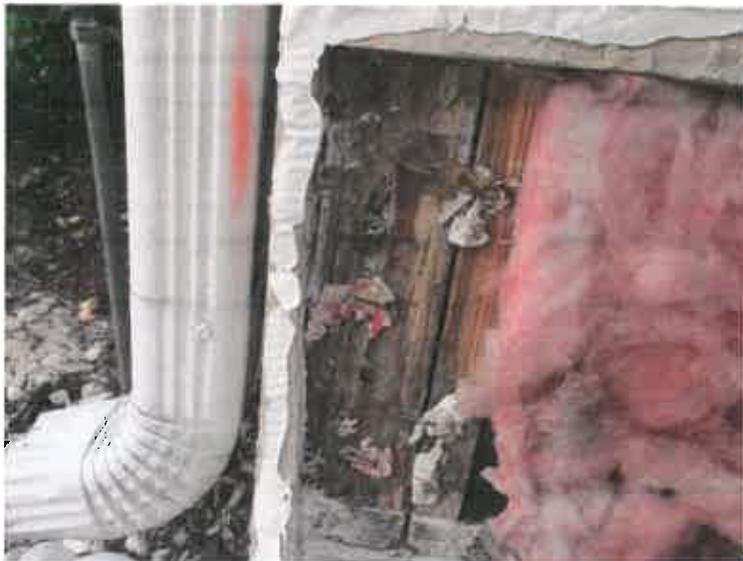
PHOTOGRAPH #322

**DESTRUCTIVE INVESTIGATION
OPENINGS – MARK 6
1st Floor Outside Corner**

Wood frame damage

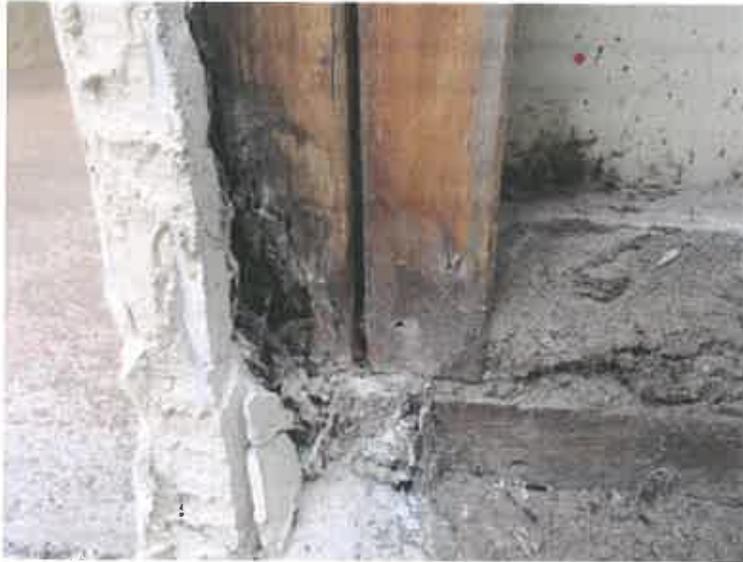
PHOTOGRAPH #323

**DESTRUCTIVE INVESTIGATION
OPENINGS – MARK 7
1st Floor Near Stair at Base**

Wood frame damage

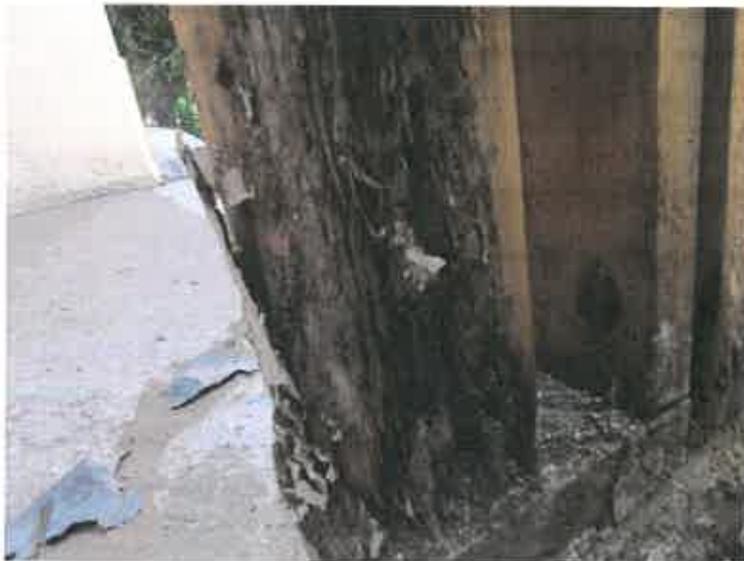
PHOTOGRAPH #324

**DESTRUCTIVE INVESTIGATION
OPENINGS – MARK 8
1st Floor Near Stair at Base**

Wood frame damage

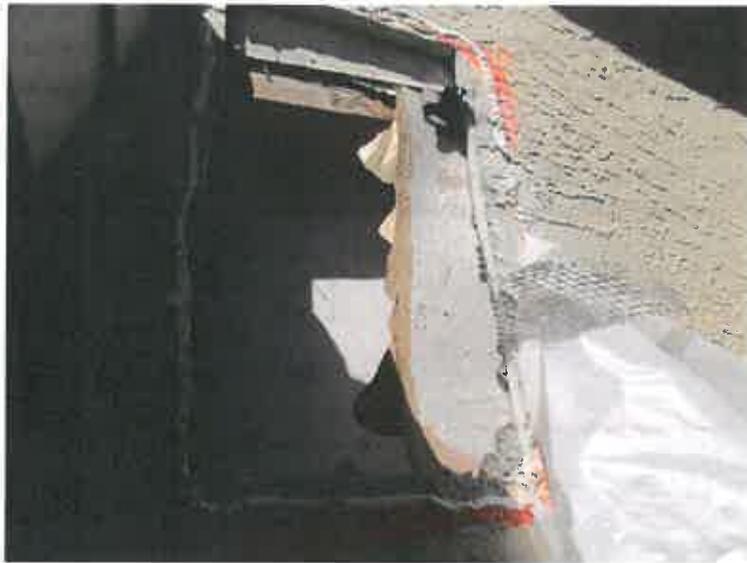
PHOTOGRAPH #325

**DESTRUCTIVE INVESTIGATION
OPENINGS – MARK 9
Roof to Wall Intersection**

No damage

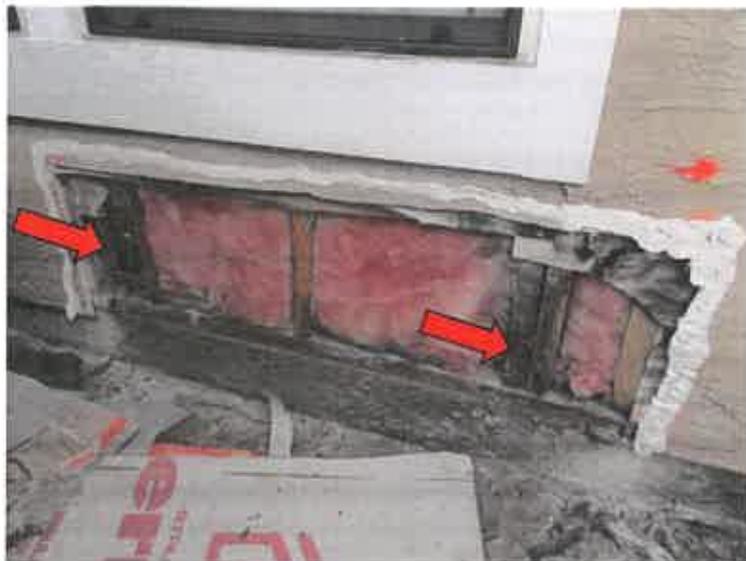
PHOTOGRAPH #326

**DESTRUCTIVE INVESTIGATION
OPENINGS – MARK 10
1st Floor Below Window**

Water stains on studs

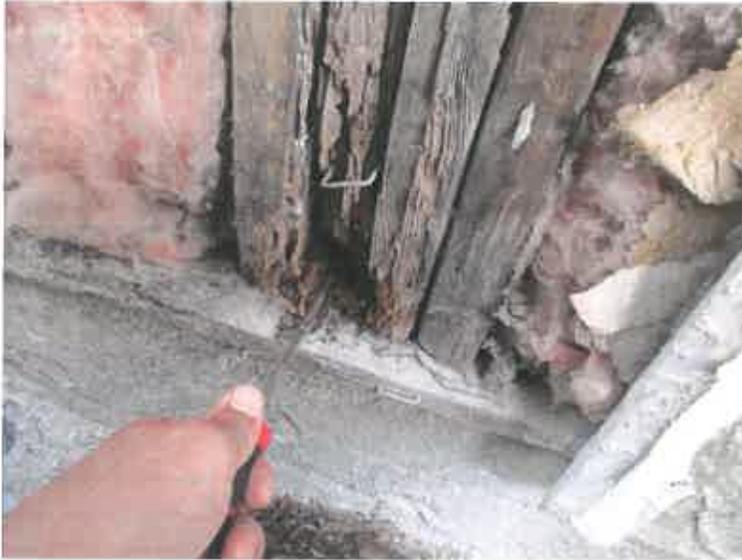
PHOTOGRAPH #327

**DESTRUCTIVE INVESTIGATION
OPENINGS – MARK 11
1st Floor Below Window**

Wood frame damage

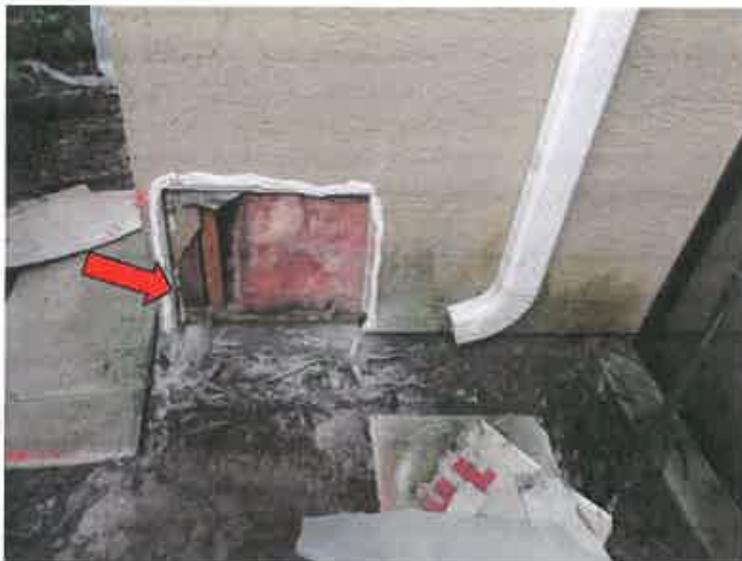
PHOTOGRAPH #328

**DESTRUCTIVE INVESTIGATION
OPENINGS – MARK 12
1st Floor Outside Corner**

Water stains on studs

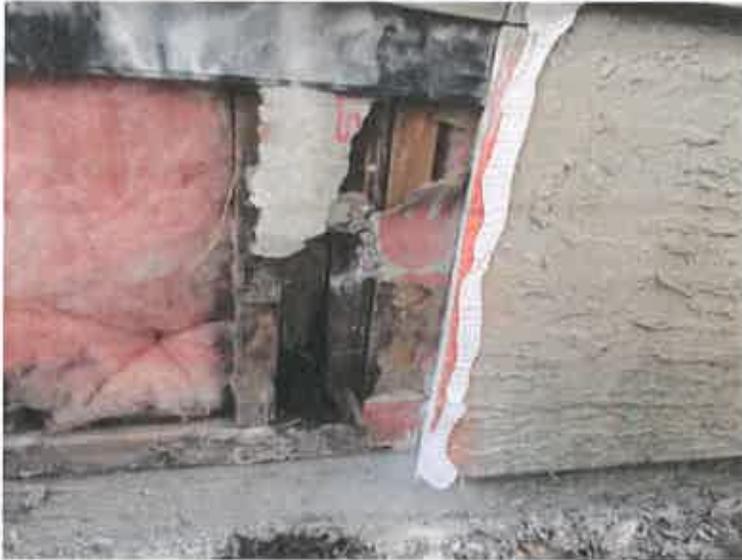
PHOTOGRAPH #329

**DESTRUCTIVE INVESTIGATION
OPENINGS – MARK 13
1st Floor Below Window**

Wood frame damage

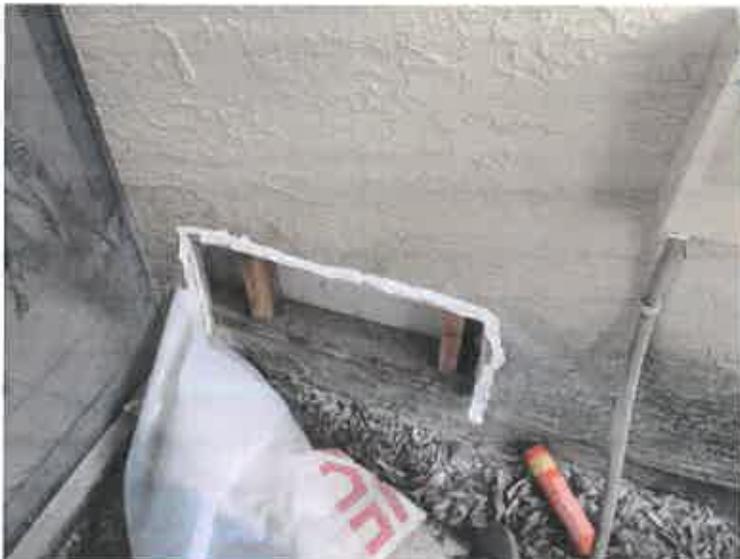
PHOTOGRAPH #330

**DESTRUCTIVE INVESTIGATION
OPENINGS – MARK 14
1st Floor Adjacent to Lanai**

No damage

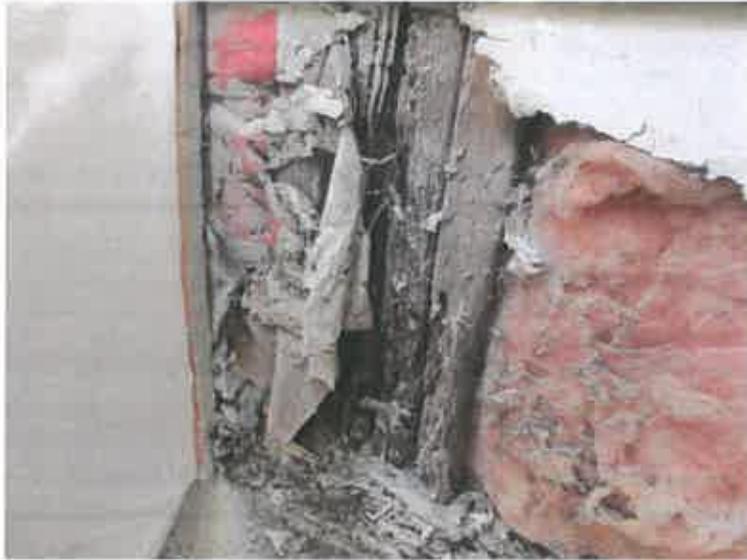
PHOTOGRAPH #331

**DESTRUCTIVE INVESTIGATION
OPENINGS – MARK 15
1st Floor Below Window**

Wood frame damage

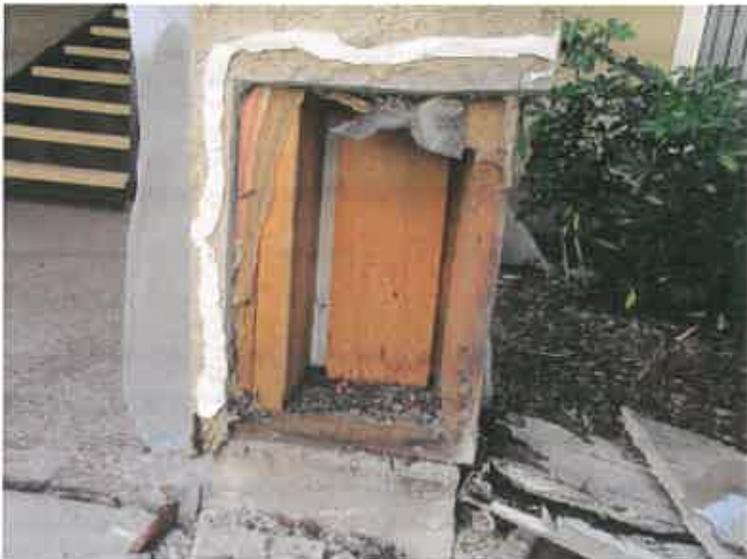
PHOTOGRAPH #332

**DESTRUCTIVE INVESTIGATION
OPENINGS – MARK 16
1st Floor Near Stair at Base**

No damage

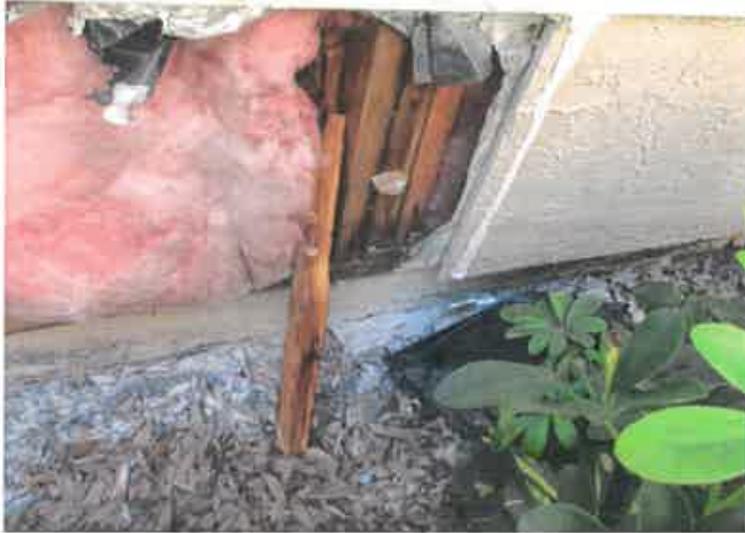
PHOTOGRAPH #333

**DESTRUCTIVE INVESTIGATION
OPENINGS – MARK 17
1st Floor Below Window**

Wood frame damage

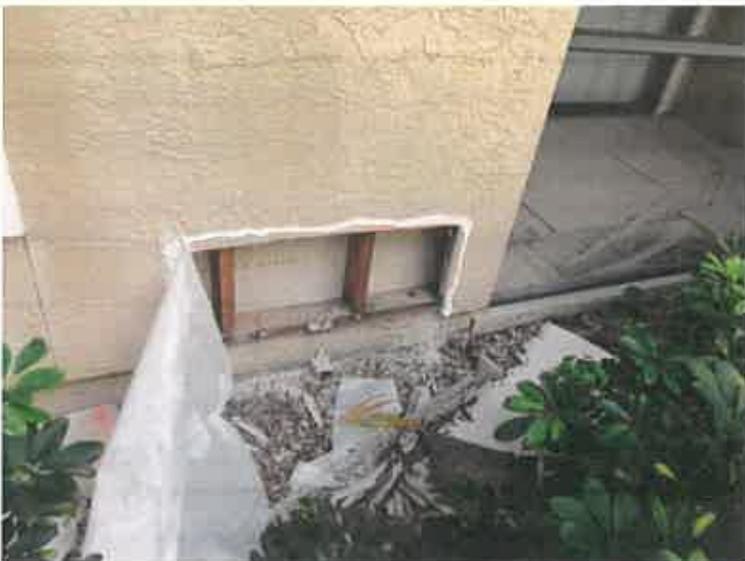
PHOTOGRAPH #334

**DESTRUCTIVE INVESTIGATION
OPENINGS – MARK 18
1st Floor Adjacent to Lanai**

No damage

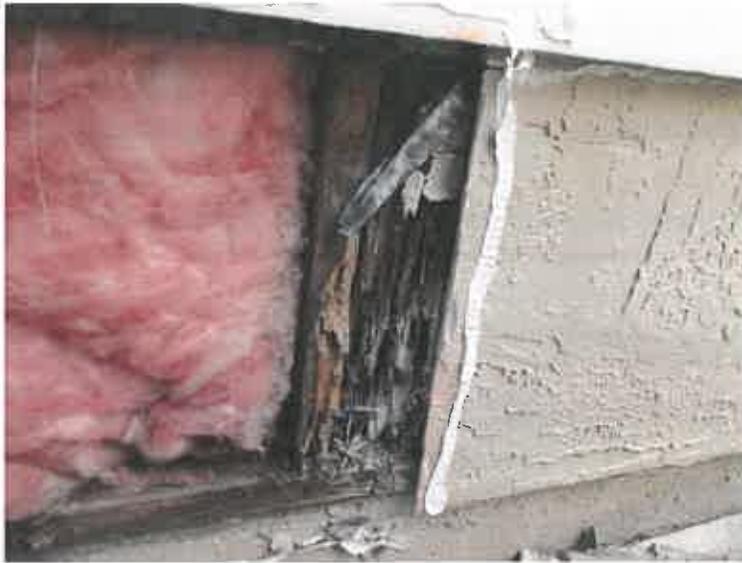
PHOTOGRAPH #335

**DESTRUCTIVE INVESTIGATION
OPENINGS – MARK 19
1st Floor Below Window**

Wood frame damage

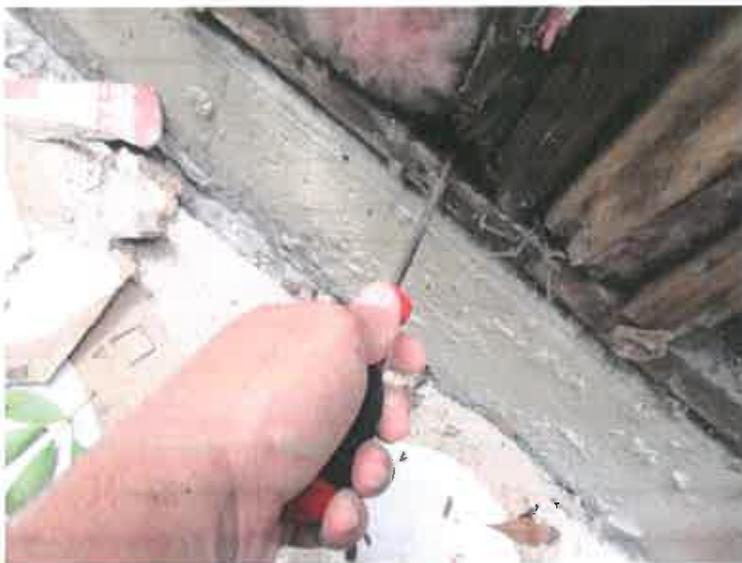
PHOTOGRAPH #336

**DESTRUCTIVE INVESTIGATION
OPENINGS – MARK 20
1st Floor Below Window**

Wood frame damage

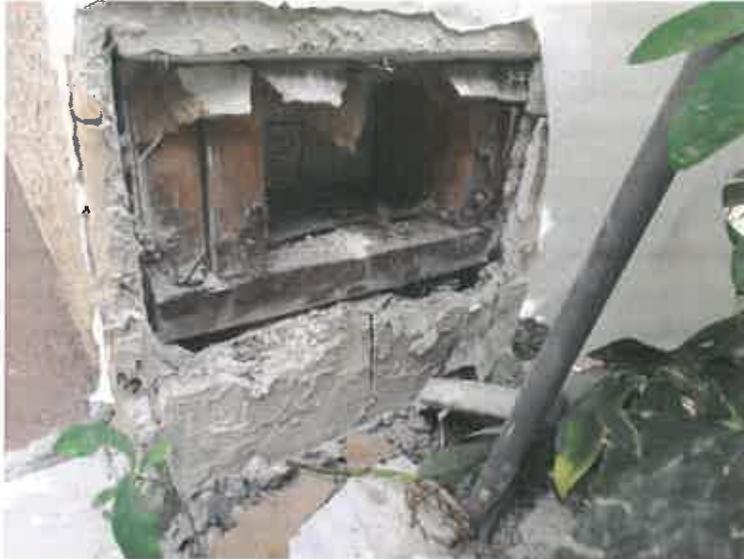
PHOTOGRAPH #337

**DESTRUCTIVE INVESTIGATION
OPENINGS – MARK 21
1st Floor Near Stair at Base**

No damage

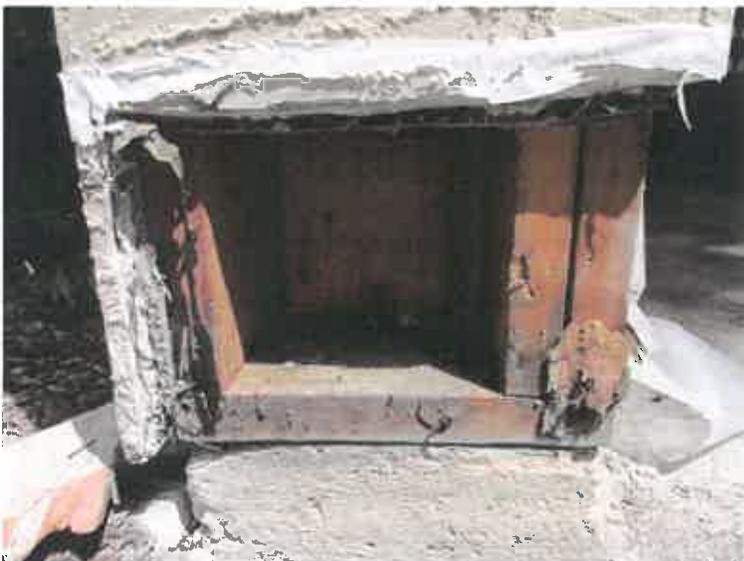
PHOTOGRAPH #338

**DESTRUCTIVE INVESTIGATION
OPENINGS – MARK 22
1st Floor Near Stair at Base**

No damage

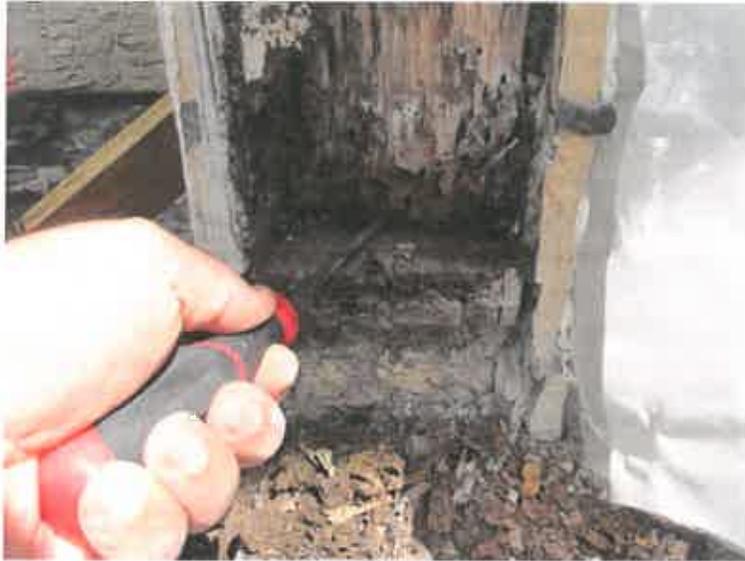
PHOTOGRAPH #339

**DESTRUCTIVE INVESTIGATION
OPENINGS – MARK 23
1st Floor Near Stair at Base**

Wood frame damage

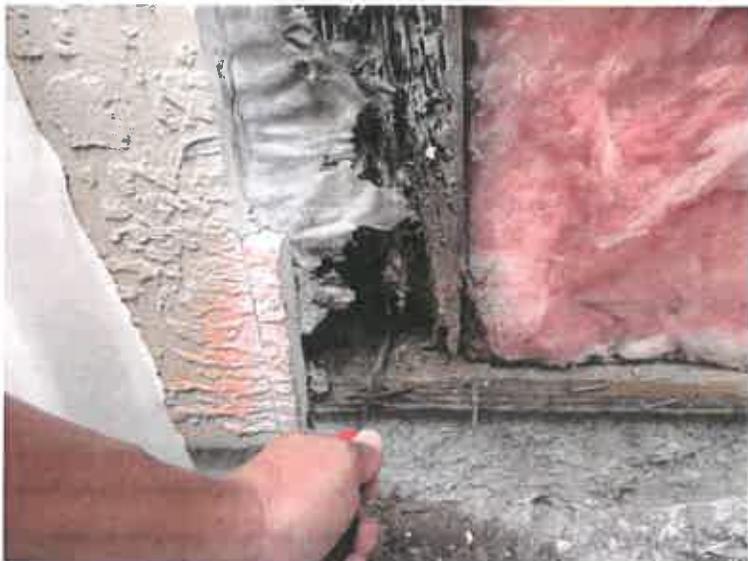
PHOTOGRAPH #340

**DESTRUCTIVE INVESTIGATION
OPENINGS – MARK 24
1st Floor Below Window**

Wood frame damage

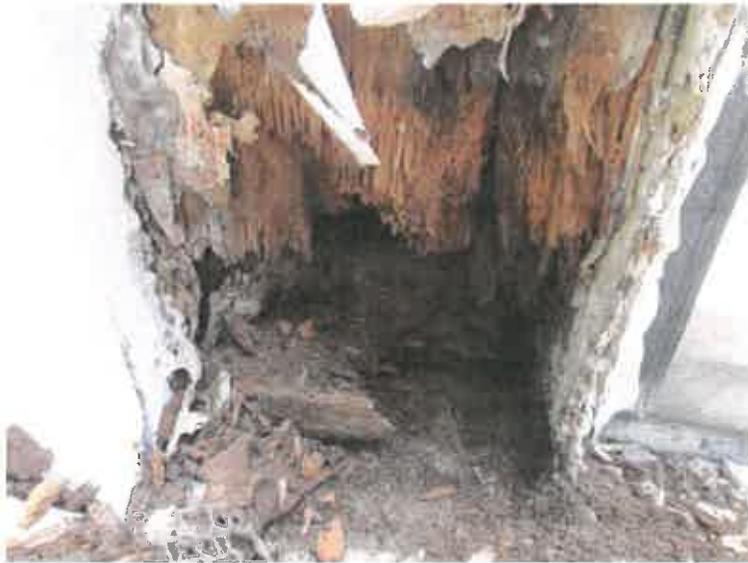
PHOTOGRAPH #341

**DESTRUCTIVE INVESTIGATION
OPENINGS – MARK 25
1st Floor Adjacent to Lanai**

Wood frame damage

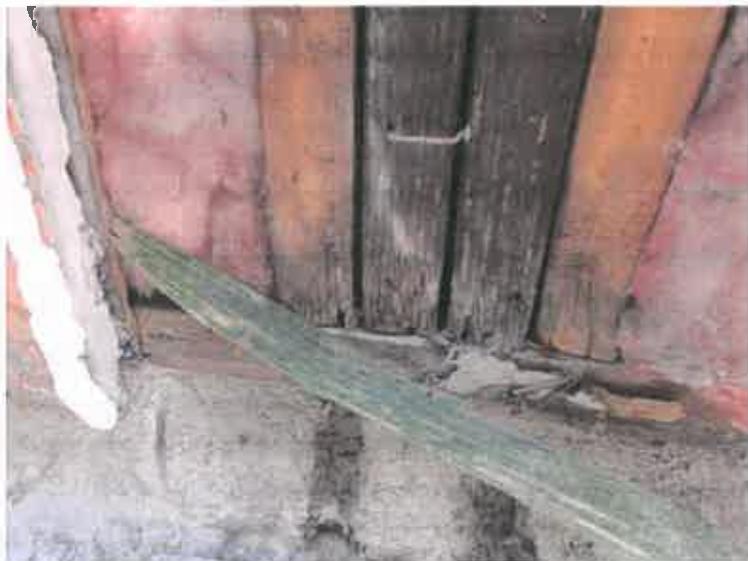
PHOTOGRAPH #342

**DESTRUCTIVE INVESTIGATION
OPENINGS – MARK 26
1st Floor Below Window**

Wood frame damage

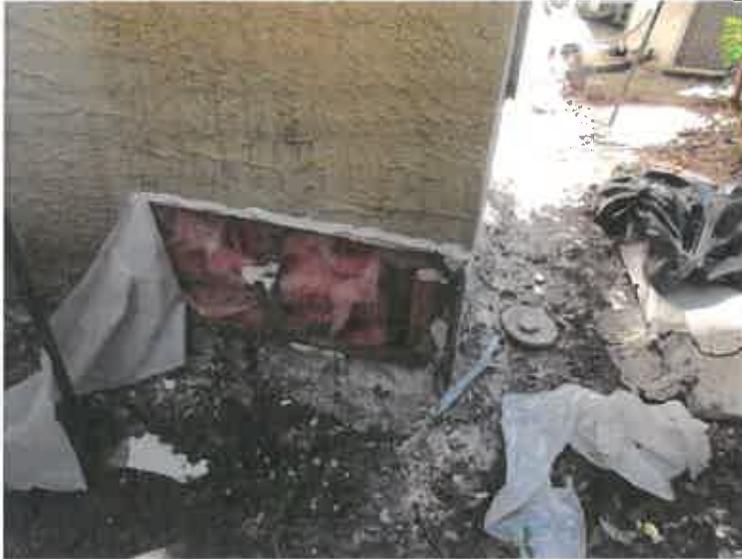
PHOTOGRAPH #343

**DESTRUCTIVE INVESTIGATION
OPENINGS – MARK 27
1st Floor at Outside Corner**

No damage

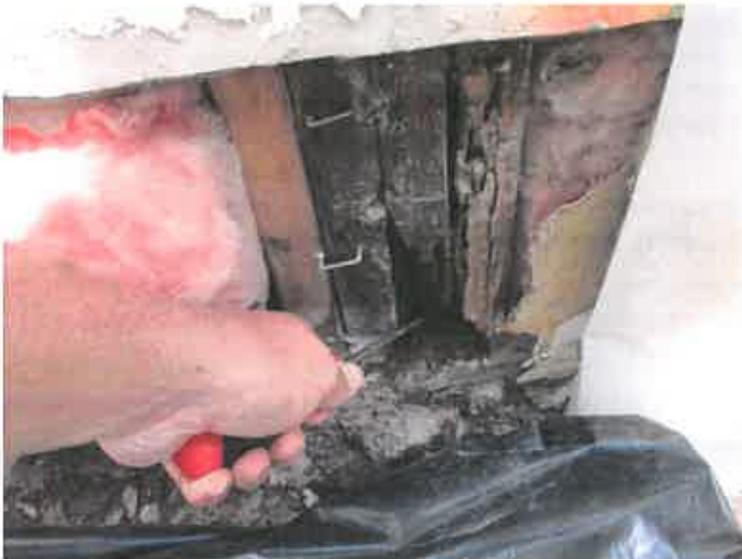
PHOTOGRAPH #344

**DESTRUCTIVE INVESTIGATION
OPENINGS – MARK 28
1st Floor Below Window**

Wood frame damage

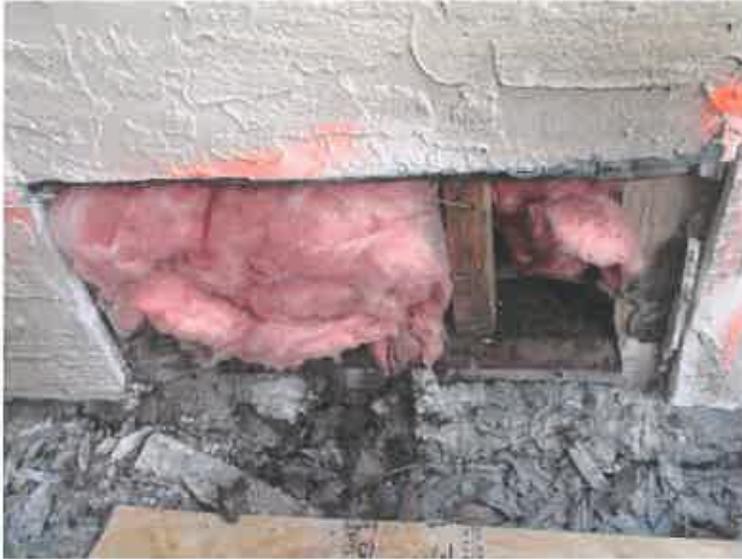
PHOTOGRAPH #345

**DESTRUCTIVE INVESTIGATION
OPENINGS – MARK 29
1st Floor Inside Corner**

No damage

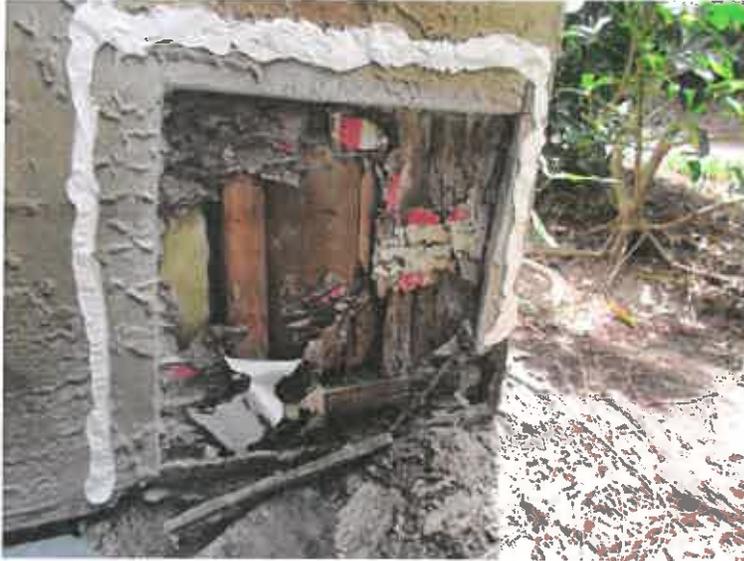
PHOTOGRAPH #346

**DESTRUCTIVE INVESTIGATION
OPENINGS – MARK 1
1st Floor Outside Corner**

Wood frame damage
