SUPPLEMENTAL DESTRUCTIVE INVESTIGATION

**Vintage Grand Condominium
4012 Crockers Lake Blvd.
Sarasota, FL 34238**

Project No. R1606-231

October 28, 2016

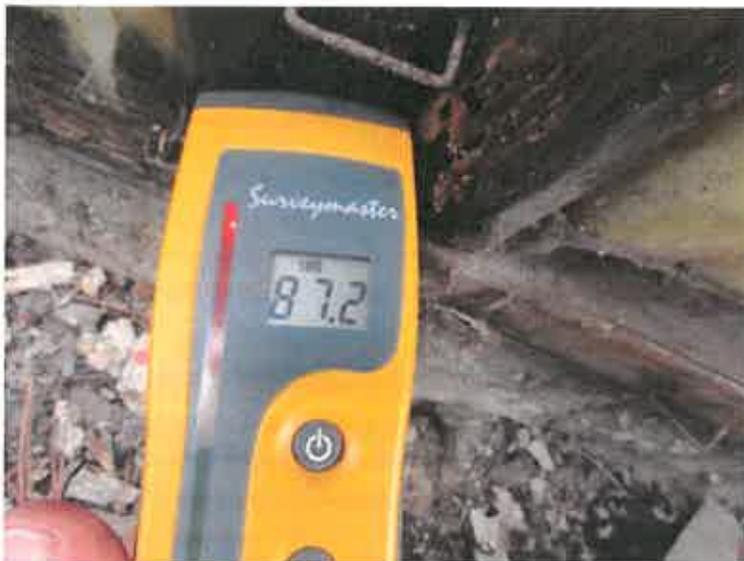
PHOTOGRAPH #347

**DESTRUCTIVE INVESTIGATION
OPENINGS – MARK 2
1st Floor Below Window**

Wood frame damage, high moisture

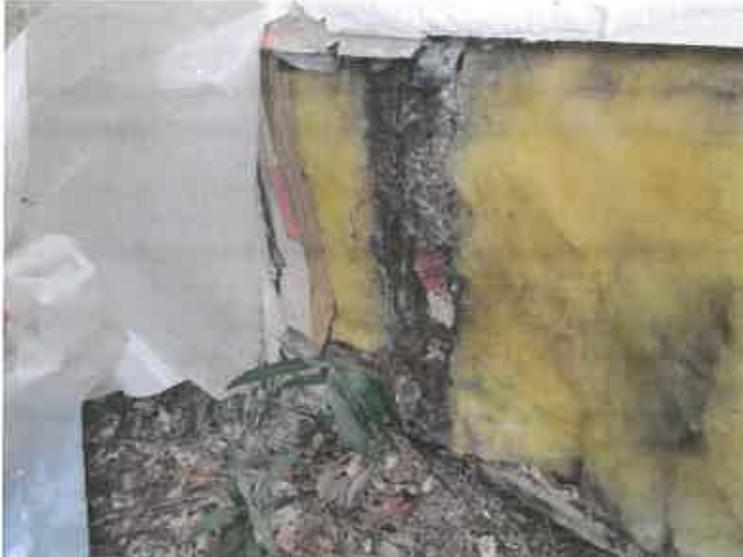
PHOTOGRAPH #348

**DESTRUCTIVE INVESTIGATION
OPENINGS – MARK 3
1st Floor Below Window**

Wood frame damage

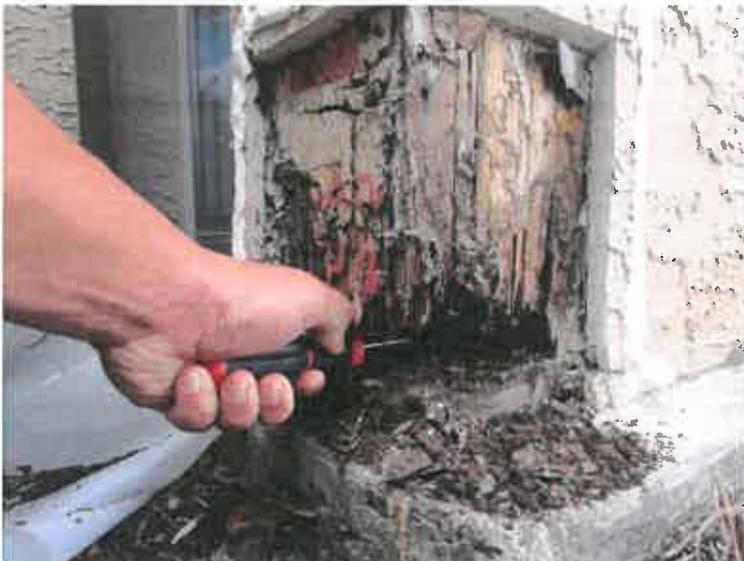
PHOTOGRAPH #349

**DESTRUCTIVE INVESTIGATION
OPENINGS – MARK 4
1st Floor Adjacent to Lanai**

Wood frame damage

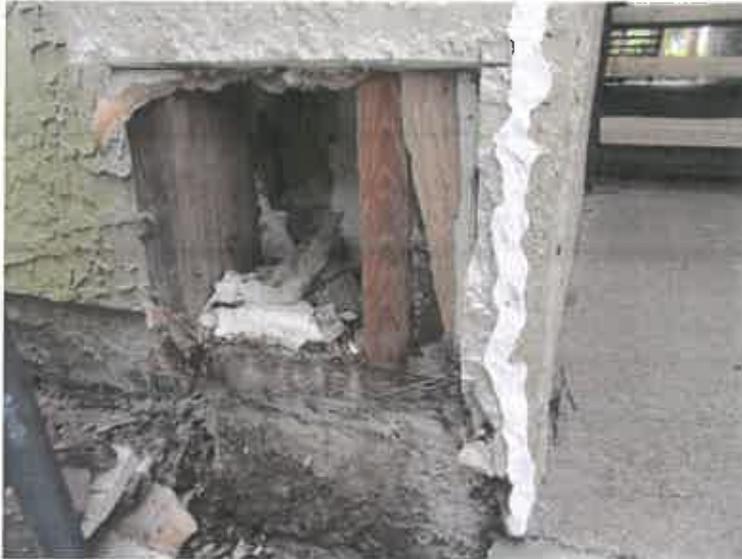
PHOTOGRAPH #350

**DESTRUCTIVE INVESTIGATION
OPENINGS – MARK 5
1st Floor Near Stair at Base**

No damage

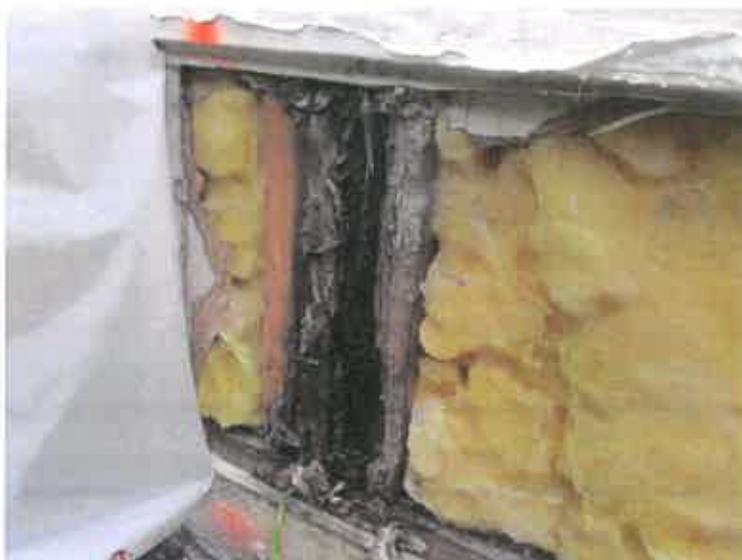
PHOTOGRAPH #351

**DESTRUCTIVE INVESTIGATION
OPENINGS – MARK 6
1st Floor Below Window**

Wood frame damage

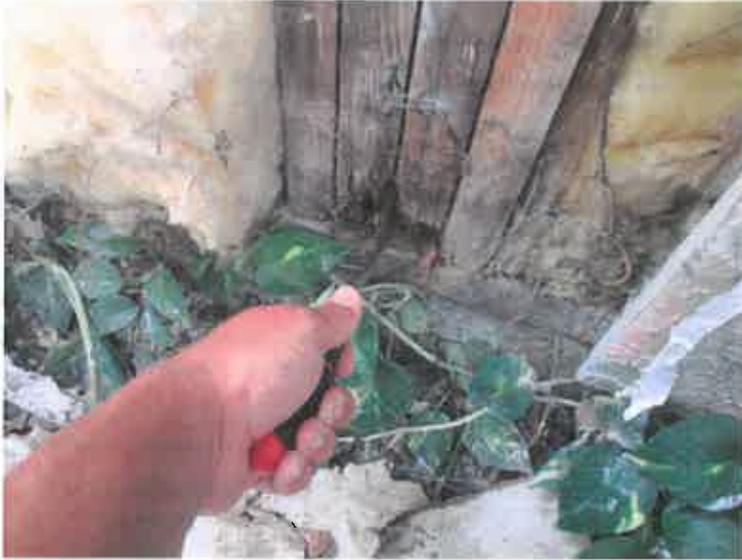
PHOTOGRAPH #352

**DESTRUCTIVE INVESTIGATION
OPENINGS – MARK 7
1st Floor Below Window**

Wood frame damage

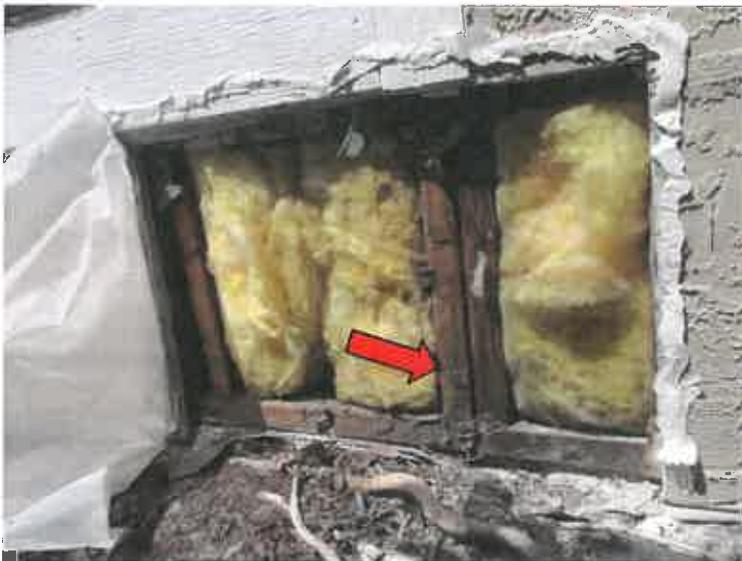
PHOTOGRAPH #353

**DESTRUCTIVE INVESTIGATION
OPENINGS – MARK 8
1st Floor Below Window**

Water stains on studs

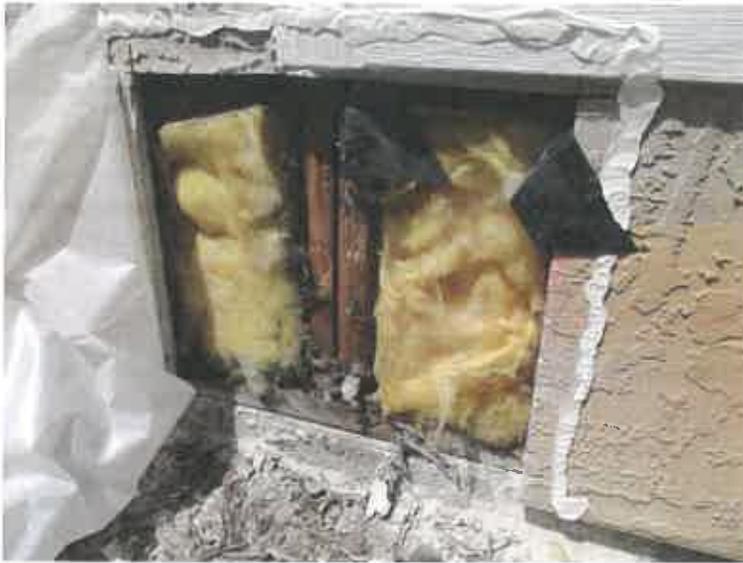
PHOTOGRAPH #354

**DESTRUCTIVE INVESTIGATION
OPENINGS – MARK 9
1st Floor Below Window**

No damage

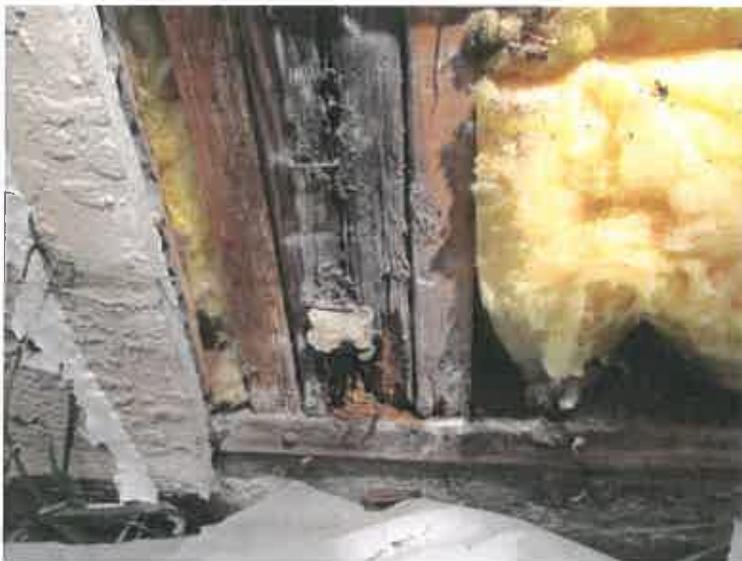
PHOTOGRAPH #355

**DESTRUCTIVE INVESTIGATION
OPENINGS – MARK 10
1st Floor Below Window**

Wood frame damage

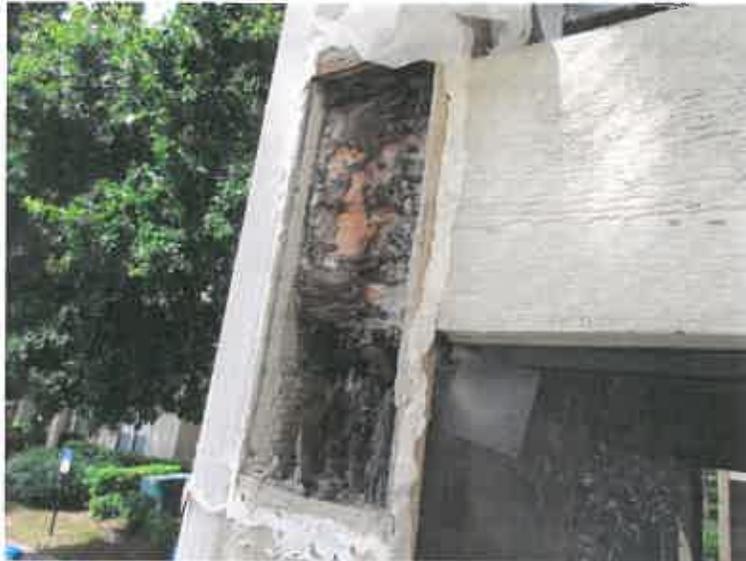
PHOTOGRAPH #356

**DESTRUCTIVE INVESTIGATION
OPENINGS – MARK 11
2nd Floor Adjacent to Balcony**

Wood frame damage

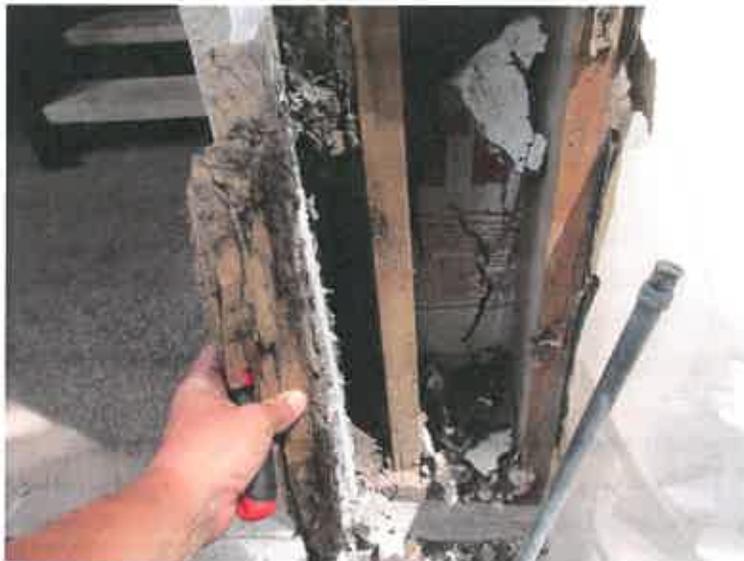
PHOTOGRAPH #357

**DESTRUCTIVE INVESTIGATION
OPENINGS – MARK 12
1st Floor Near Stair at Base**

Wood frame damage

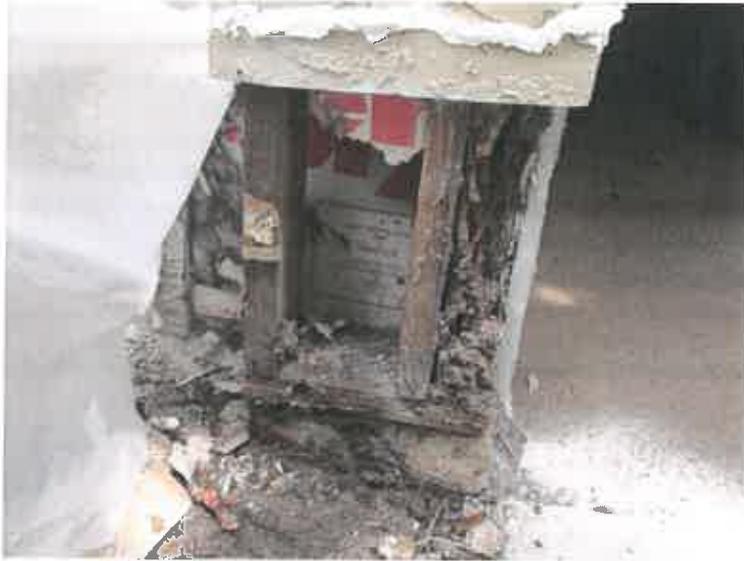
PHOTOGRAPH #358

**DESTRUCTIVE INVESTIGATION
OPENINGS – MARK 13
1st Floor Near Stair at Base**

Wood frame damage
