**Vintage Grand Condominium Association  
Hurricane Irma  
Damage Assessment**

ESi Project #: 78360G

# Investigative Report

## Vintage Grand Condominium Association Hurricane Irma Damage Assessment

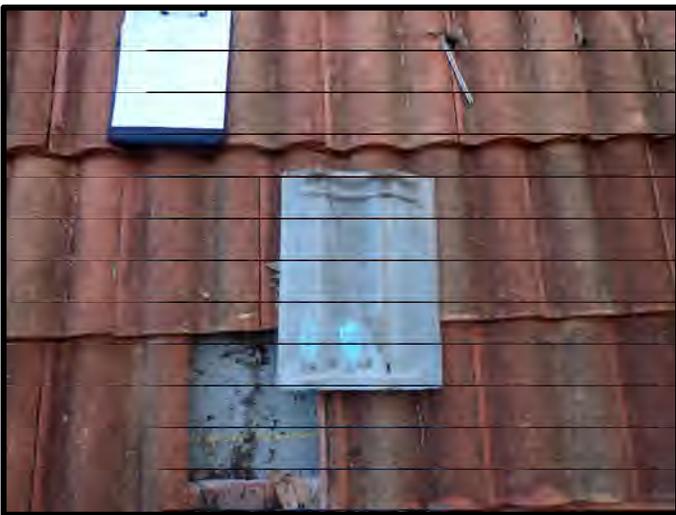
Some of the roof tiles were loose, and many of these were slightly displaced from having slid down the slope of the roof several inches. The loose tiles had no surrounding evidence of uplift from wind, nor was there any direct physical evidence of wind related damage. Had these conditions been caused by wind pressures, a significant portion of these tiles would have been displaced from the roof entirely. The loose and slipped tiles are more indicative of inadequate fastening of the tile to the roof substrate during the original installation of the tile.

Photograph 3 – Loose Monier T210A tile.

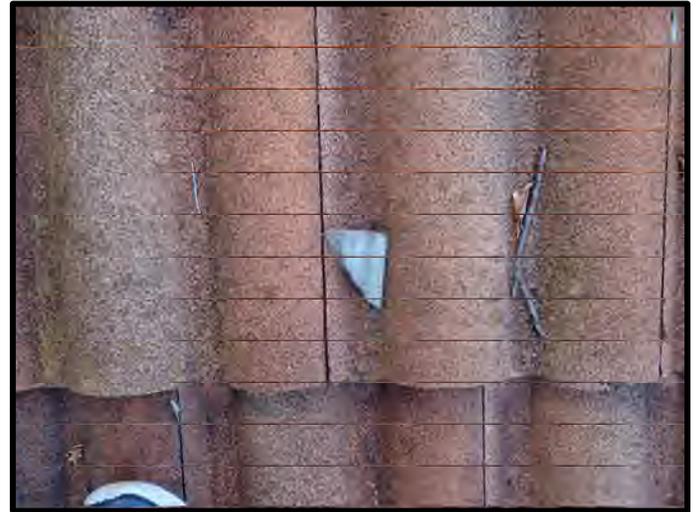
Chipped tile corners, slivered chips, depression cracks, corner cracks, and broken or cracked tiles were observed to varying degrees on the various roof facets of all buildings inspected by ESi, not just on the windward or leeward slopes. Some of the observed cracked, chipped, and broken tile and tile corners had mildewed and weathered edges or had been previously repaired. This indicates that they had been broken for some time and did not occur as a result of Hurricane Irma. In some locations where the corners of the tiles had cracked, the chipped corners were observed lying near the tile from which it had separated. In many instances the cracked tile corner piece was fractions of an inch from the rest of the roof tile. If the fractures occurred due to sufficiently high wind forces, it would be reasonable and expected that the small chipped corners would have been displaced from the roof surface, rather than located within a short distance from its origin. Reference **Figure 9**.

Photograph 6 – Chipped corner of tile still in place on the roof surface near the original tile.

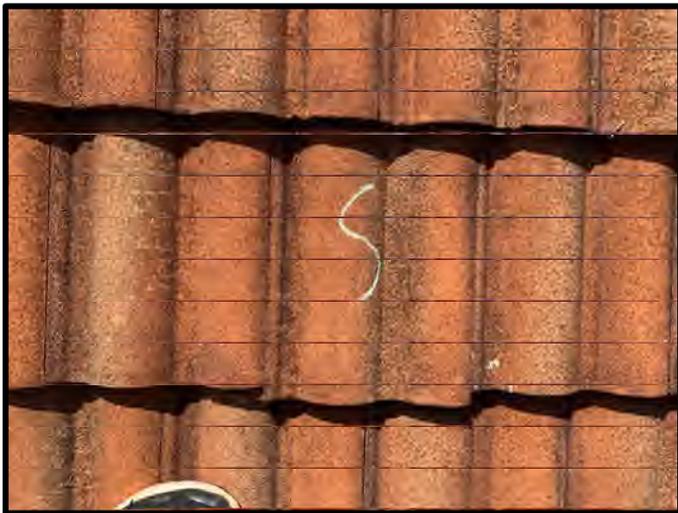
Photograph 7 – Slipped concrete roof tile.

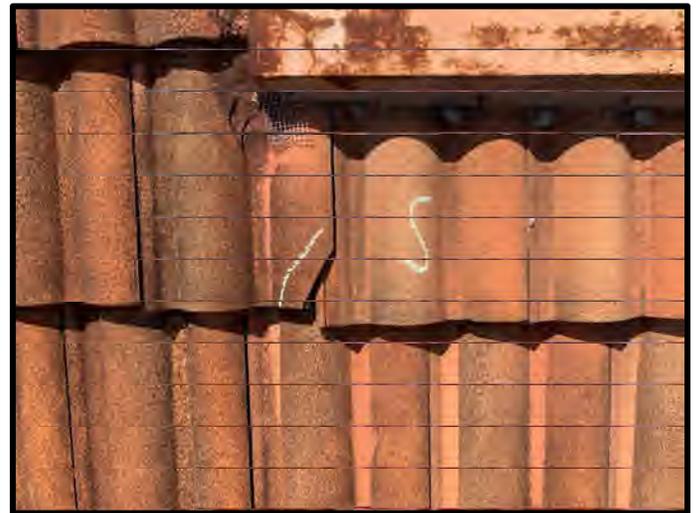
Photograph 8 – Concrete roof tile with corner chip adjacent to slipped tile at roof vent.

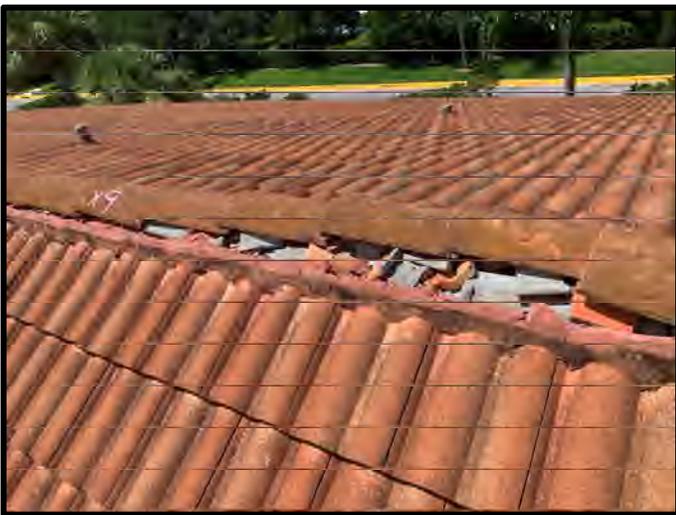
Photograph 3 – Loose ridge cap tiles.

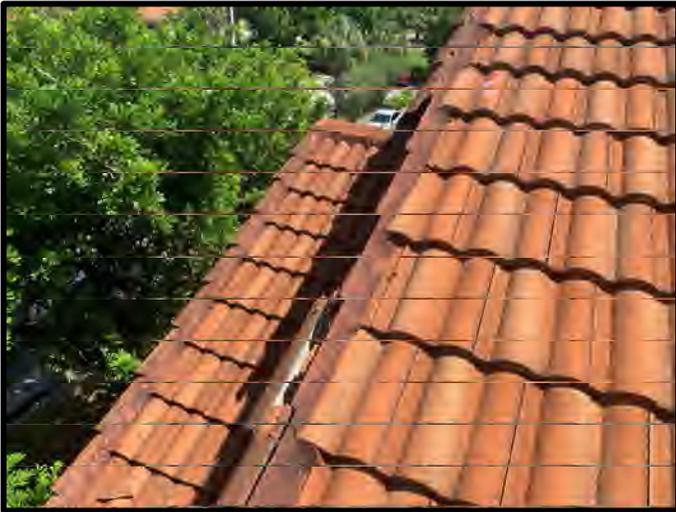
Twelve rake tiles were missing on Slope F of Building 2. The missing rake tiles may have reasonably attributed to wind damage, as they were completely removed from the roof.

Photograph 5 – Displaced rake tiles.

3. ESi's opinion of the wind-related damage from Hurricane Irma is quantified in *Appendix B*. To summarize, the following possible wind-related repairs are recommended:
  - Replace 13 LF of missing rake tile at Slope F of Building 2.
4. With the exception noted above, the majority of the observed damage to the roof coverings was indicative of footfall and/or expansion and contraction due to changes in temperature, or inadequate tile fastening during original installation. These conditions are not associated with wind from the hurricane.
5. The recommended repairs may be performed in like kind and quality as the existing roof coverings. Building code upgrades are not required in order to facilitate the necessary roof repairs.

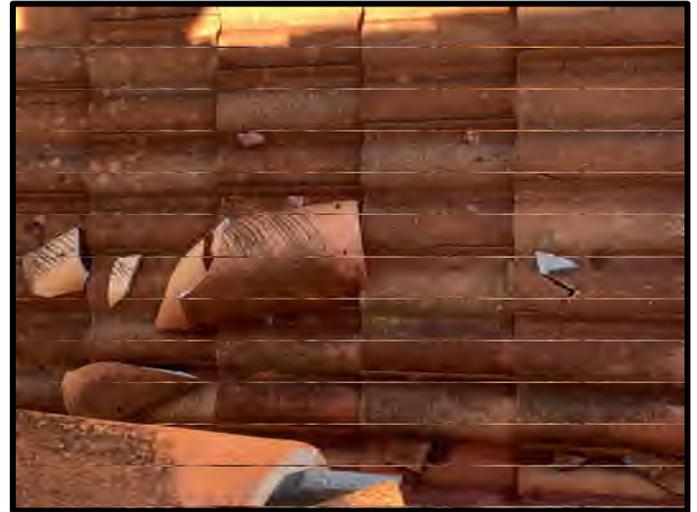
Photograph 6 – Some of the displaced rake tiles had fallen onto the lower roof slope below.

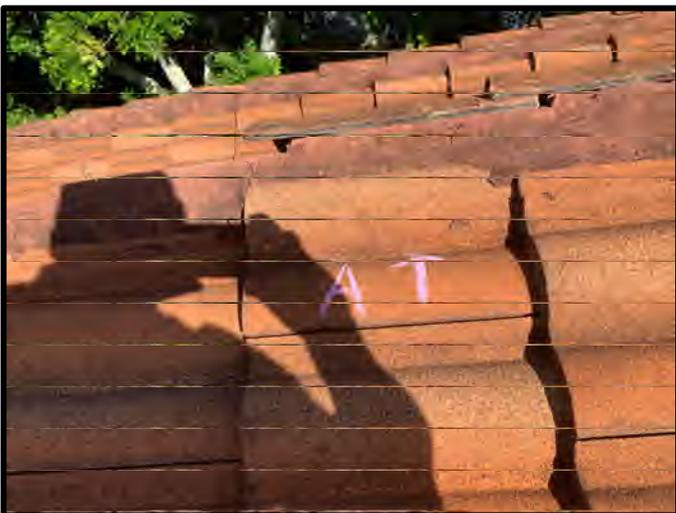
Photograph 7 – Loose rake tiles.

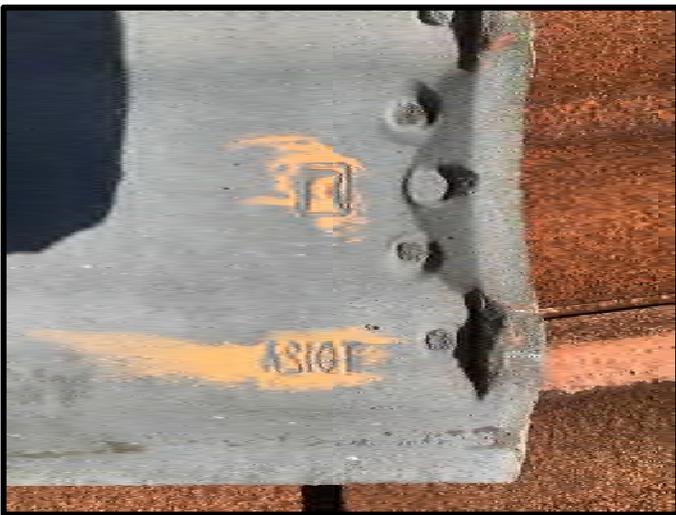
Photograph 3 – Loose Monier T210A concrete roof tile.

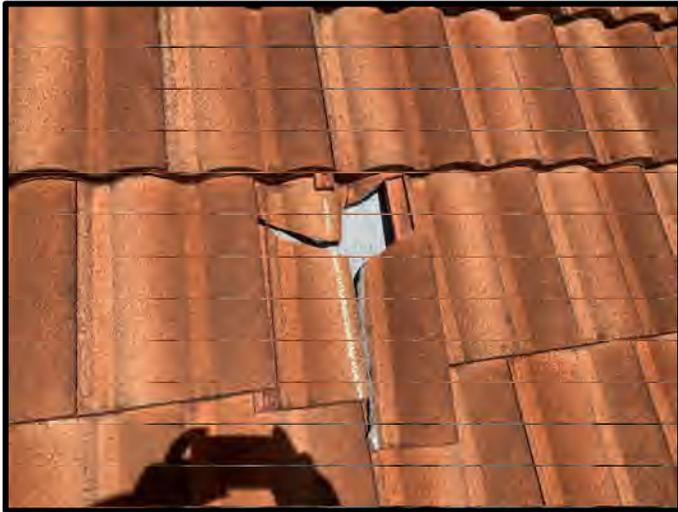
Photograph 5 – Cracked concrete roof tile.

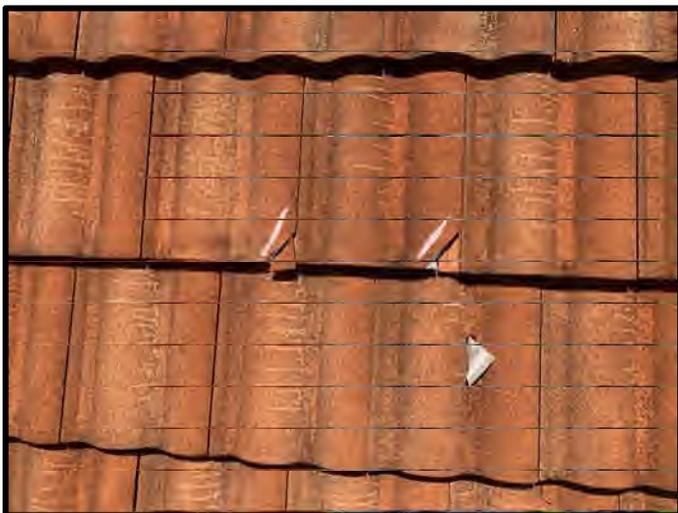
Photograph 7 – Concrete roof tiles with corner chips. Note the chipped corners are still in place on the roof surface.

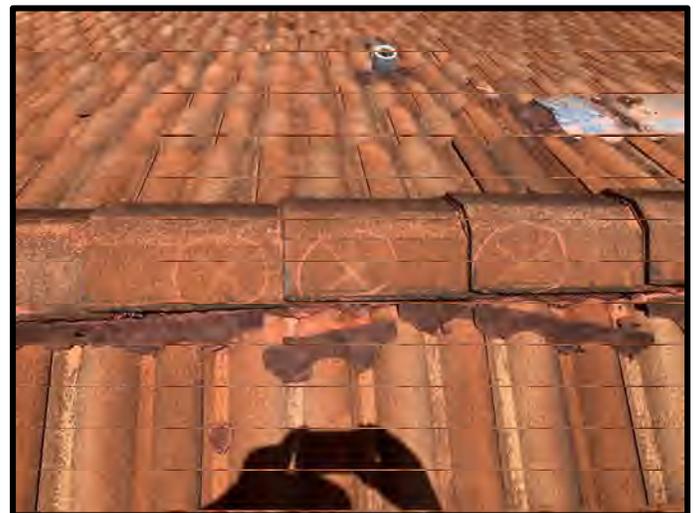
Photograph 8 – Unbonded ridge cap tiles marked thus 'X'.

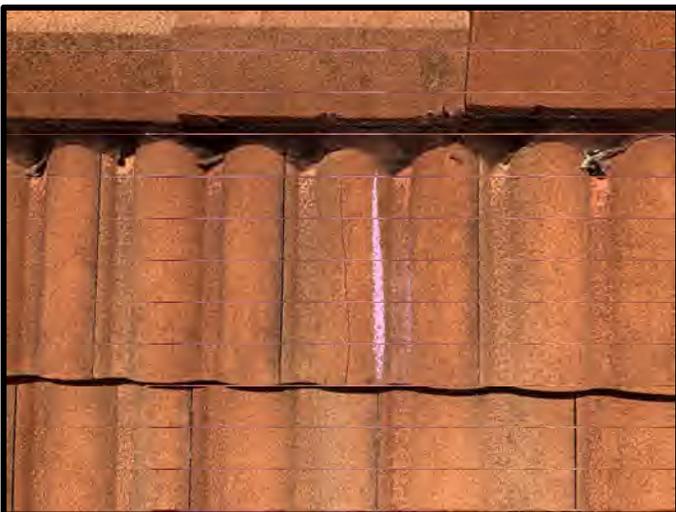
Photograph 3 – Loose Monier T210A concrete roof tile.

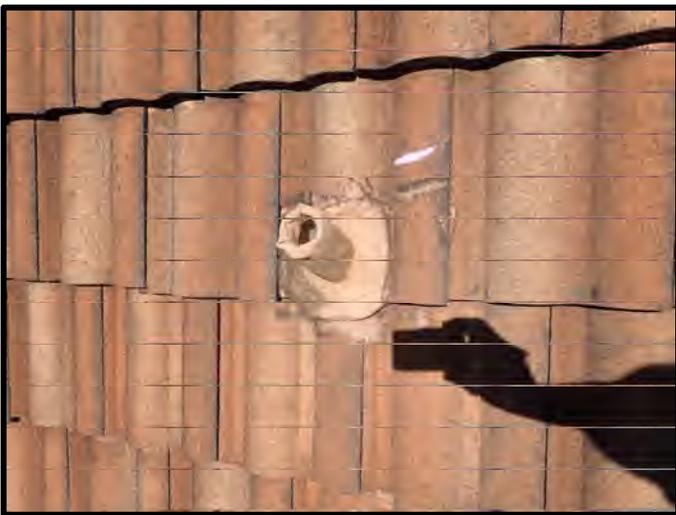
Photograph 3 – Cracked concrete roof tile at roof vent.

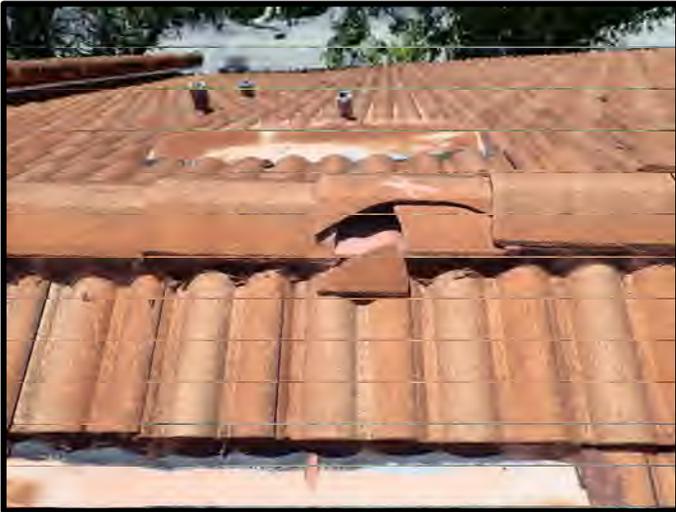
Photograph 5 – Cracked ridge cap tile.

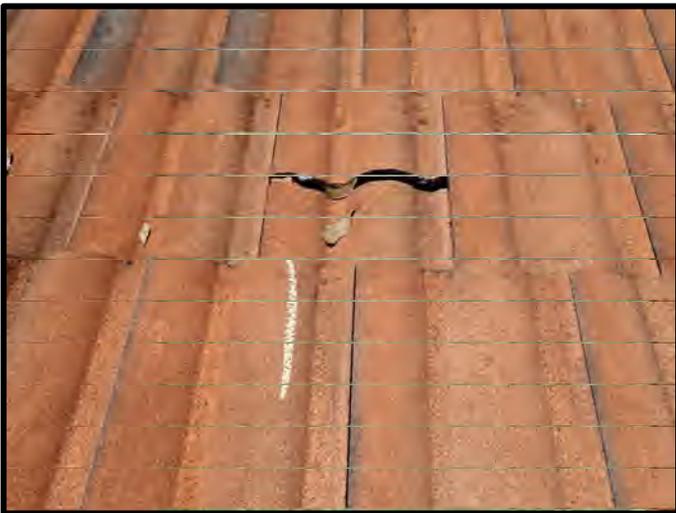
Photograph 7 – Cracked concrete roof tile.

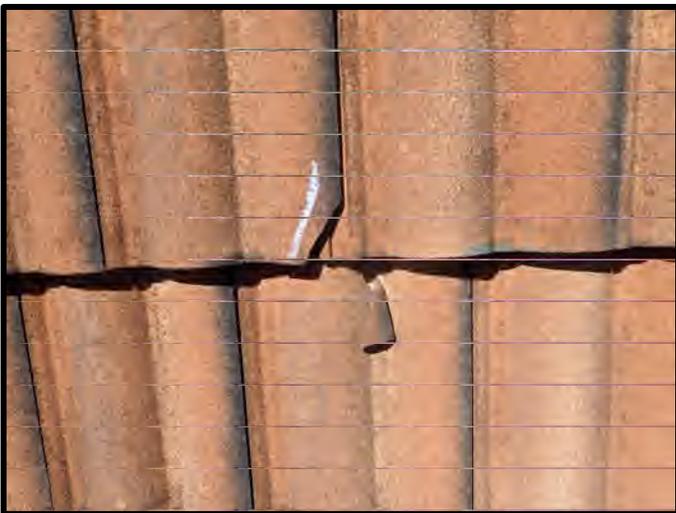
Photograph 3 – Concrete roof tile with chipped corner still in place.

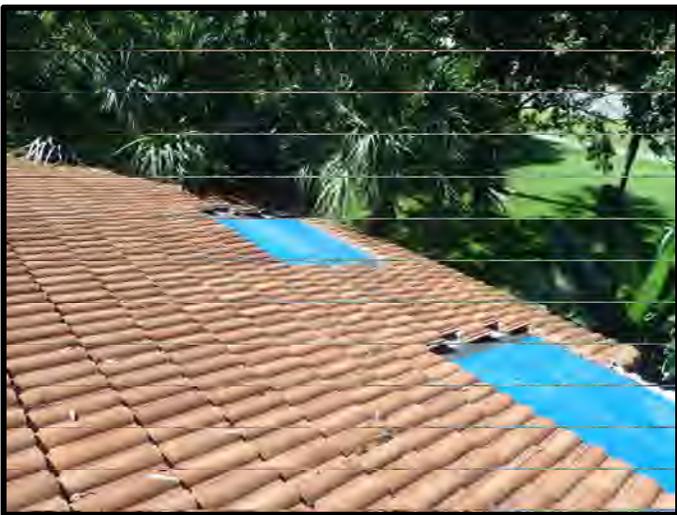
Photograph 3 – Two sections of roof covered with blue tarp labeled "Bad Wood."

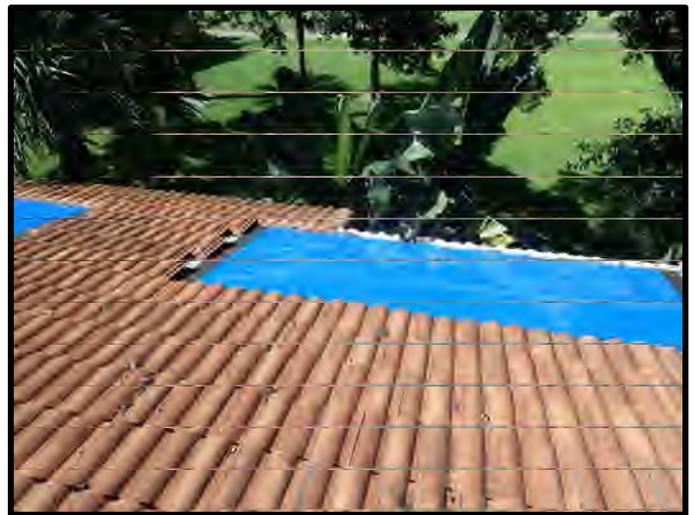
Photograph 4 – Section of roof covered with blue tarp labeled "Bad Wood."

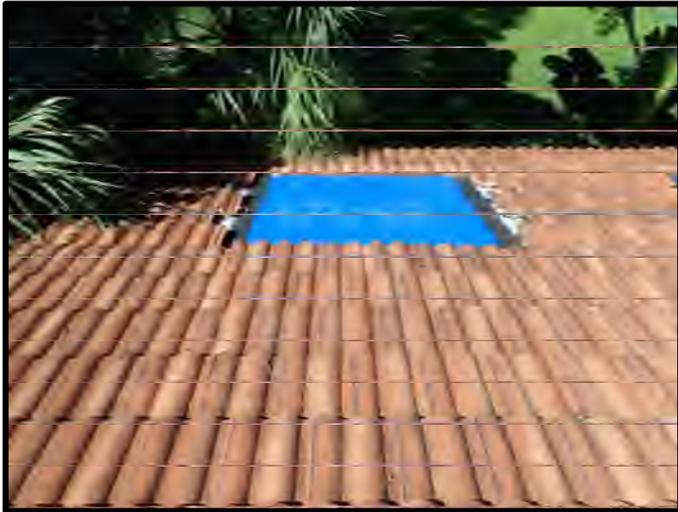
Photograph 5 – Section of roof covered with blue tarp labeled “Bad Wood.”

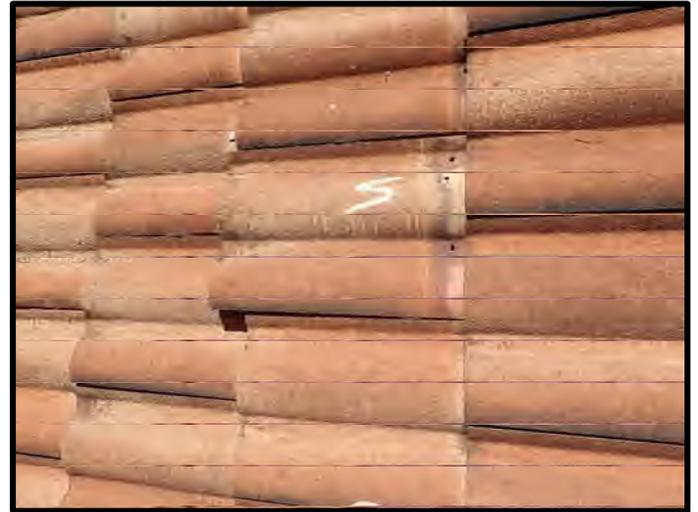
Photograph 6 – Slipped concrete roof tile.

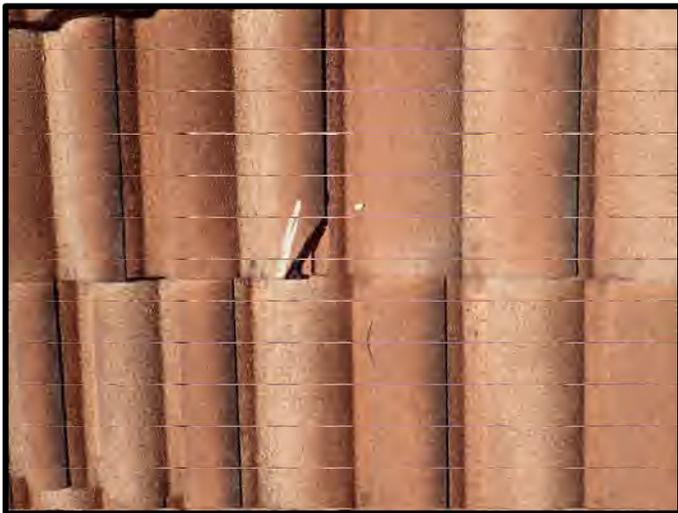
Photograph 7 – Concrete roof tile with chipped corner.

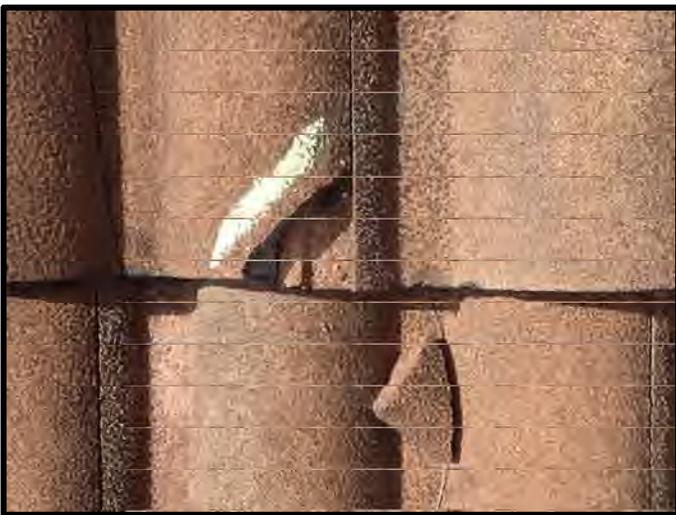
Photograph 3 – Concrete roof tile with chipped corner.

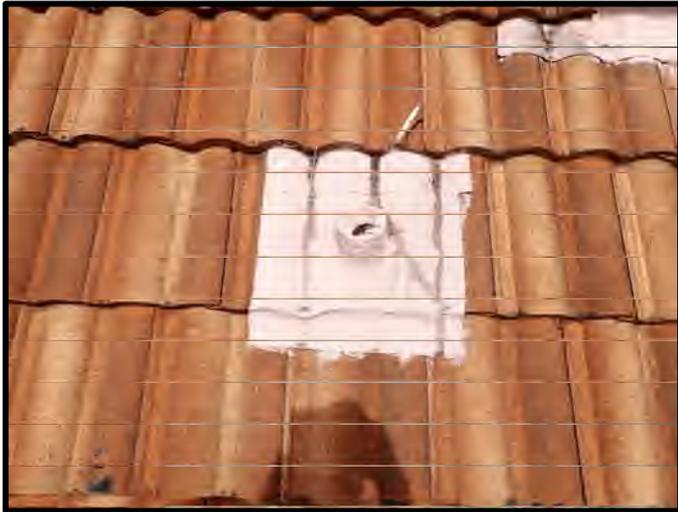
Photograph 5 – Previously repaired concrete roof tile at roof vent.

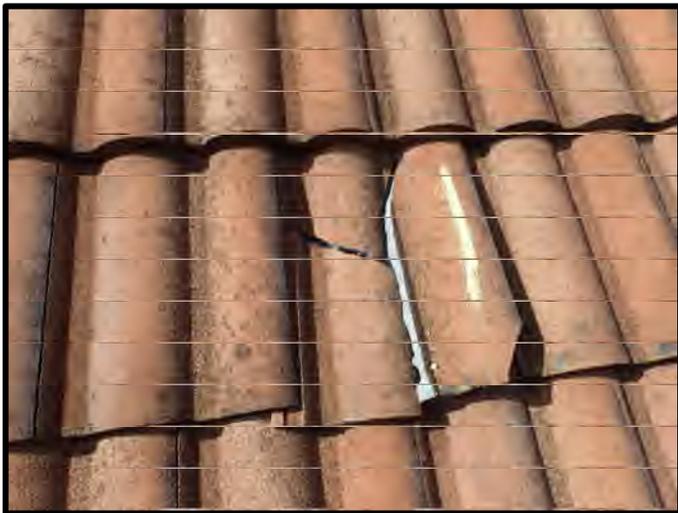
Photograph 7 – Cracked concrete roof tile with previous sealant repair.

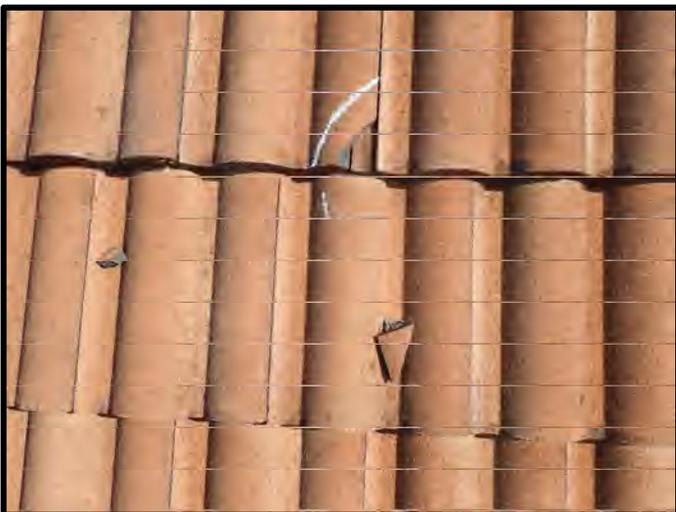
Photograph 3 – Concrete roof tile with chipped corner still in place on roof surface.

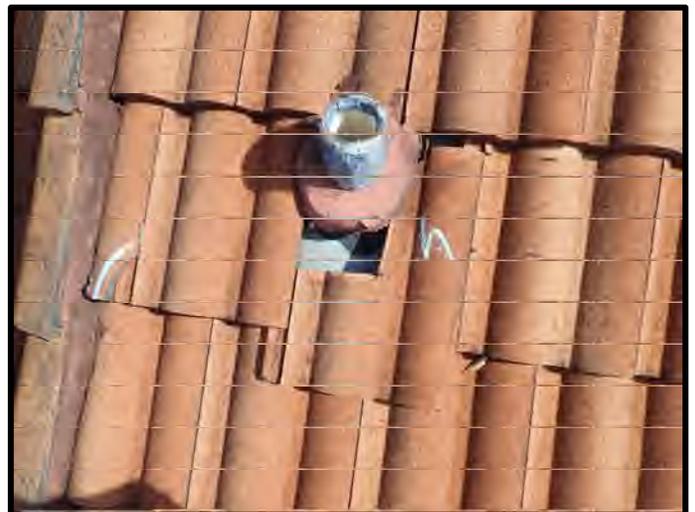
Photograph 4 – Slipped concrete roof tile at roof vent.

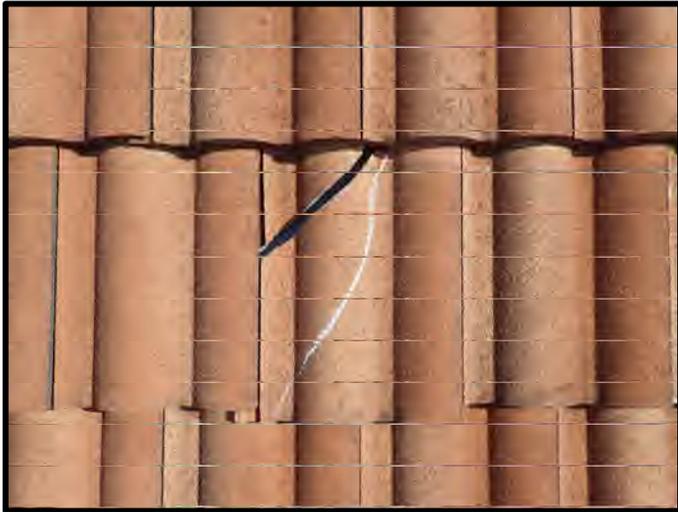
Photograph 5 – Cracked concrete roof tile.

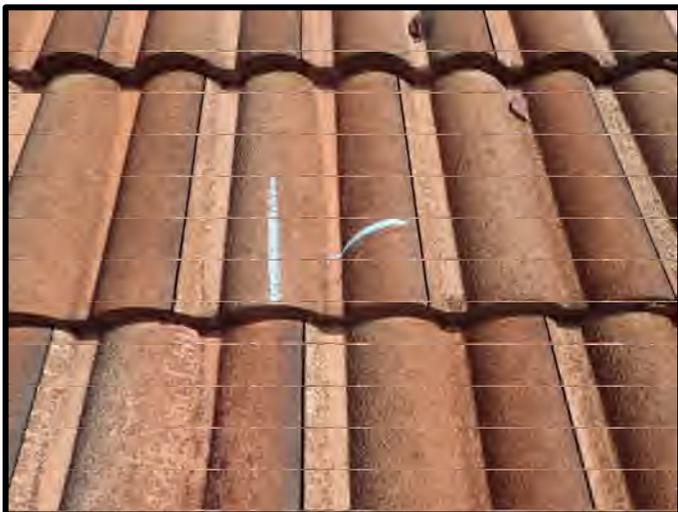
Photograph 7 – Hairline longitudinal crack and right corner crack in concrete roof tile.

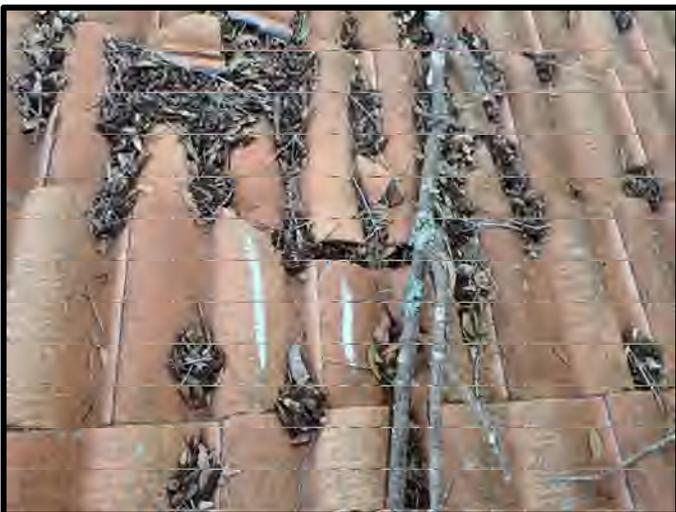
Photograph 3 – Broken concrete roof tiles under tree.

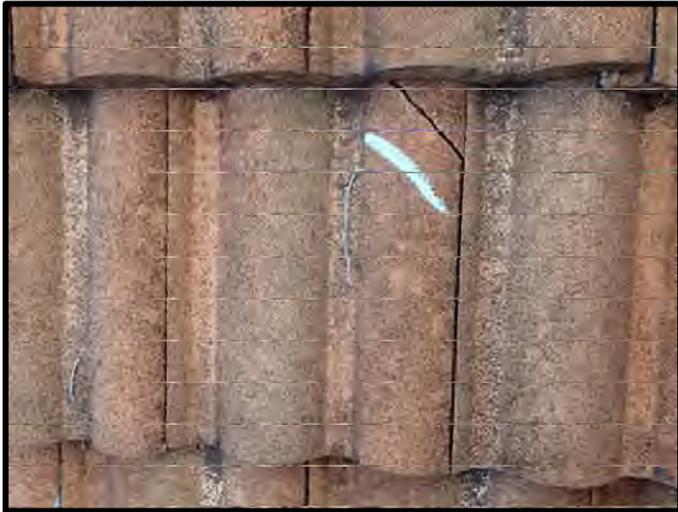
Photograph 5 – Concrete roof tile with corner crack.

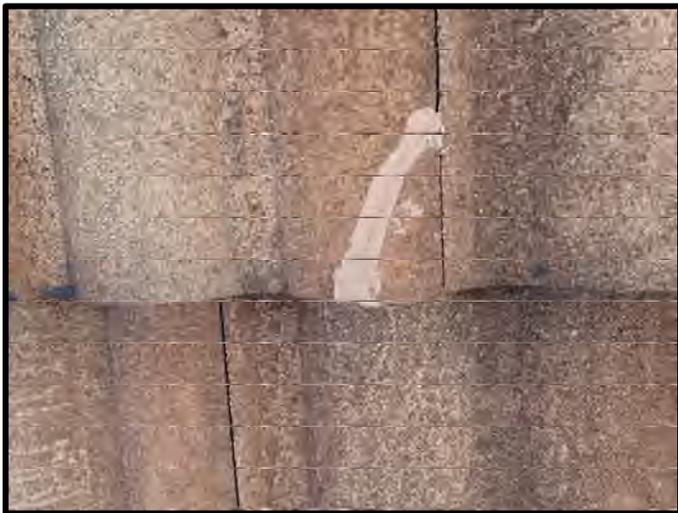
Photograph 7 – Previously repaired corner crack on concrete tile.

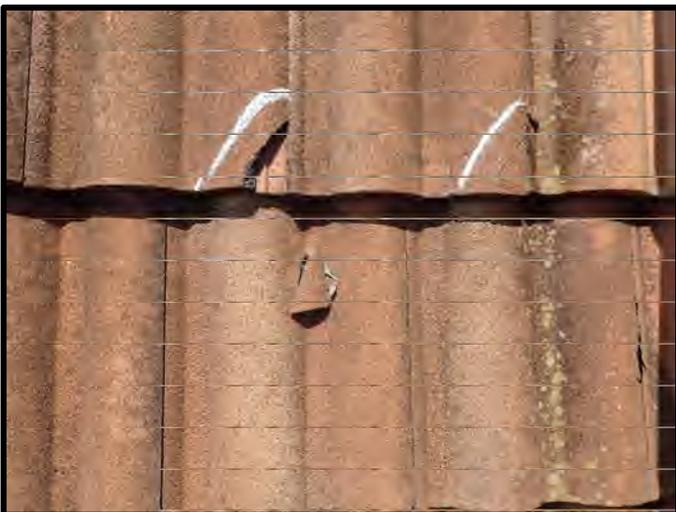
Photograph 3 – Concrete roof tiles with corner cracks.

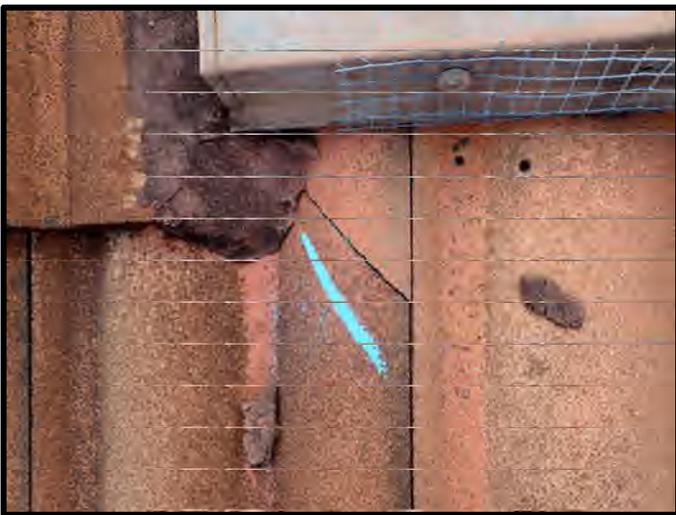
Photograph 3 – Concrete roof tile with corner crack.

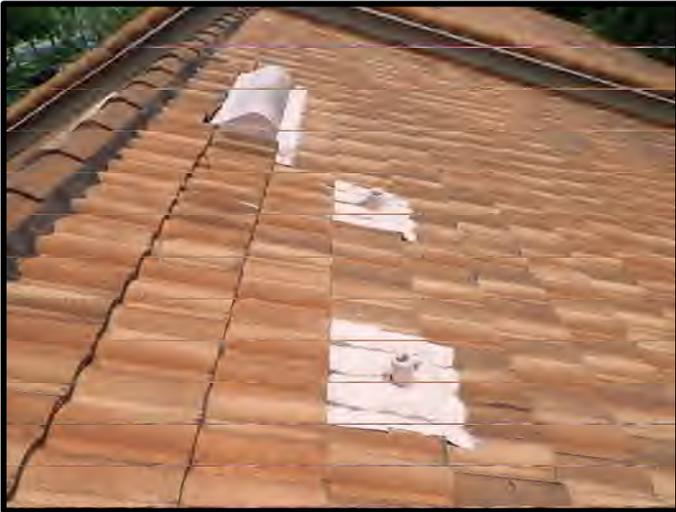
Photograph 5 – Concrete roof tile conditions at roof vent.

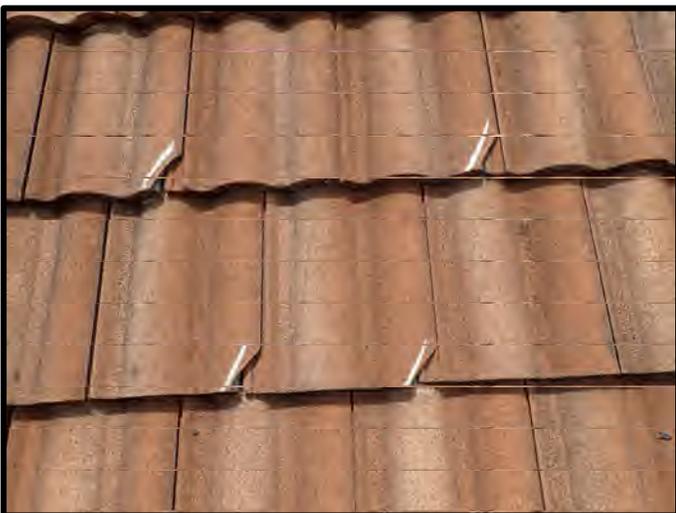
Photograph 7 – Several concrete roof tiles with chipped corners.

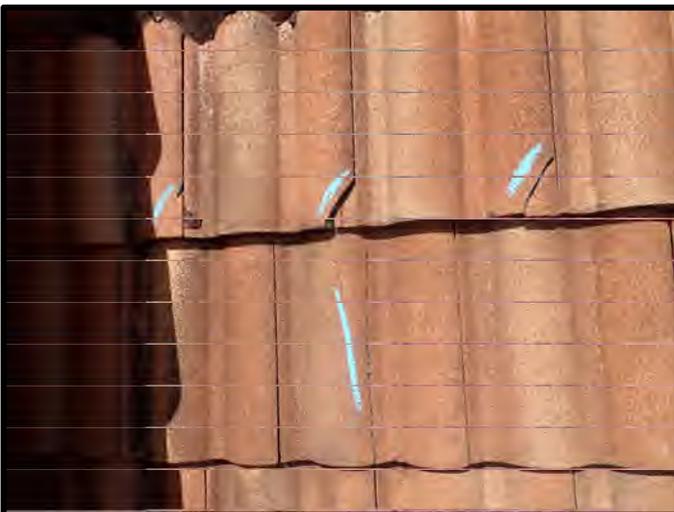
Photograph 3 – Several concrete roof tiles with corner cracks and roof tile with longitudinal crack.

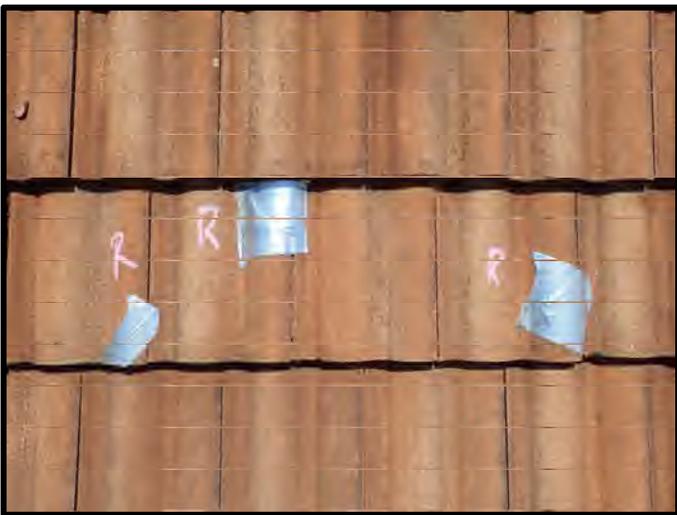
Photograph 3 – Previously repaired concrete roof tiles with metal tape.

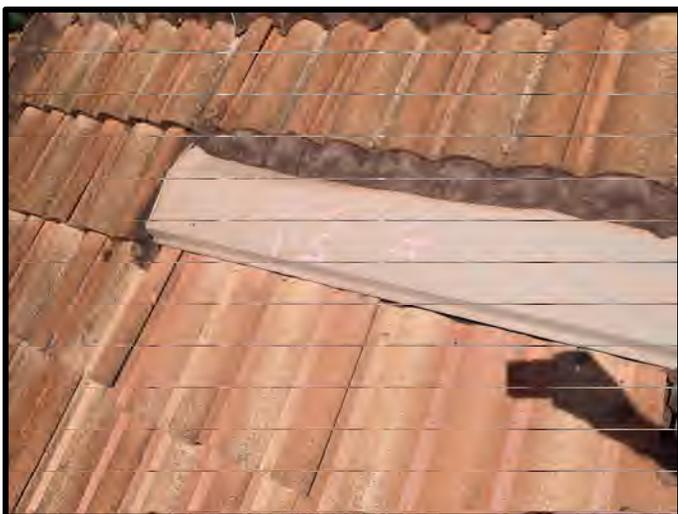
Photograph 3 – Slipped concrete roof tiles under roof vent.

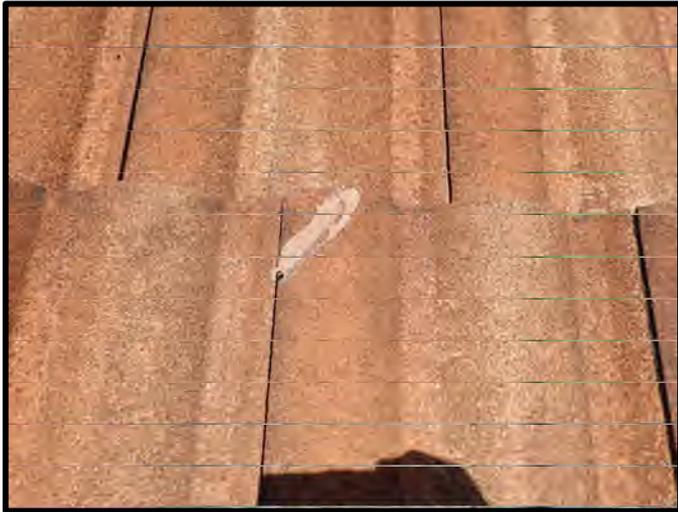
Photograph 5 – Concrete roof tile with previously repaired corner crack.

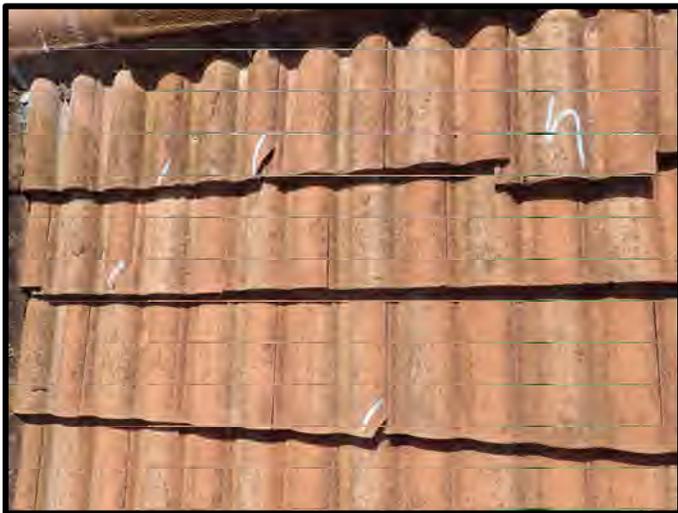
Photograph 7 – Slipped concrete roof tile and several roof tiles with corner cracks/chips.

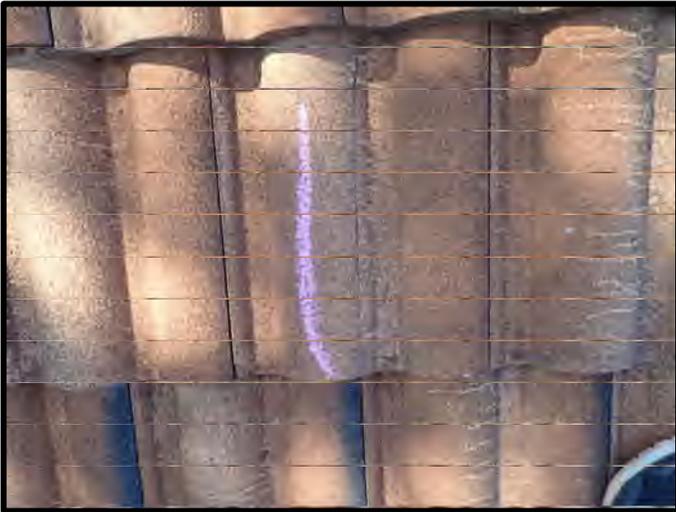
Photograph 5 – Concrete roof tile with hairline longitudinal crack.

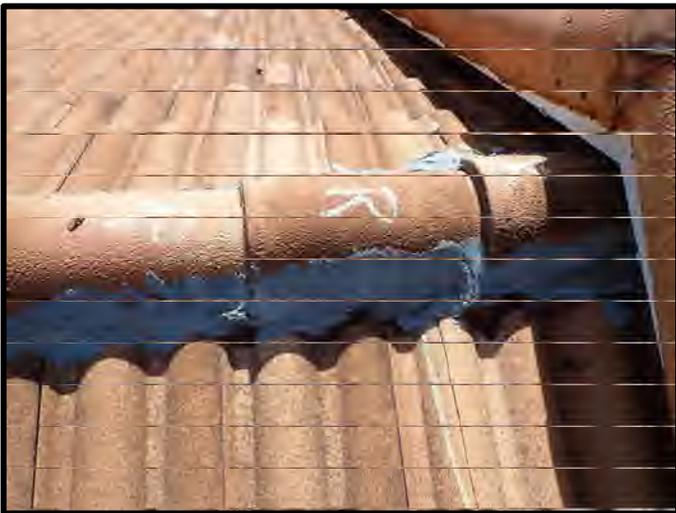
Photograph 7 – Previous mortar repairs at ridge cap tiles.

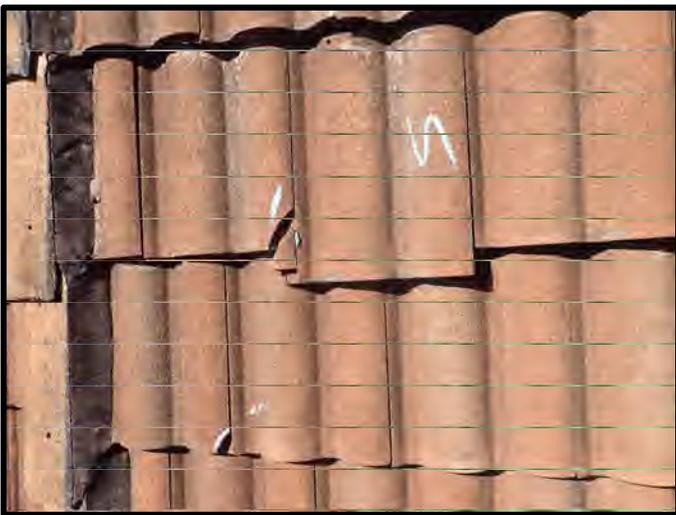
Photograph 3 – Slipped and chipped concrete roof tiles.

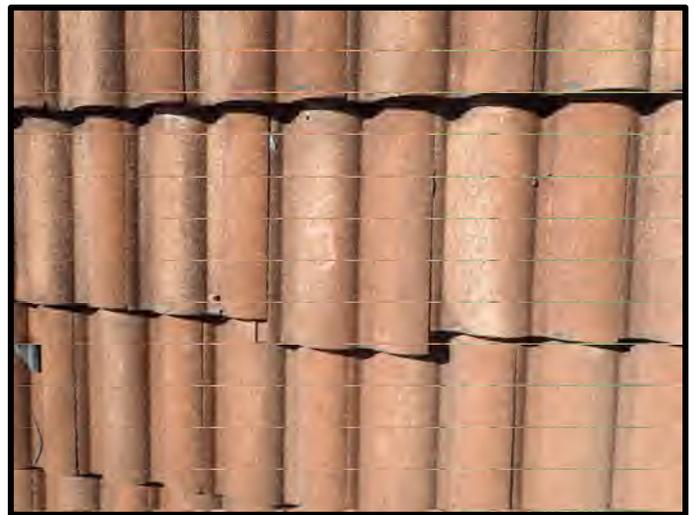
Photograph 4 – Slipped concrete roof tile.

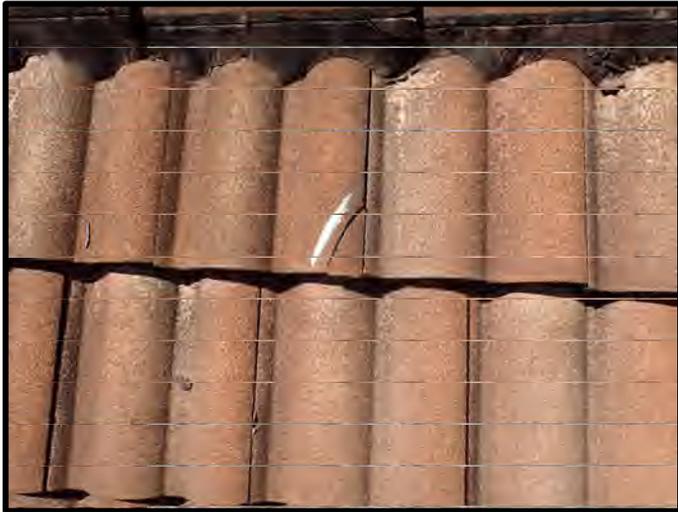
Photograph 5 – Concrete roof tile with corner crack.

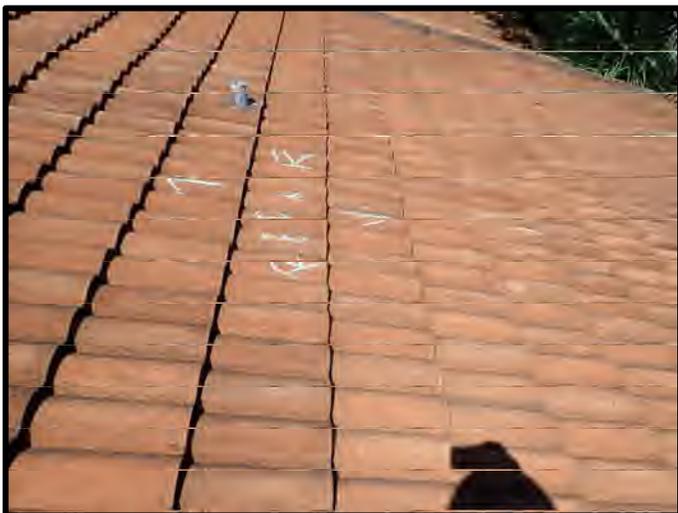
Photograph 7 – Area of previously repaired concrete roof tiles.

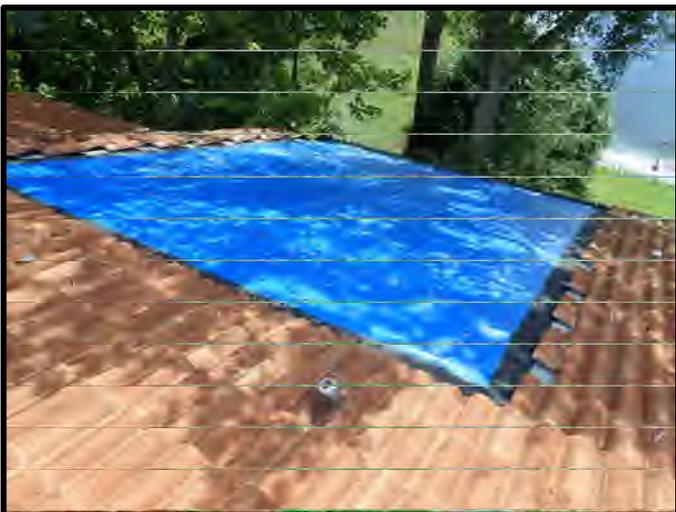
Photograph 3 – Tarpaulin (tarp) covering area of missing tiles.

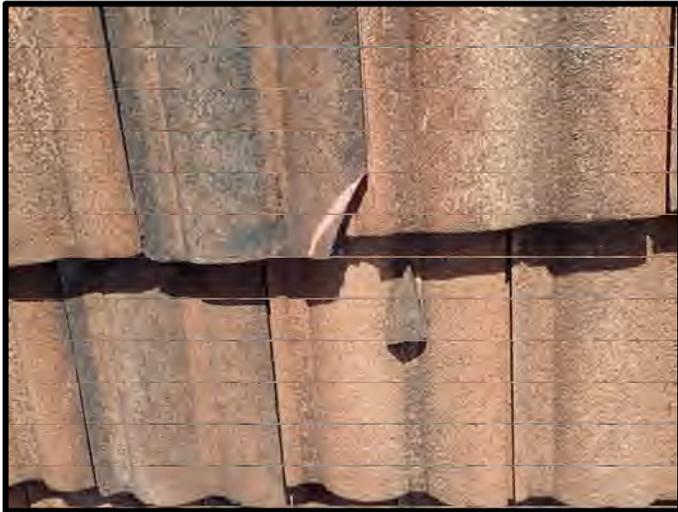
Photograph 5 – Concrete roof tile with corner chip still in place on roof surface.

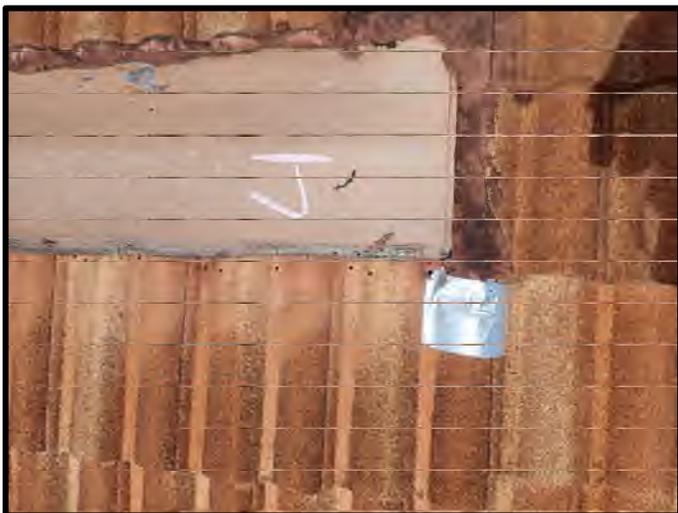
Photograph 7 – Previously repaired concrete roof tile with metal tape.

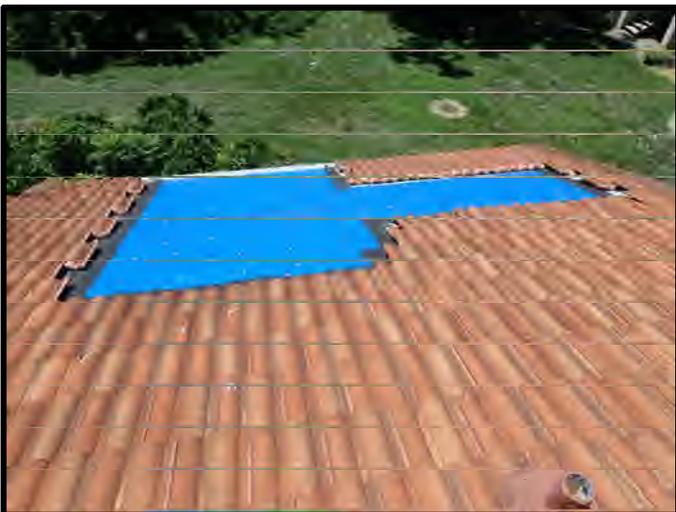
Photograph 3 – Tarpaulin (tarp) covering area of missing roof tiles.

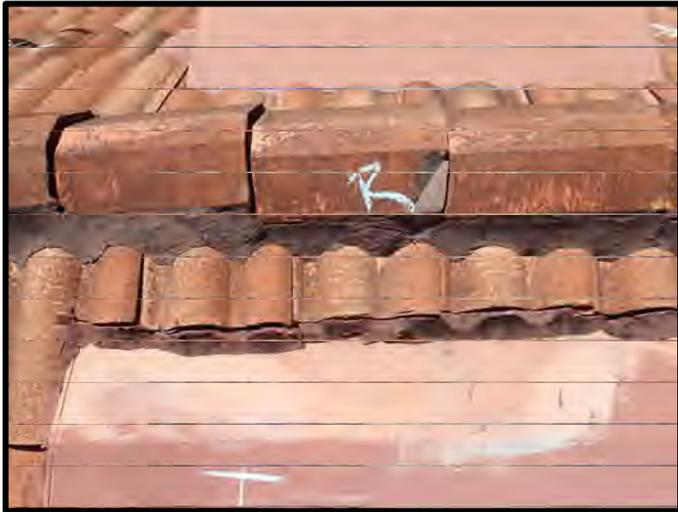
Photograph 5 – Ridge cap tile with previous repair.

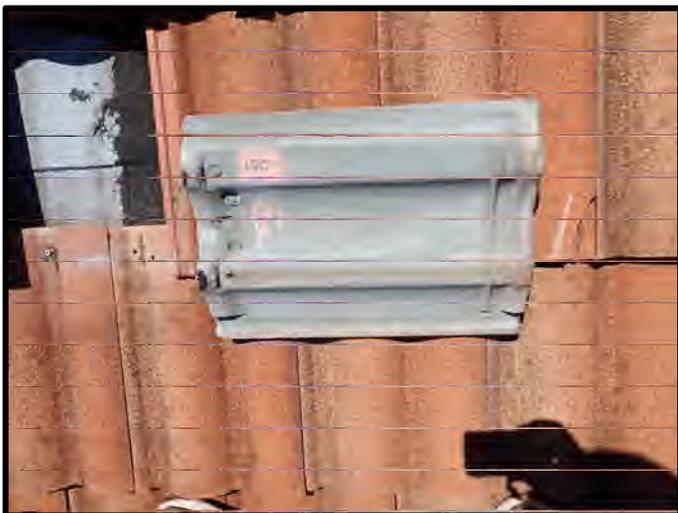
Photograph 7 – Loose Monier A210T tile temporarily removed for inspection.

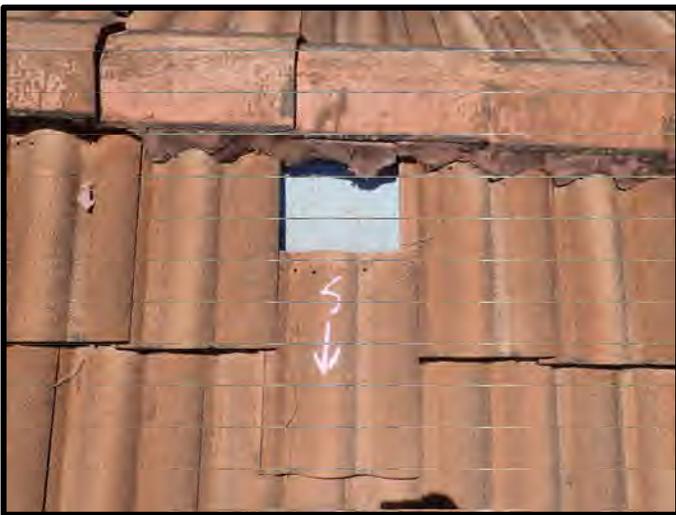
Photograph 3 – Slipped concrete roof tile.

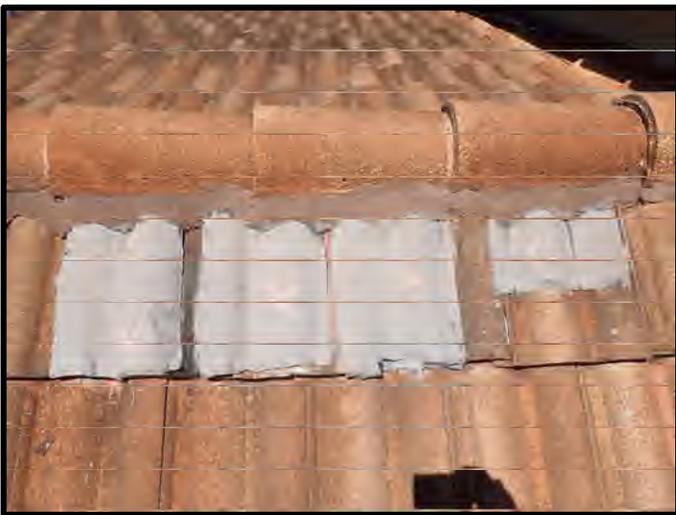
Photograph 3 – Previously repaired concrete roof tiles.

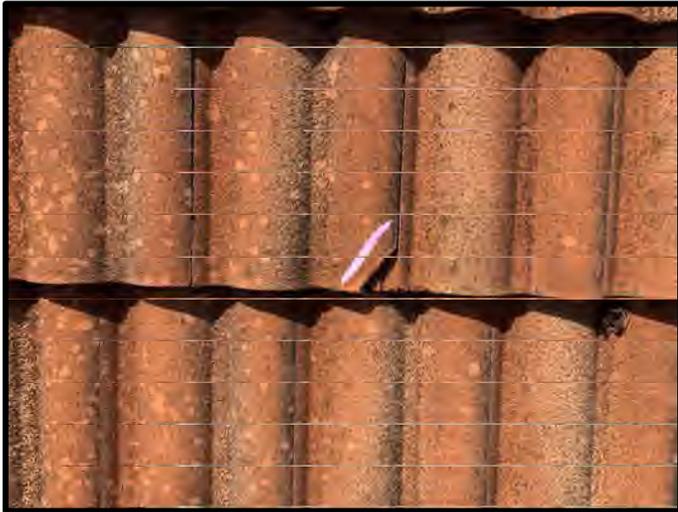
Photograph 5 – Concrete roof tile with corner chip.

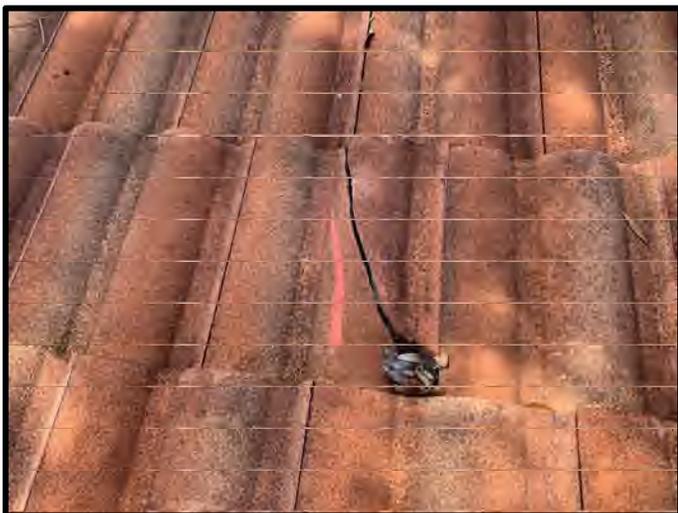
Photograph 7 – Cracked concrete roof tile.

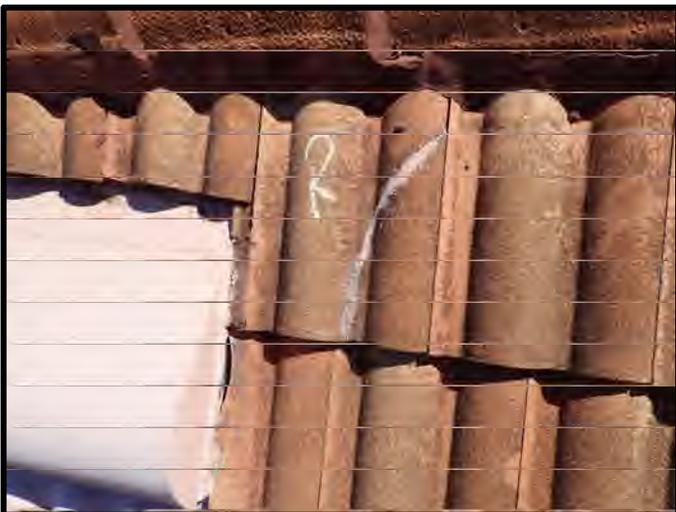
Photograph 3 – Previously repaired concrete roof tile with sealant.

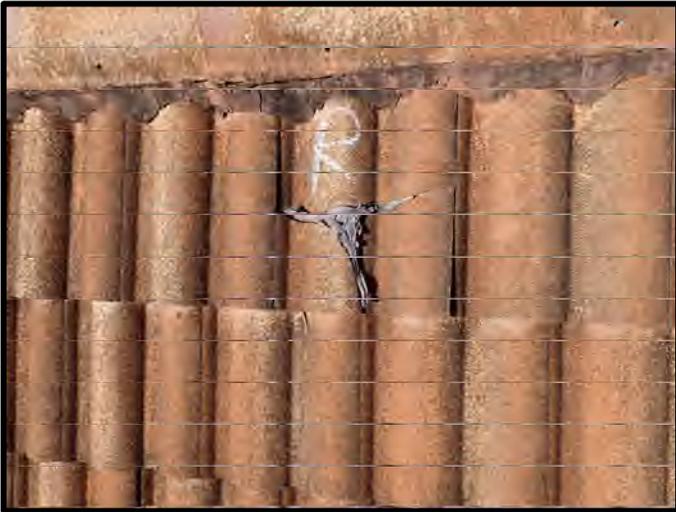
Photograph 5 – Previously repaired concrete roof tile with sealant.

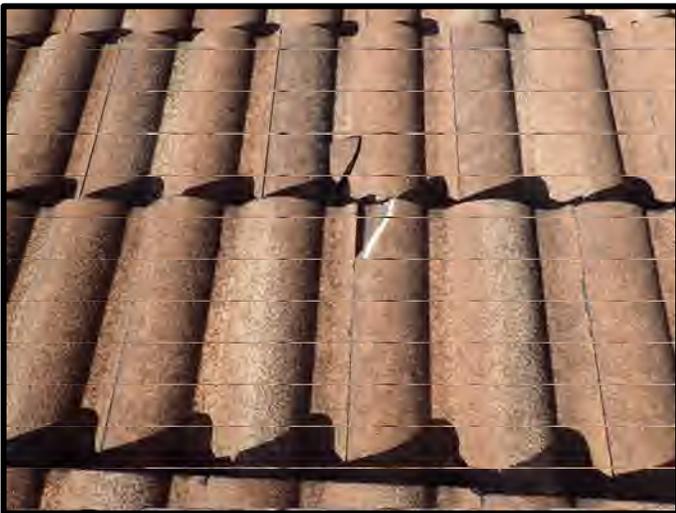
Photograph 7 – Cracked concrete roof tile with cracked portion still in place on roof surface.

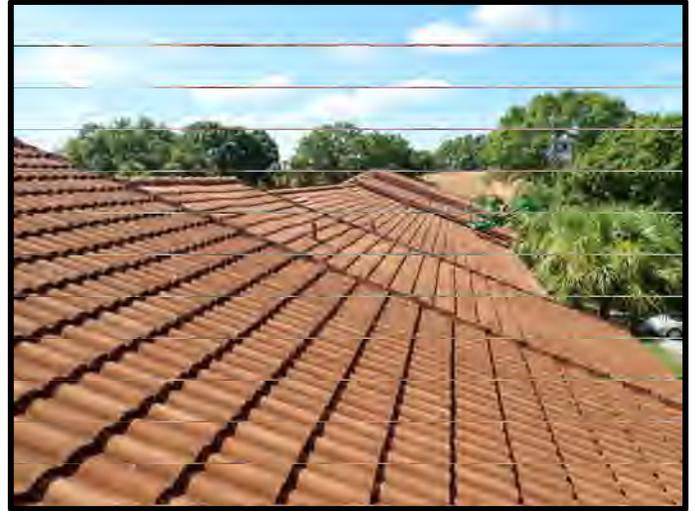
Photograph 2 – Overall roof condition of subject building.
