**Vintage Grand Condominium Association  
Hurricane Irma  
Damage Assessment**

ESi Project #: 78360G

# Investigative Report

## Vintage Grand Condominium Association Hurricane Irma Damage Assessment

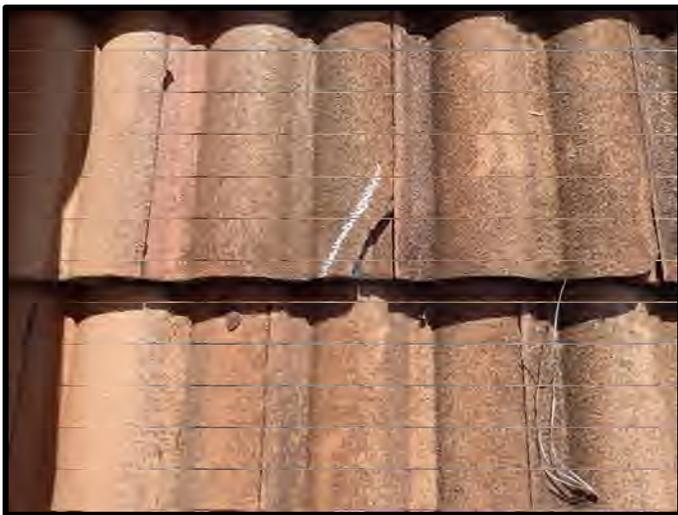
Photograph 3 – Cracked concrete roof tile.

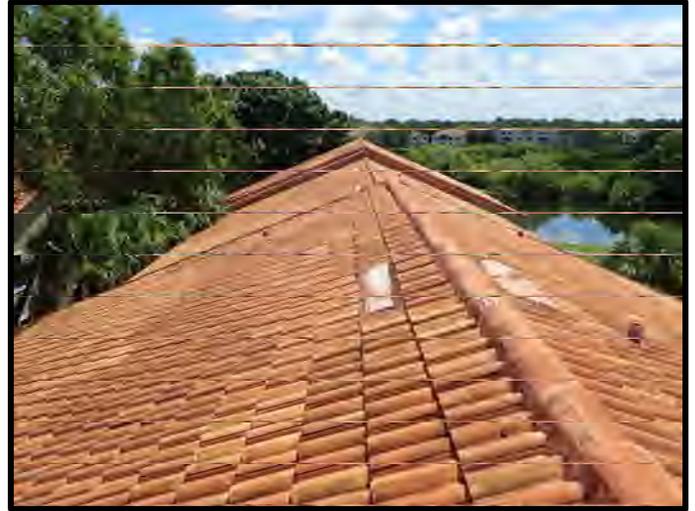
Photograph 2 – Overall roof condition of subject building.

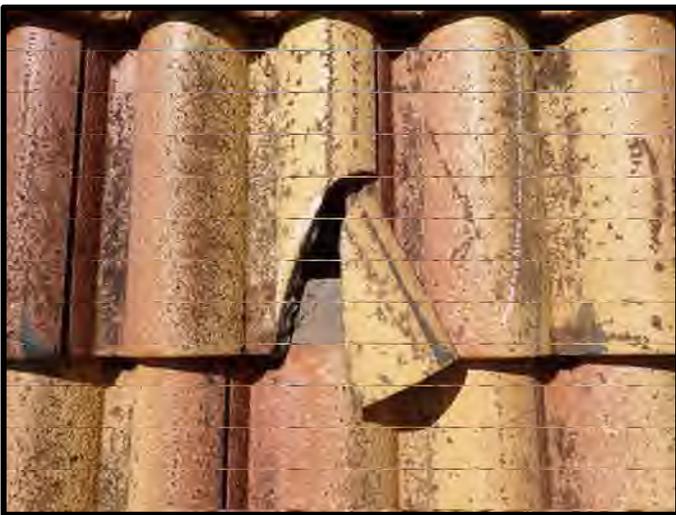
Photograph 3 – Cracked concrete roof tile.

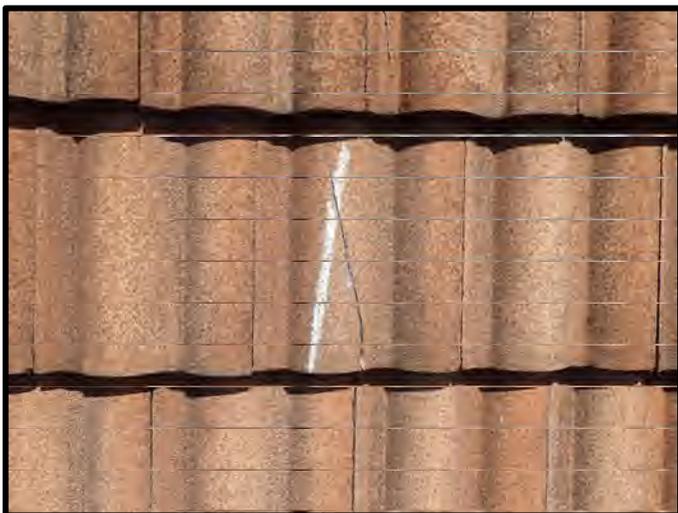
Photograph 7 – Concrete roof tile with longitudinal crack.

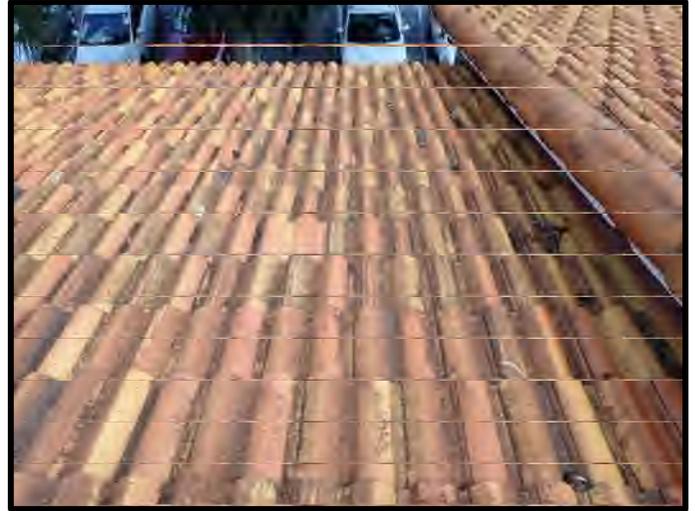
Photograph 2 – Overall roof condition of subject building.

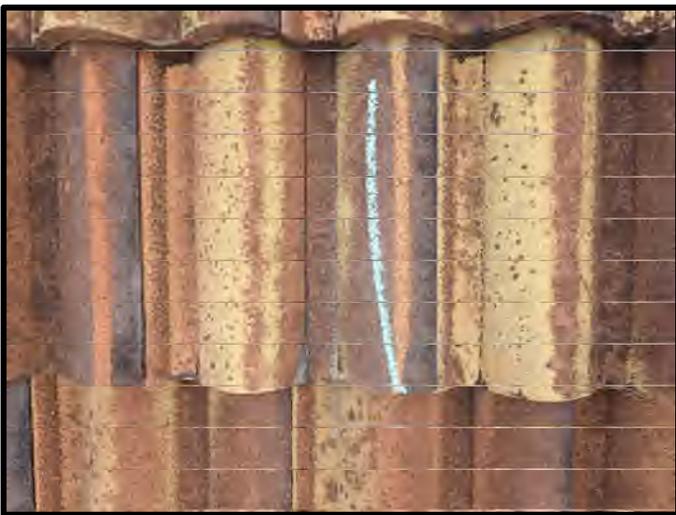
Photograph 3 – Concrete roof tile with longitudinal crack.

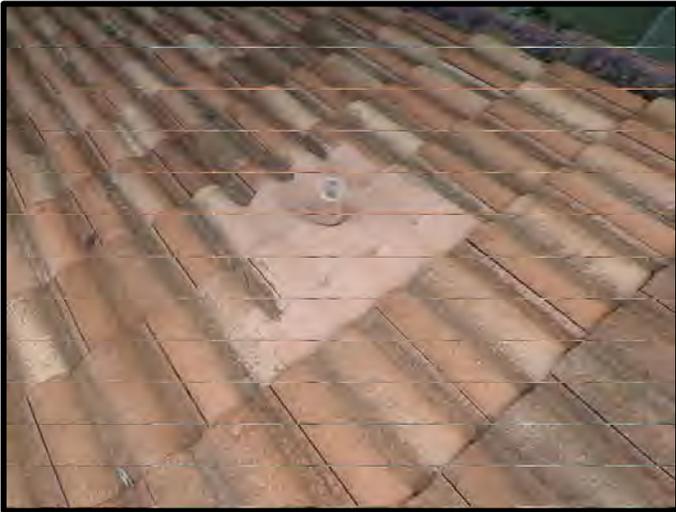
Photograph 5 – Condition at roof vent.

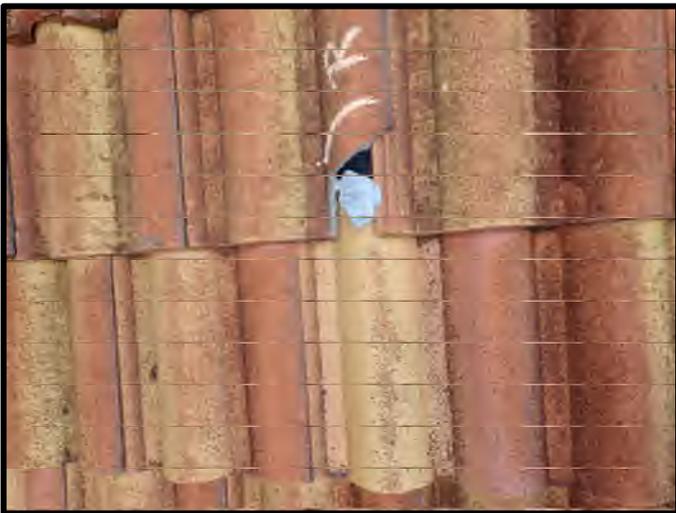
Photograph 7 – Cracked concrete roof tile.

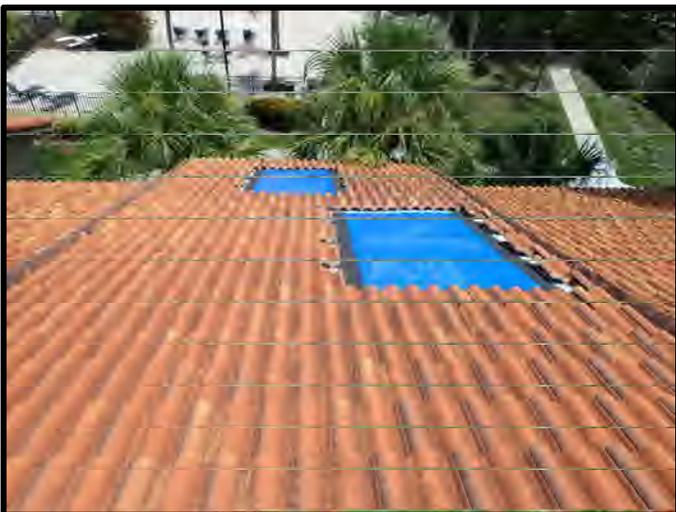
Photograph 3 – Tarpaulin (tarp) covering two areas where roof tiles were removed.

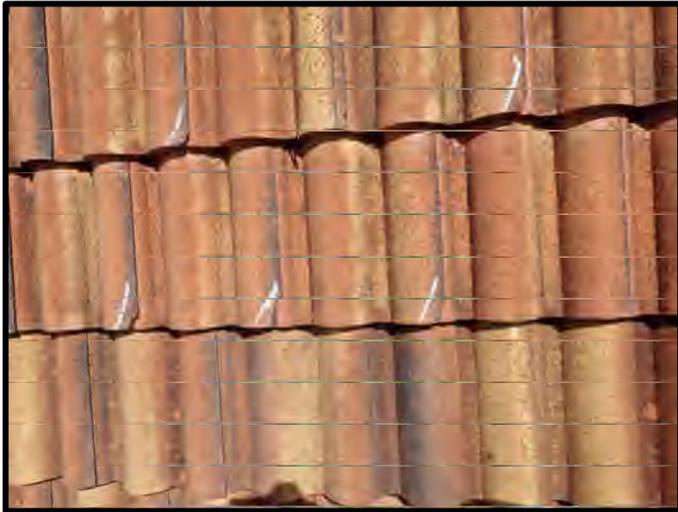
Photograph 5 – Several concrete roof tiles with corner chips.

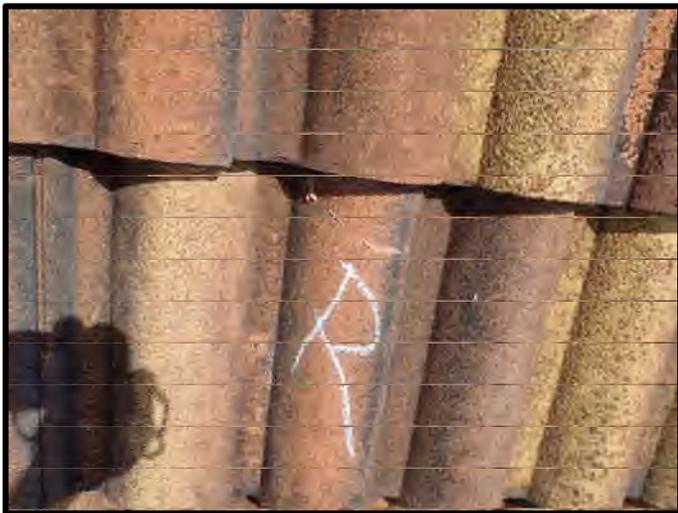
Photograph 7 – Previously repaired concrete roof tile.

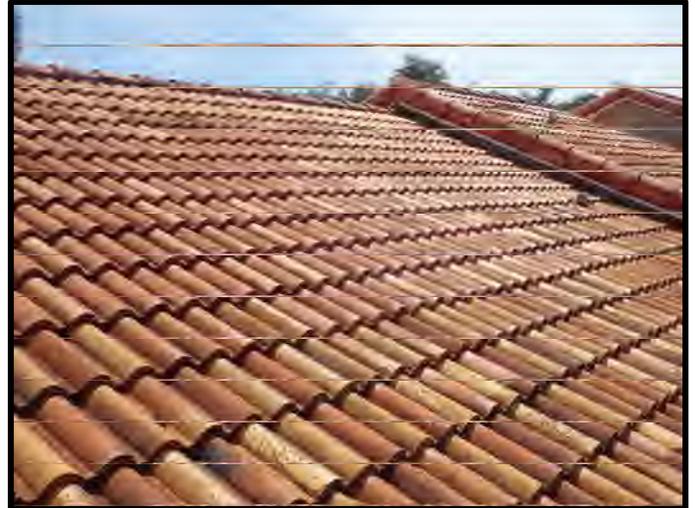
Photograph 2 – Overall roof condition of subject building.

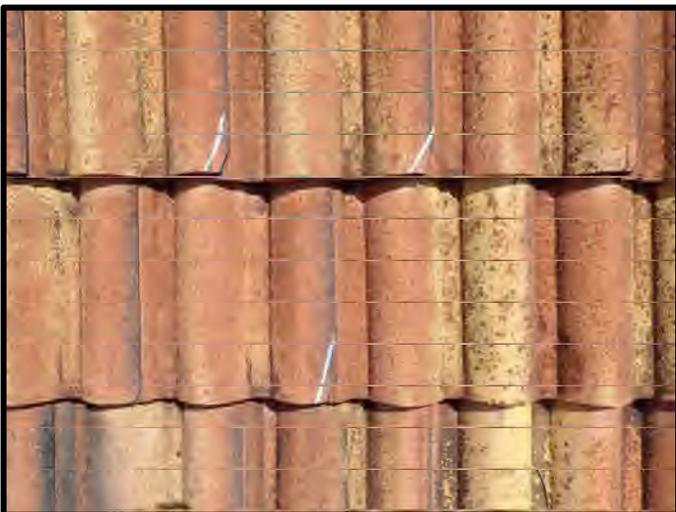
Photograph 3 – Concrete roof tiles with chipped corners.

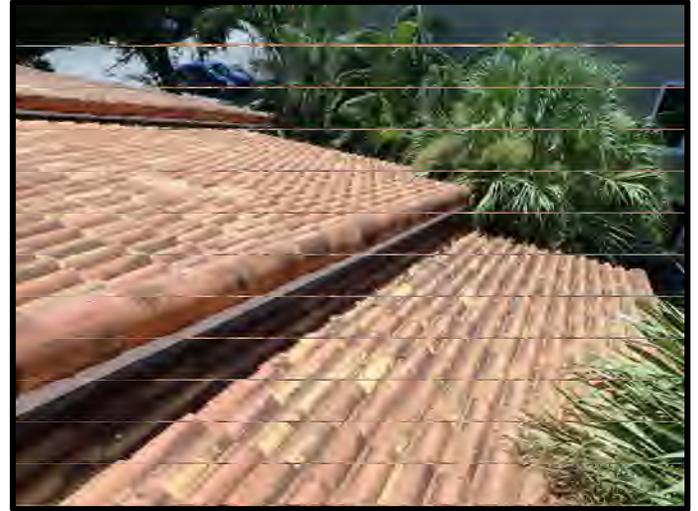
Photograph 2 – Overall roof condition of subject building.

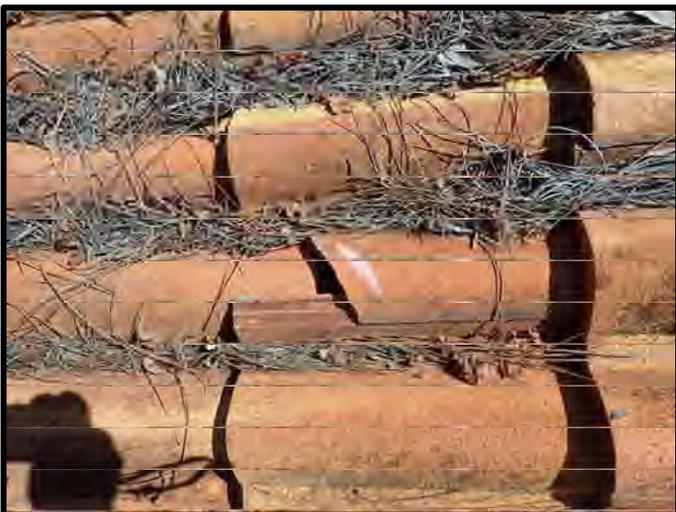
Photograph 3 – Cracked concrete roof tile and pine needles covering roof.

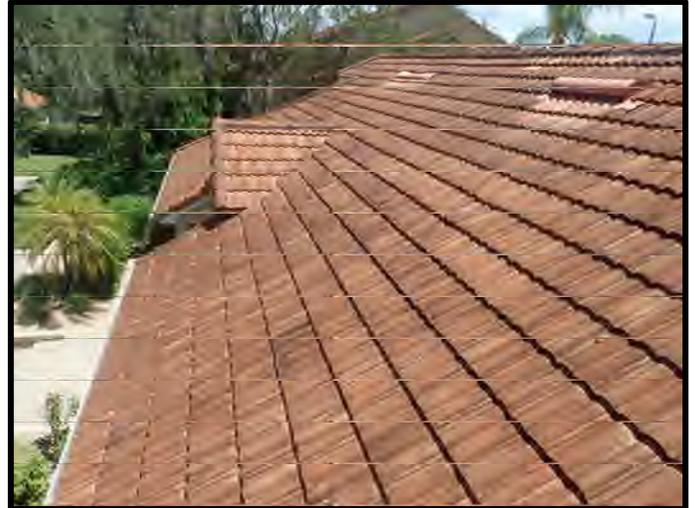
Photograph 2 – Overall roof condition of subject building.

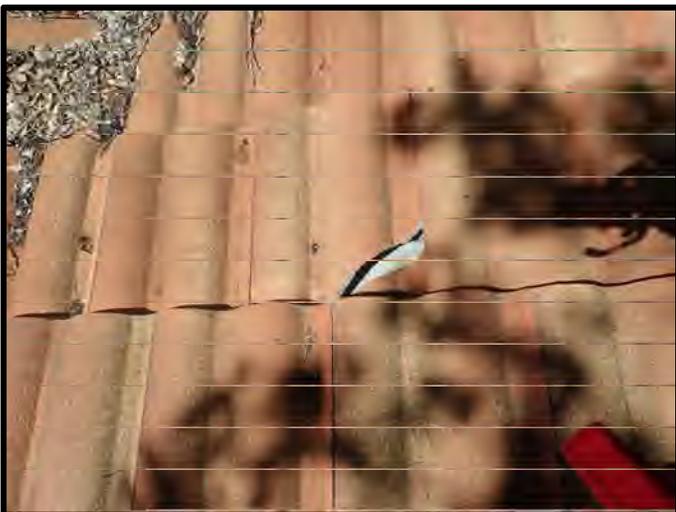
Photograph 3 – Loose Monier T210A tile.
